## **TENDER NO: 2024-17**

# <u>Lower Cove Loop –</u>

## **CSO Chamber Rehab & Check Valve Installation**

### **ADDENDUM**

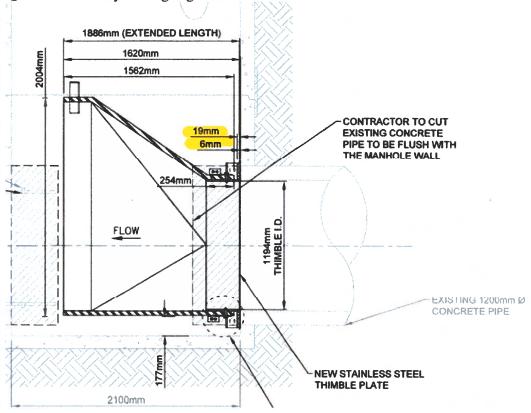
Q2: Please clarify the highlighted dimensions

**A2:** 6mm represents the gasket and 19mm represents the plate thickness. This is based on a shop drawing from the valve supplier for the thimble plate.

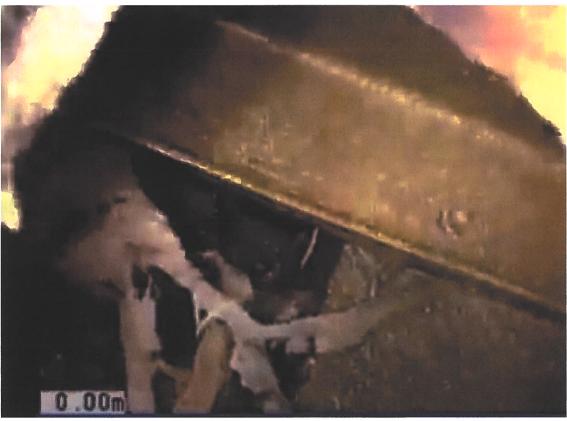
Figure 2: Concrete cut-out below the flap gate downstream of CSO No. 1, including segregated grout (1:53 of video CSO#1 (90 Manhole WWN-COM-MH-84269.mp4)

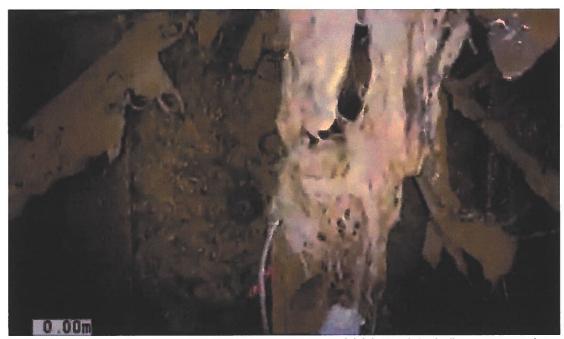
Figure 3: Concrete cut-out below the flap gate downstream of CSO No. 1, including segregated grout (2:20 of video CSO#1 (90 Manhole WWN-COM-MH-84269.mp4)

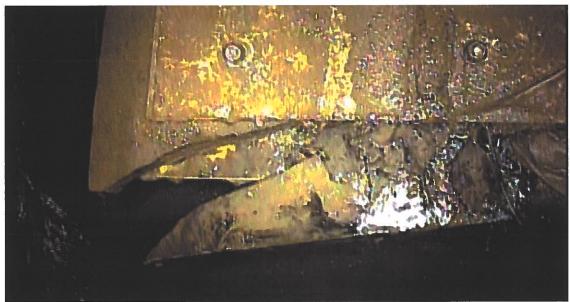
Figure 4: CSO No. 1 flap gate gasket visibly ripped

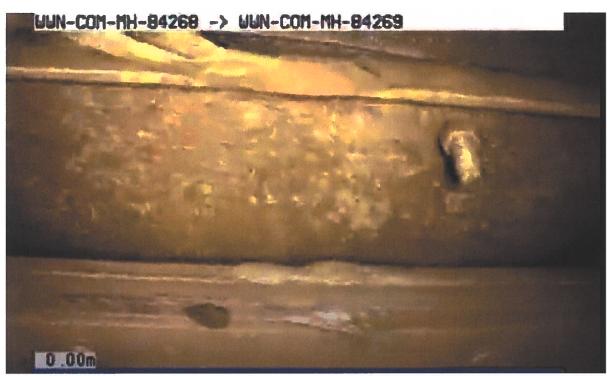
Figure 5: Sealant around flap gate in CSO No. 1 dislodged and no longer sealing (90 Manhole WWN-COM-MH-84269.mp4)

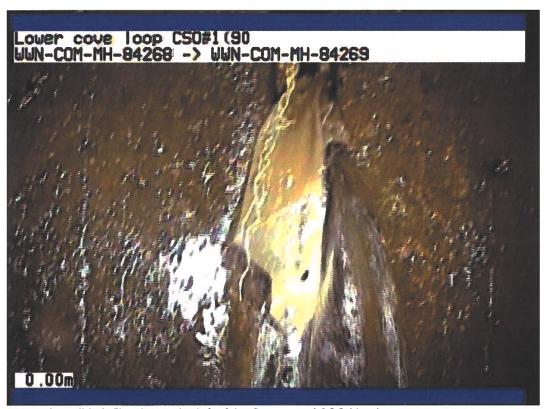
Figure 6: Visible infiltration to the left of the flap gate of CSO No. 1

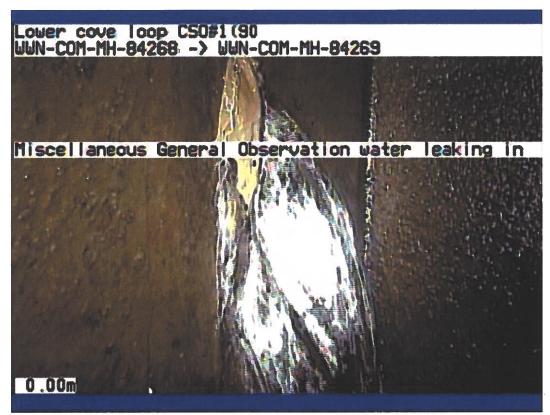
Figure 7: Visible infiltration to the left of the flap gate of CSO No. 1

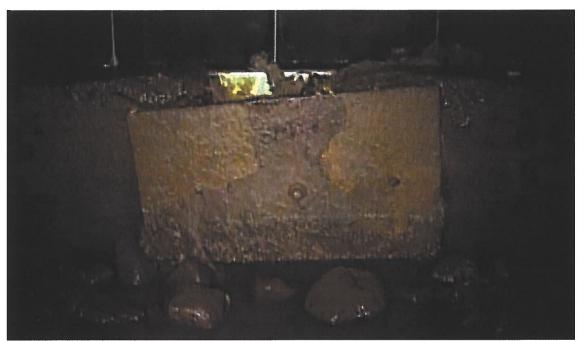
Figure 9: Metal plate blocking the cut-out concrete below the flap gate on the upstream side of CSO No. 1

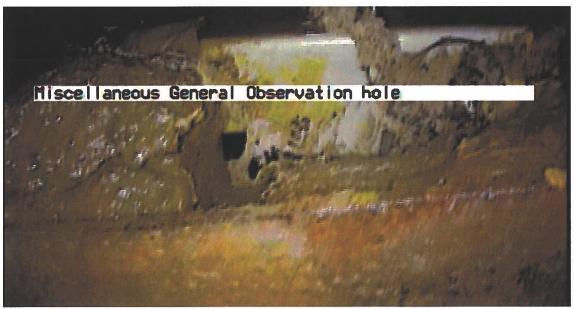
Figure 10: Top metal plate blocking the cut-out concrete below the flap gate on the upstream side of CSO No. 1. Visible gap between the flap gate and the concrete/grout.

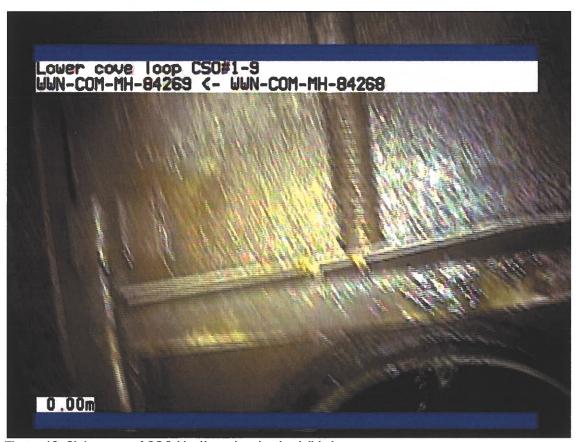
Figure 12: Sluice gate of CSO No.1's outlet pipe is visibly bent

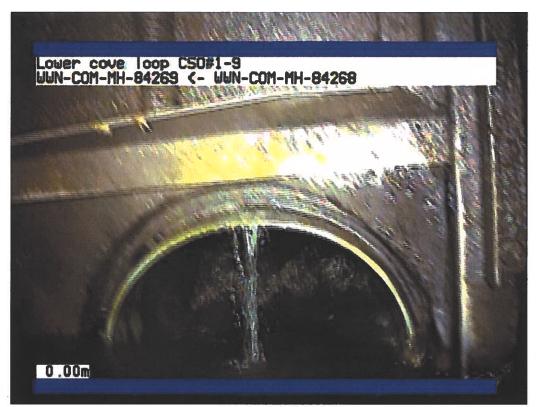
Figure 13: Sluice gate of CSO No. 1's outlet pipe is visibly bent

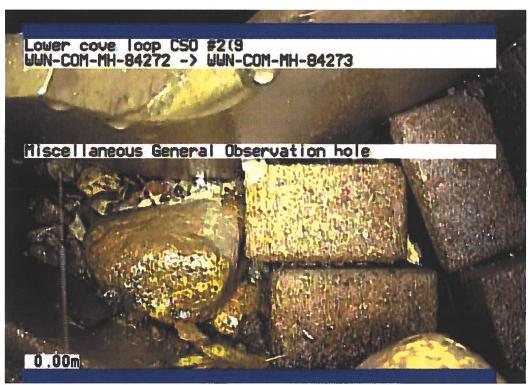
Figure 14: Perimeter of CSO No. 2's outlet pipe filled with brick and rocks. Mortar seems to be washed away

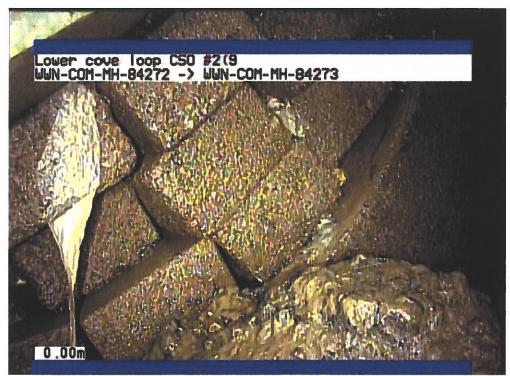
Figure 15: Perimeter of CSO No.2's outlet pipe filled with brick and rocks. Mortar seems to be washed away

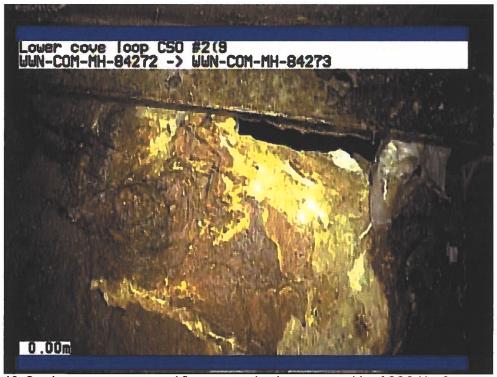
Figure 16: Gap between concrete and flap gate on the downstream side of CSO No, 2

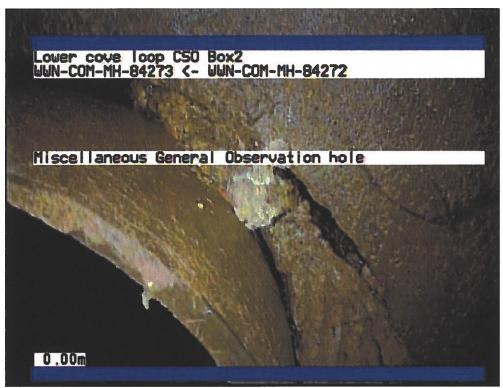
Figure 17: Perimeter of CSO No.2's inlet pipe filled with brick and rocks. Mortar seems to be washed away

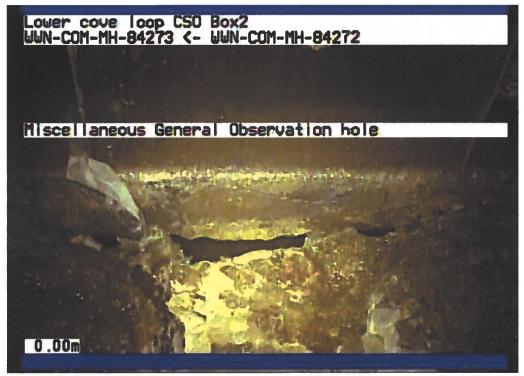
Figure 18: Gap between concrete and flap gate on the upstream side of CSO No, 2

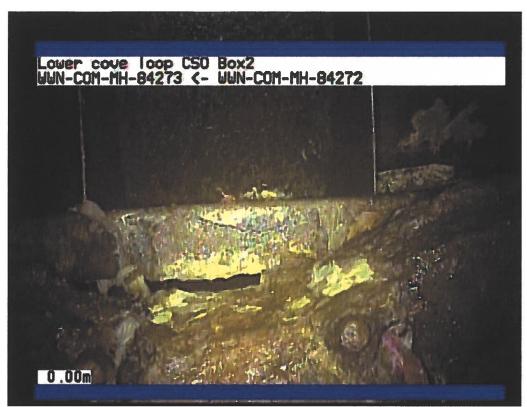
Figure 19: Gap between concrete and flap gate on the upstream side of CSO No, 2

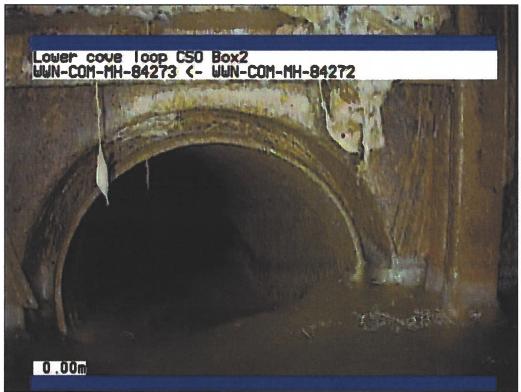
Figure 20: Debris accumulated on the bottom lip of the sluice gate on the upstream side of CSO No, 2

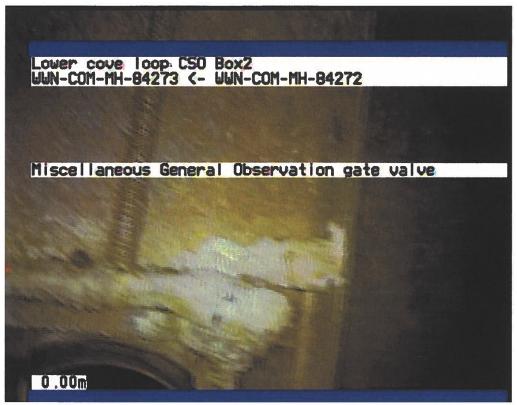
Figure 21: Debris accumulated on the bottom lip of the sluice gate on the upstream side of CSO No, 2

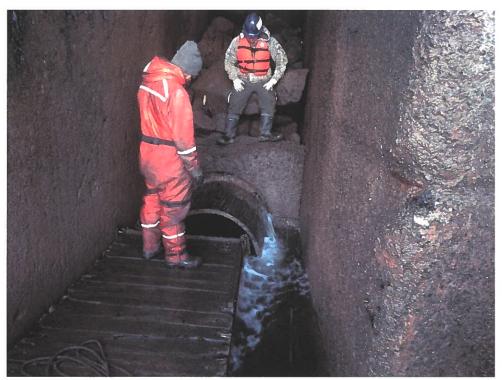
Figure 1: HDPE Sliplining at Outfall - Before Tideflex Install

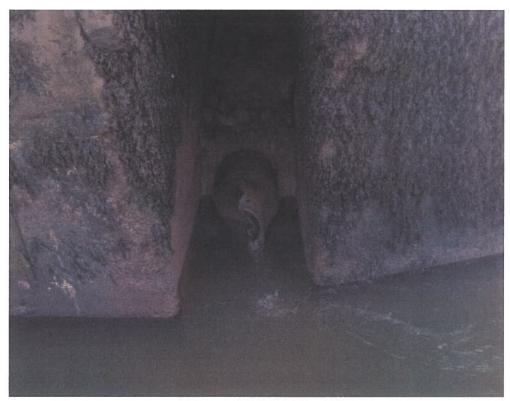
Figure 2: Damaged Tideflex at Outfall
