**Capital Management
Engineering Limited**

**Capital Plan
Building Condition and Energy Assessment
Canada Games Aquatic Centre
50 Union Street
Saint John, New Brunswick**

Final Report

**April 2020
Project Number 1901028**

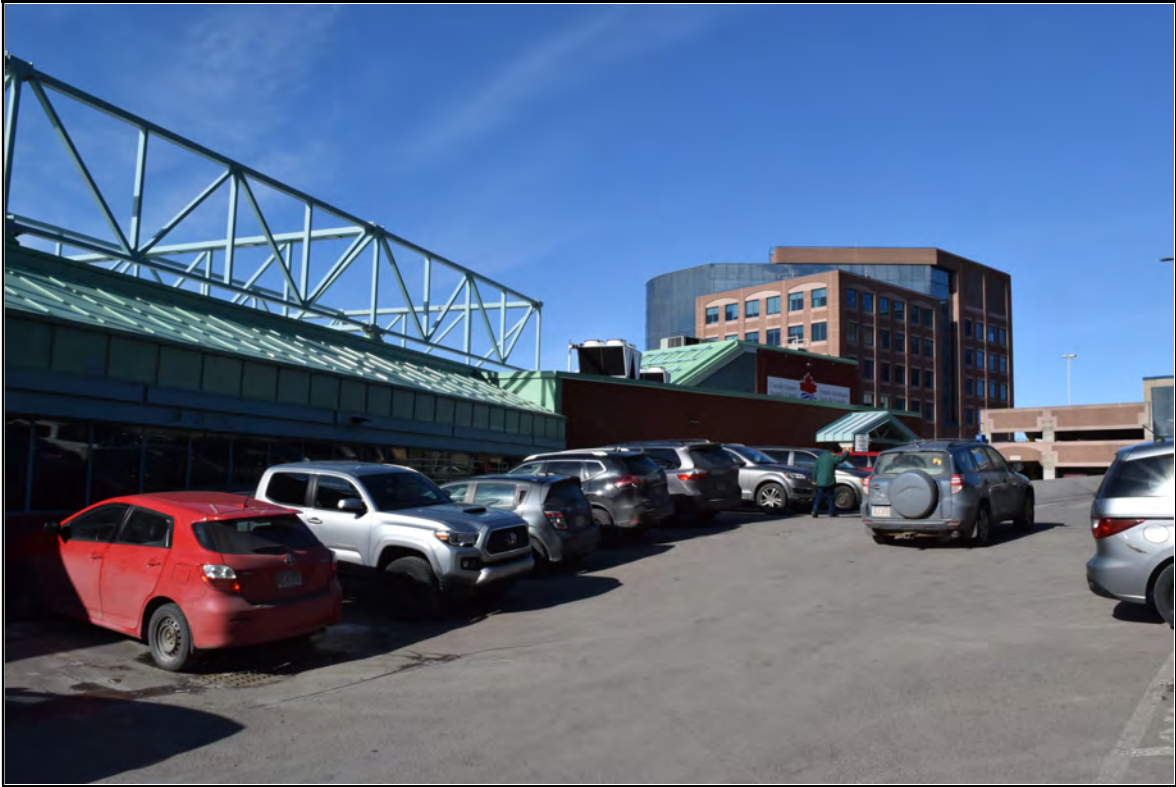
The limited asphalt paving on the east side of the property was observed to be in fair condition overall with some areas of settlement and alligator cracking. The age of the paving was not reported but appears to be fifteen or more years in age. Paving will typically have an expected useful of fifteen to twenty years but can be extended with partial resurfacing at approximately five year intervals. Based on the observed condition, it is anticipated that ongoing partial resurfacing will be required during at ten year intervals during the evaluation period. The estimated cost and timing of the resurfacing has been included in the Cost Table.

Photo 1: Asphalt Paved Parking Area

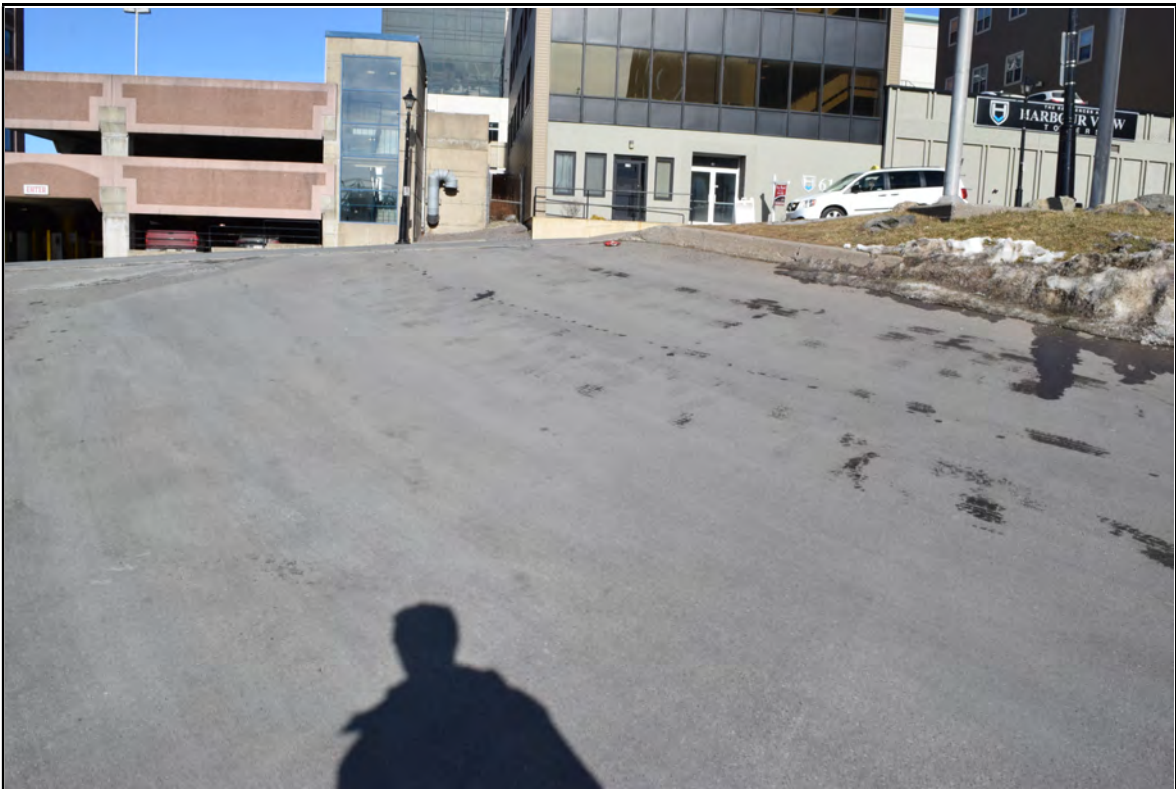
Photo 2: Asphalt Roadway

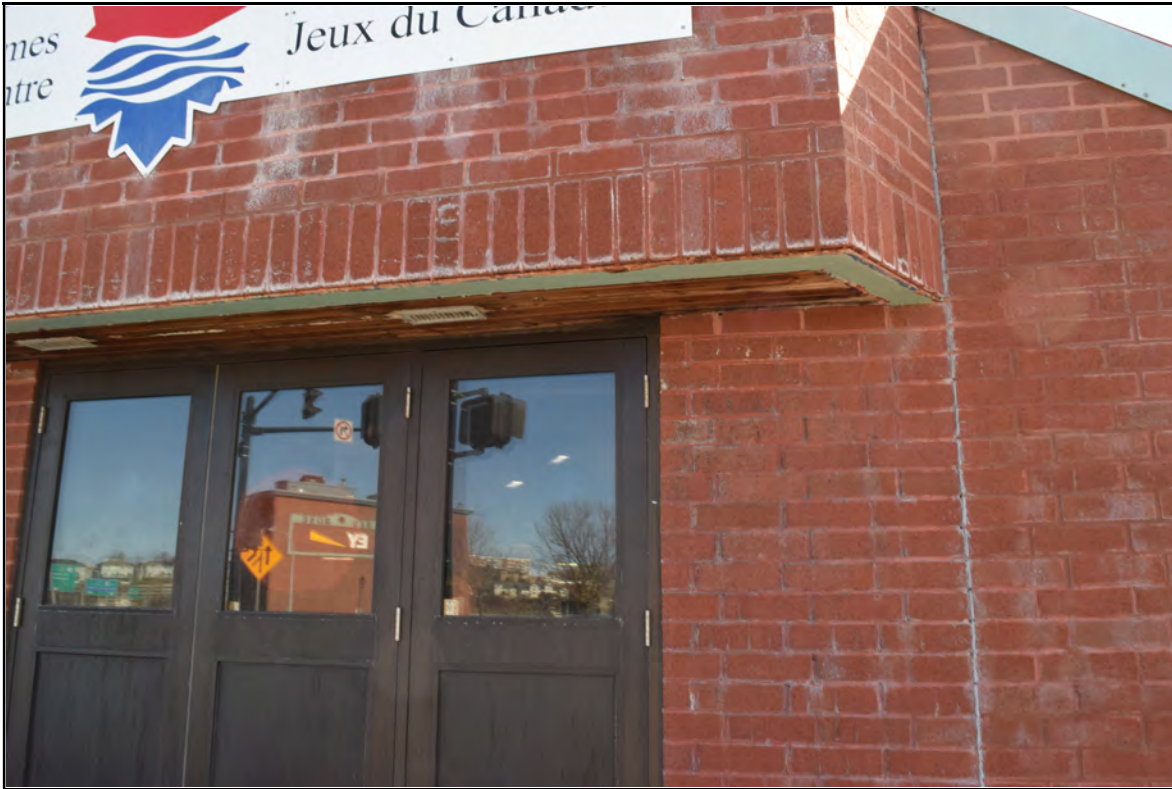
The main entrance prefinished metal exterior doors with glazing appeared to be in fair to poor condition and appear to be original to the building. Typically storefront style doors have an expected useful life of thirty-five years depending on the amount of use and frequency of maintenance, hardware replacement, etc.. Based on the observed condition and estimated remaining useful life it is expected that the doors will require replacement in the short term of the evaluation period. Occasional maintenance including hardware replacement will be required during the evaluation period and be

Photo 3: Entrance Doors

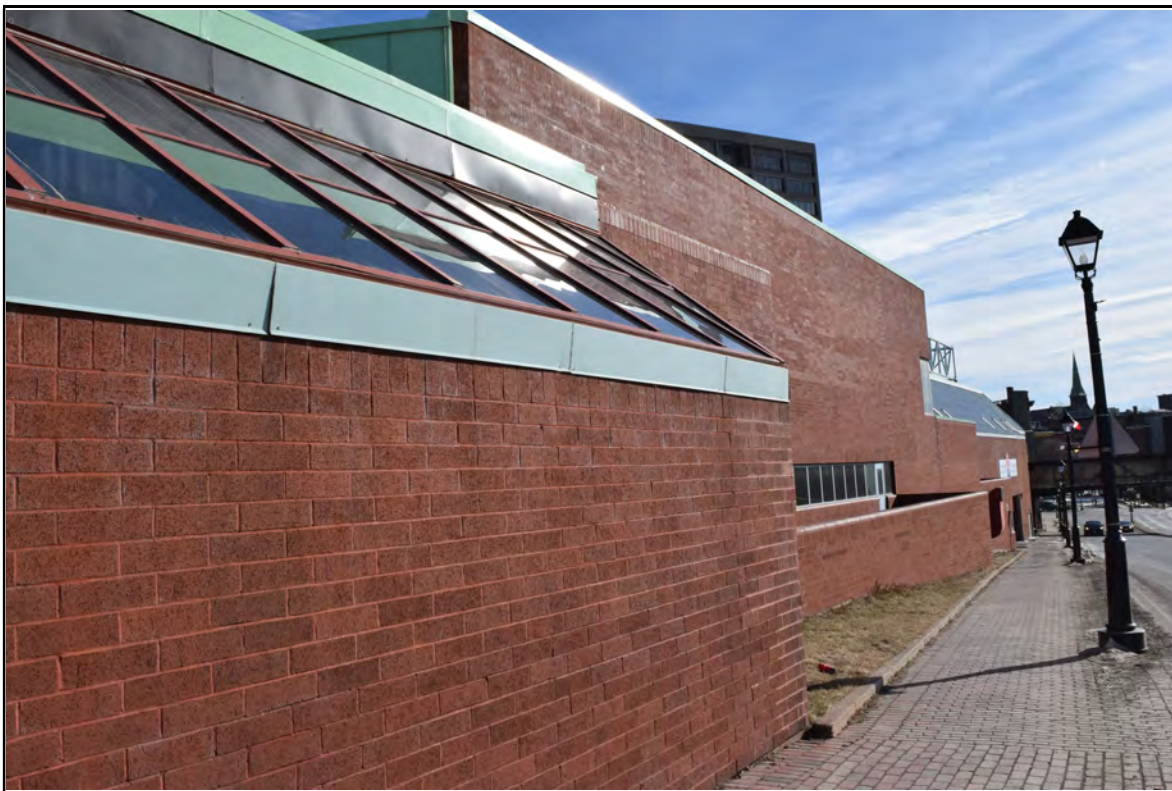
The brick veneer exterior walls varied in overall condition from good to poor depending on the location. Areas of efflorescence were noted in a number of areas on the west

and south elevations and are assumed to be the result of the limited dehumidification in the pool area in the past. In addition evidence of mortar deterioration and spalling was observed on the west elevation beginning at the sloped metal roof to wall transition. The expected useful life of brick veneers is typically in excess of sixty years with localized repairs and repointing beginning after approximately twenty-five years of service. Based on the observed condition and estimated remaining useful life it is recommended that an ongoing phased repointing program be completed during the evaluation period. For the purposes of the capital plan an allowance to repoint approximately fifteen percent of the brick at seven year intervals beginning in the short term has been included in the Cost Table.

The insulated glazing units appeared to be in fair to poor condition with evidence of failed seals and damaged glazing. The glazing is generally original to the building. Typically prefinished metal glazing has an expected useful life of thirty-five to forty years. Based on the observed condition it is anticipated that the glazing will require replacements in the short term of the evaluation period. The estimated cost and timing of the replacement has been included in the Cost Table.

Photo 4: Brick Veneer and Glazing

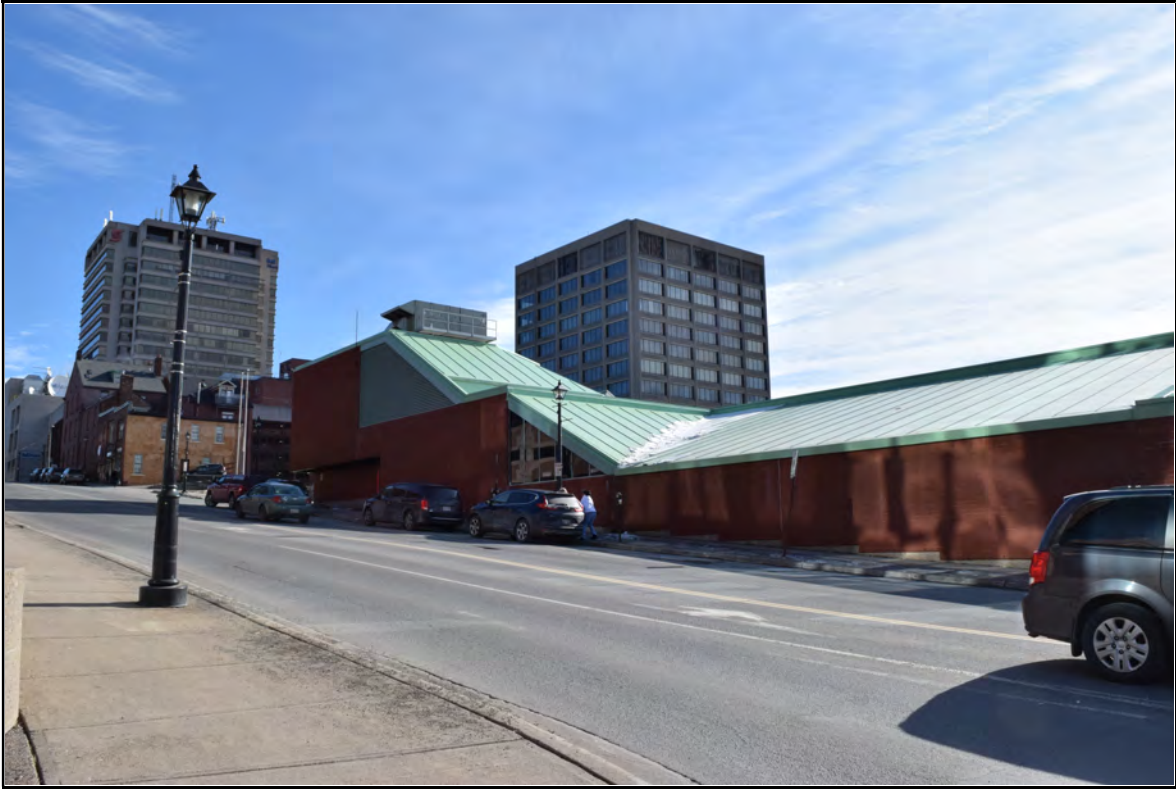
Photo 5: Exterior Brick Veneer and Sloped Metal Roofing

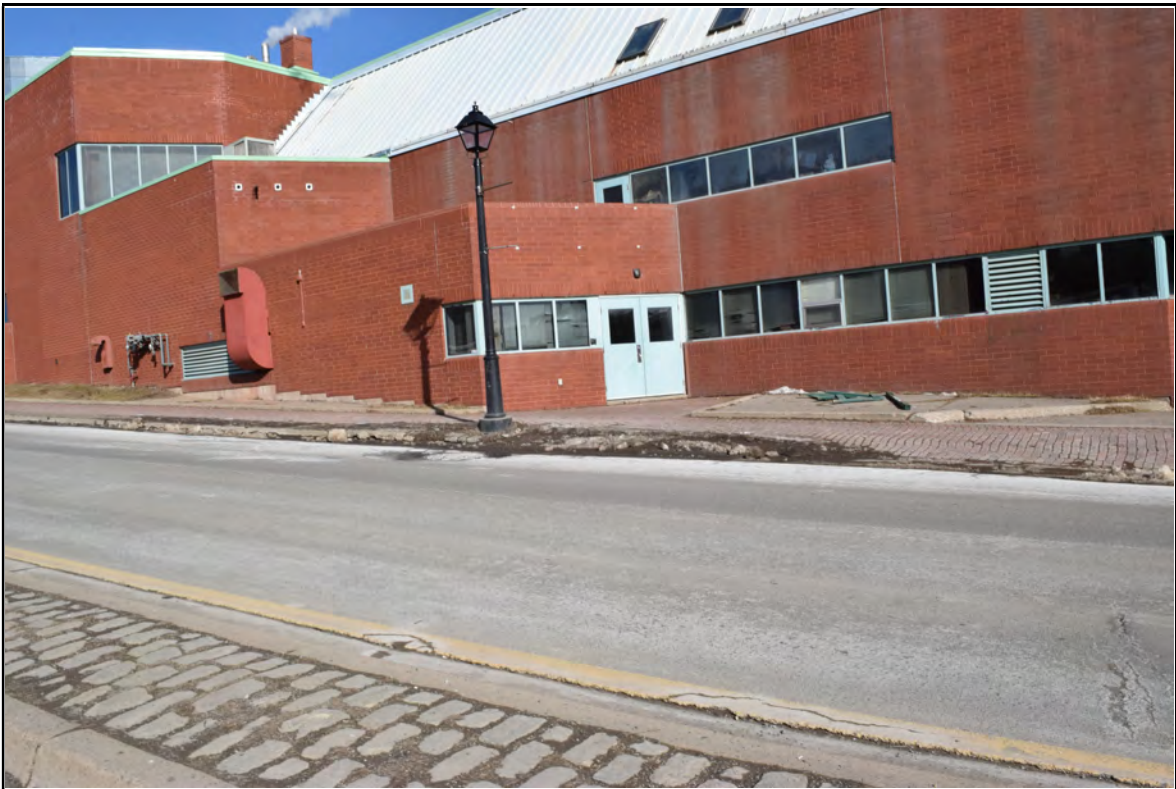
The prefinished metal cladding appeared to be in generally poor condition with evidence of corrosion and faded finishes. Metal cladding will typically have an expected useful life of thirty-five to forty years. Based on the observed condition and estimated remaining useful life it is expected that replacement will be required in the short term of the evaluation period. The estimated cost and timing of the replacement has been included in the Cost Table.

The exit and service doors appeared to be in fair to poor condition with areas of surface corrosion and faded finishes. Typically metal exterior doors have an expected useful life of twenty to twenty-five years. Based on the observed condition and estimated remaining useful life replacement of the majority of the doors are expected to be required during the short term of the evaluation period. Occasional maintenance including hardware replacement will be required during the evaluation period and be completed as part of operations and maintenance budgets. The estimated cost and timing of the replacements has been included in the Cost Table.

Photo 6: Exterior Cladding and Secondary Entrance Doors

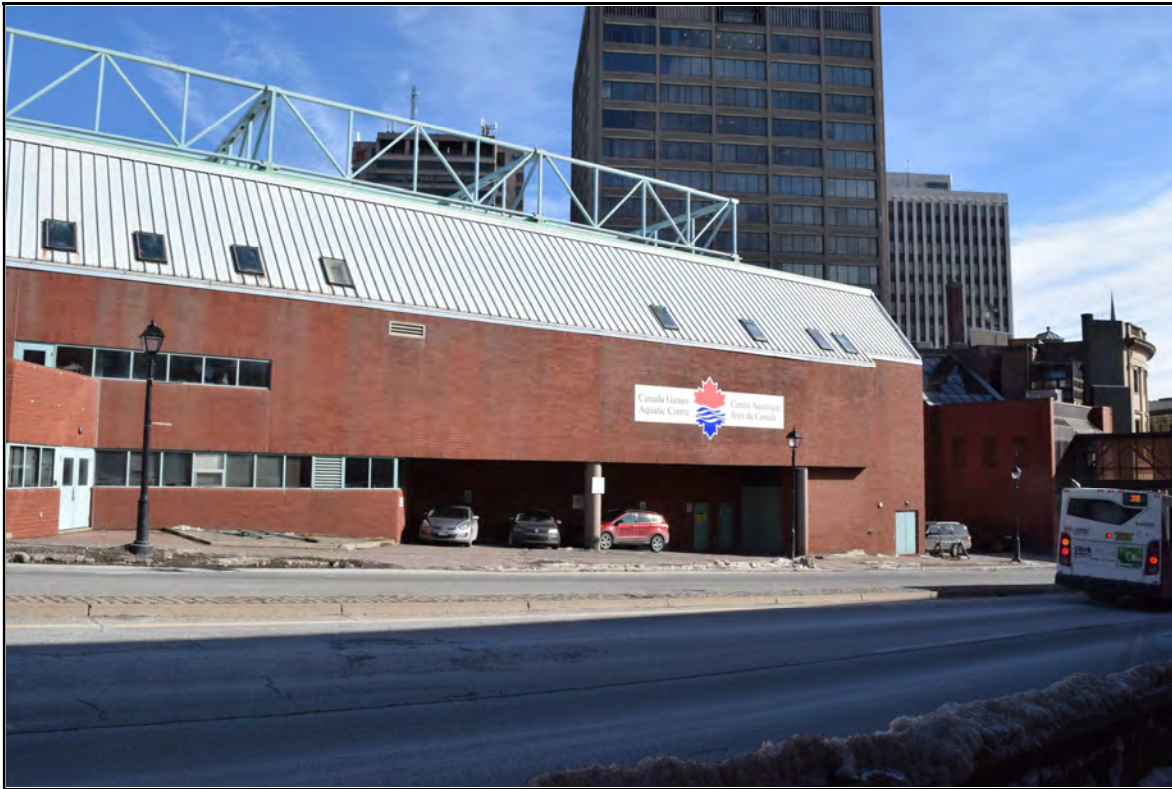
Photo 7: Exterior Cladding

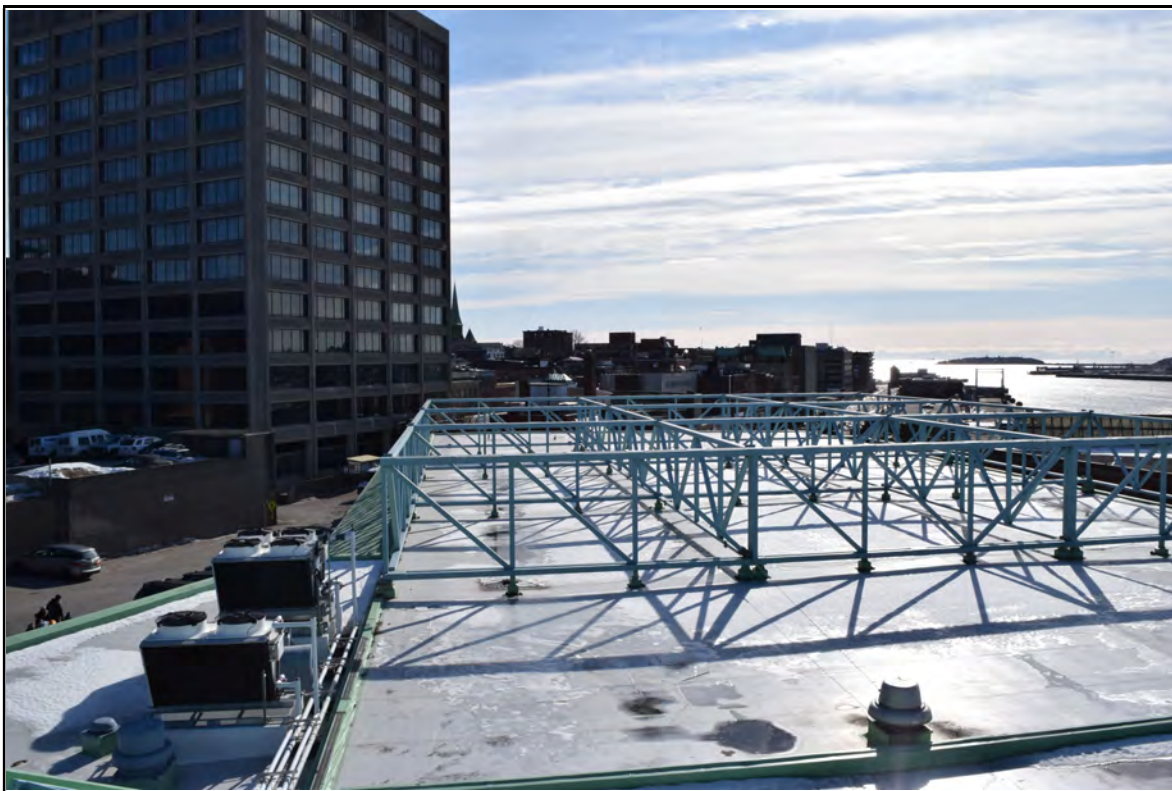
The painted metal frame on the roof appeared to be in fair to good condition with no significant evidence of corrosion or staining. The frame appears to have been recently painted and maintained. Typically painted metal exposed to the elements will require frequent ongoing maintenance including painting. Assuming ongoing maintenance it is anticipated that the frame will have a remaining expected useful life of thirty or more years. For the purposes of the capital plan an allowance has been included for refurbishment beyond ongoing maintenance beginning in the in the long term of the evaluation period.

Photo 8: Modified Bitumen Roofing and Metal Frame on Roof

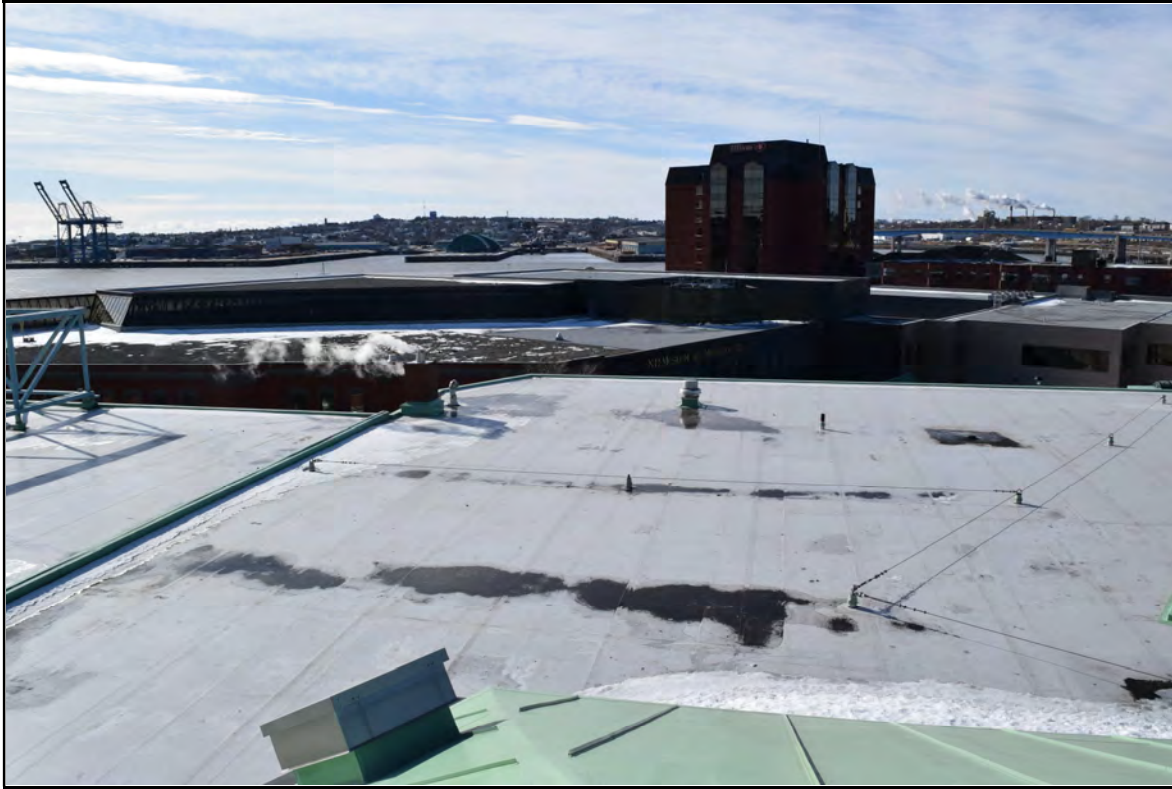
Photo 9: Modified Bitumen Roofing

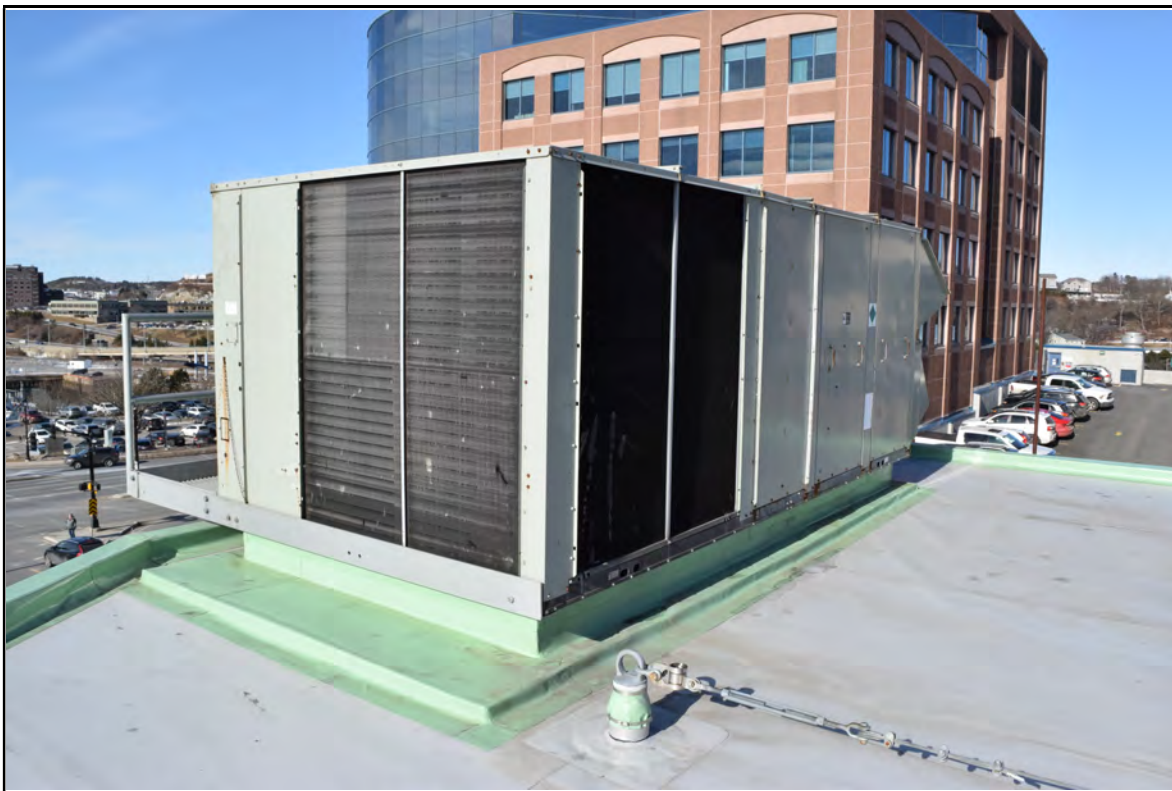
Photo 10: Trane Rooftop Unit

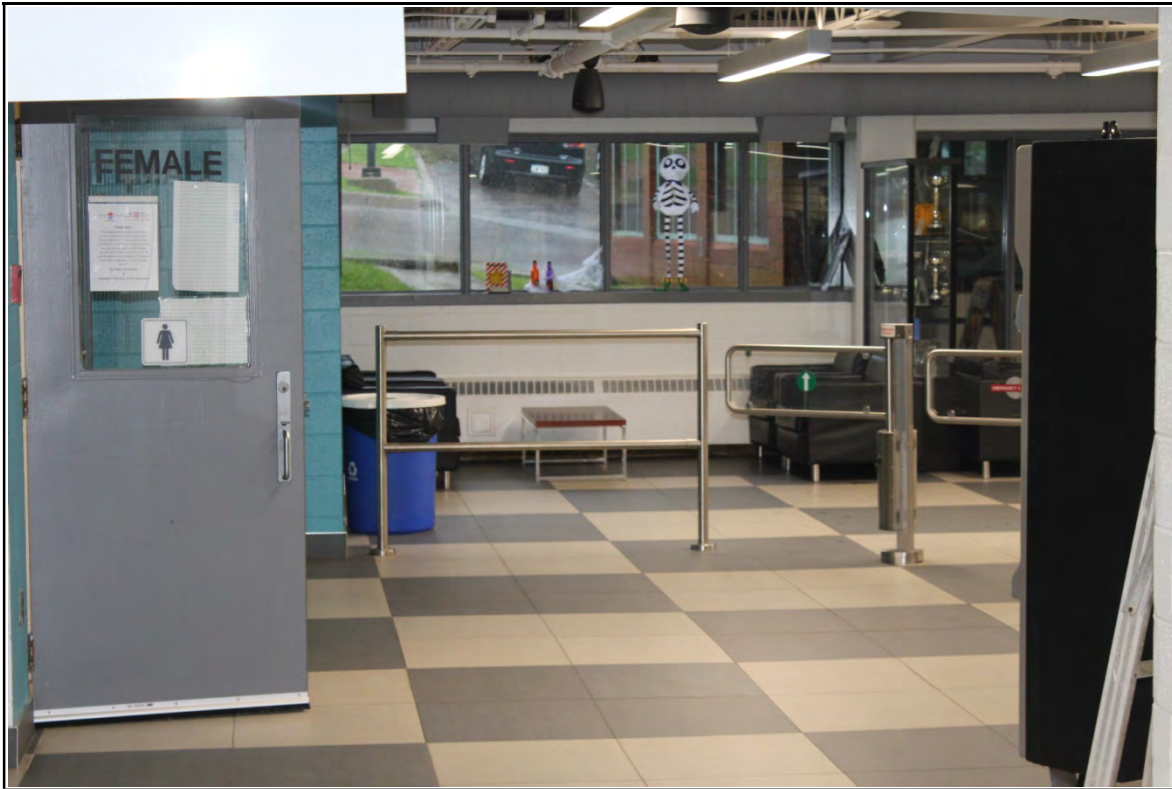
The ceramic tile flooring in the main lobby was reported to have been installed in 2016 and appeared to be in good condition. Ceramic tile flooring will have an expected useful life of forty or more years. Based on the observed condition and estimated remaining useful life it is not expected that the tile will require replacement during the current evaluation period. No costs have been included in the Cost Table.

Photo 11: Main Lobby Finishes

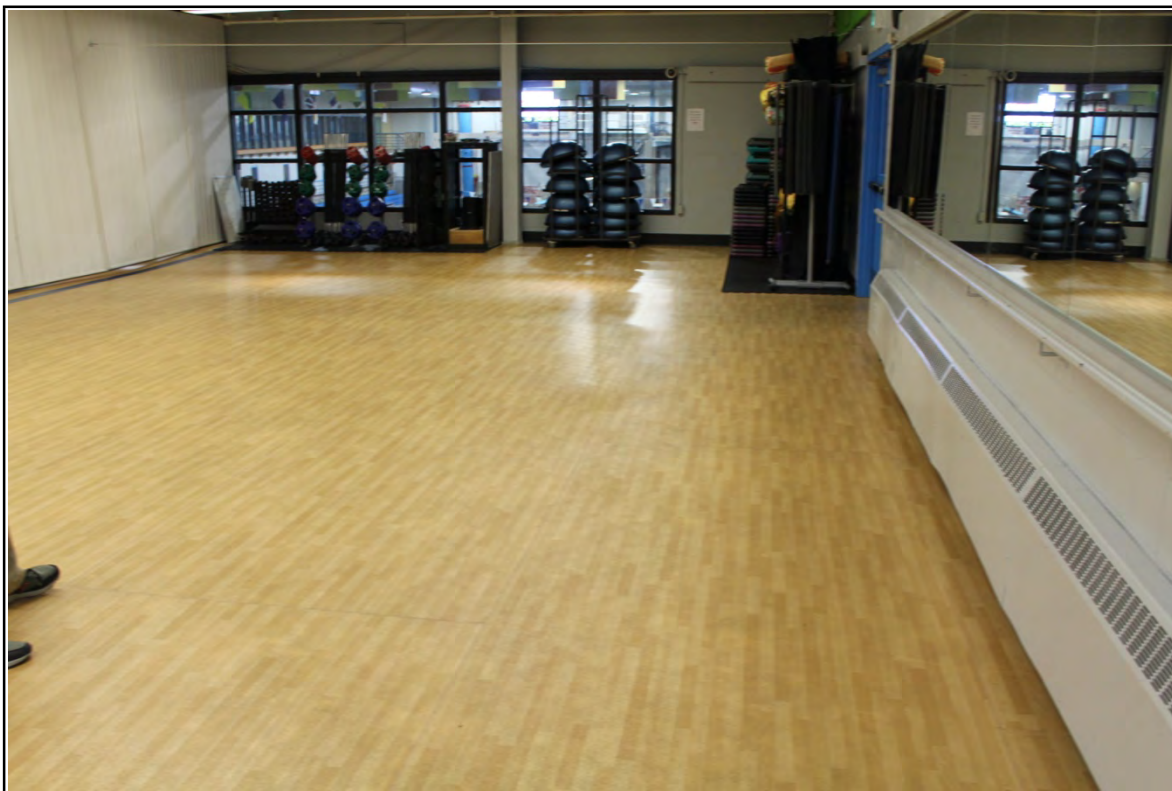
Photo 12: General Fitness Room Condition

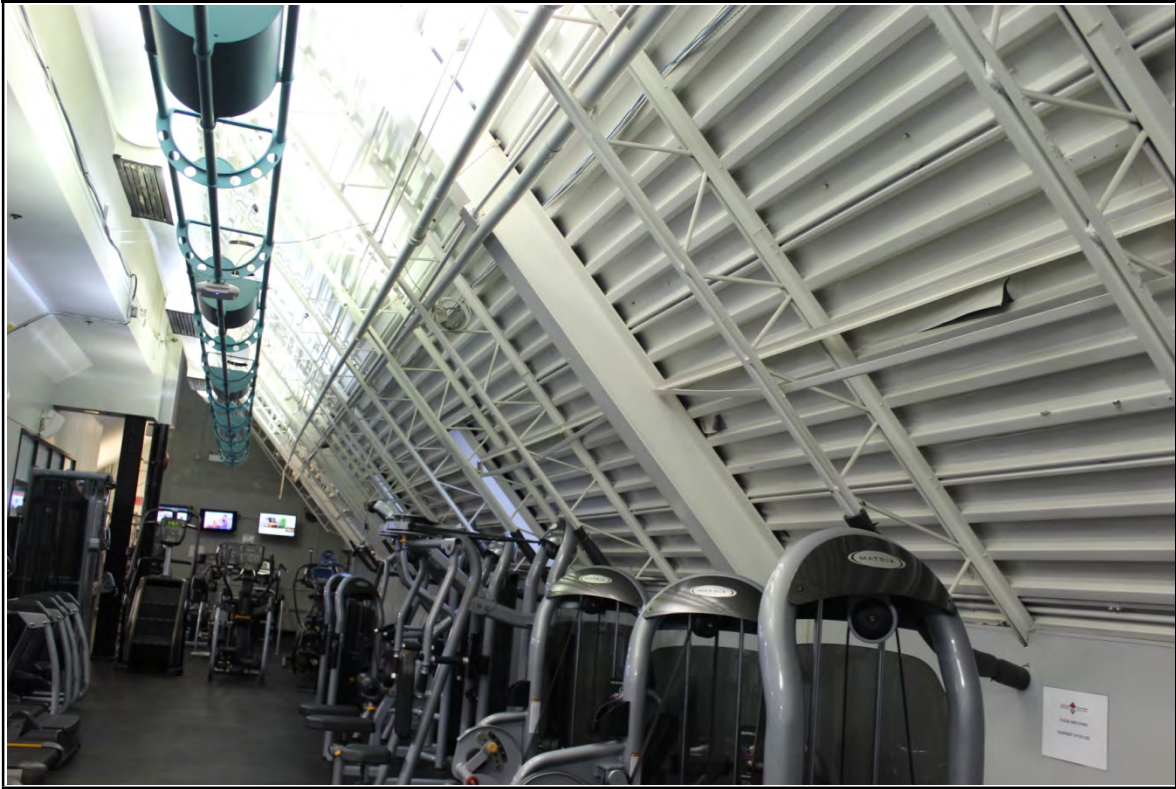
Photo 13: General Gym Conditions

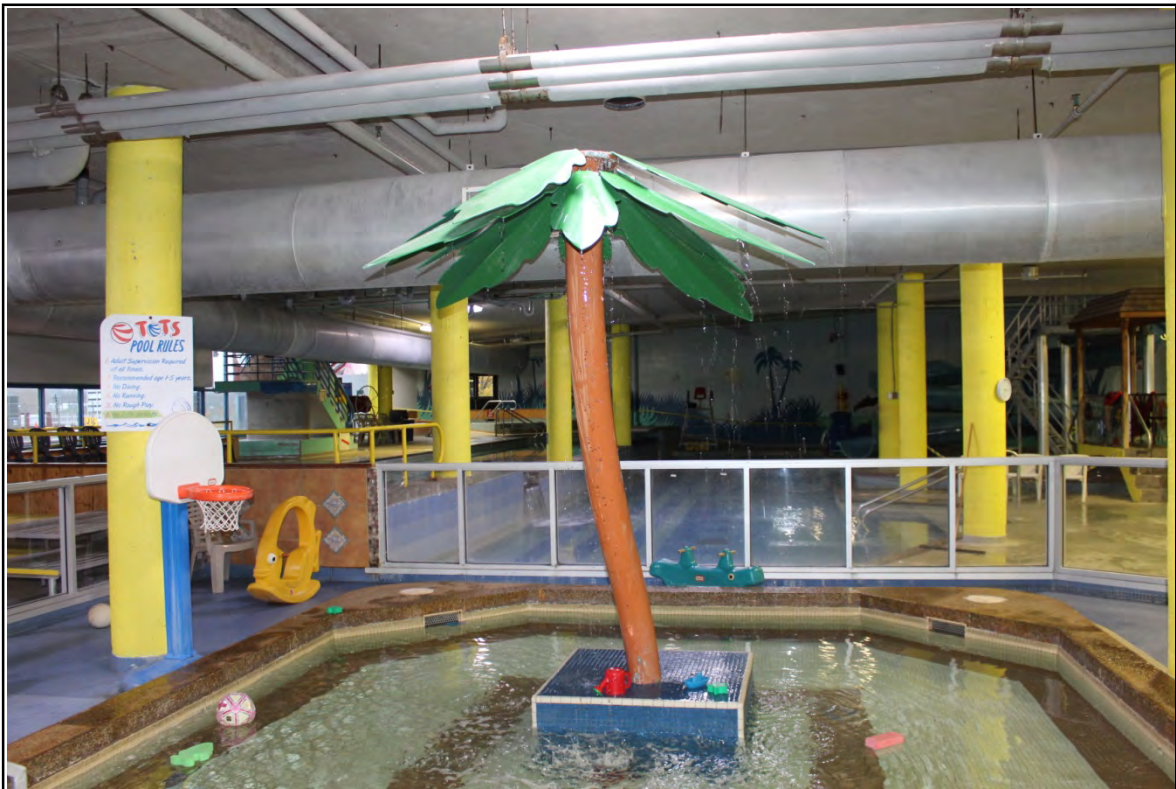
Photo 14: Kids pool amenities

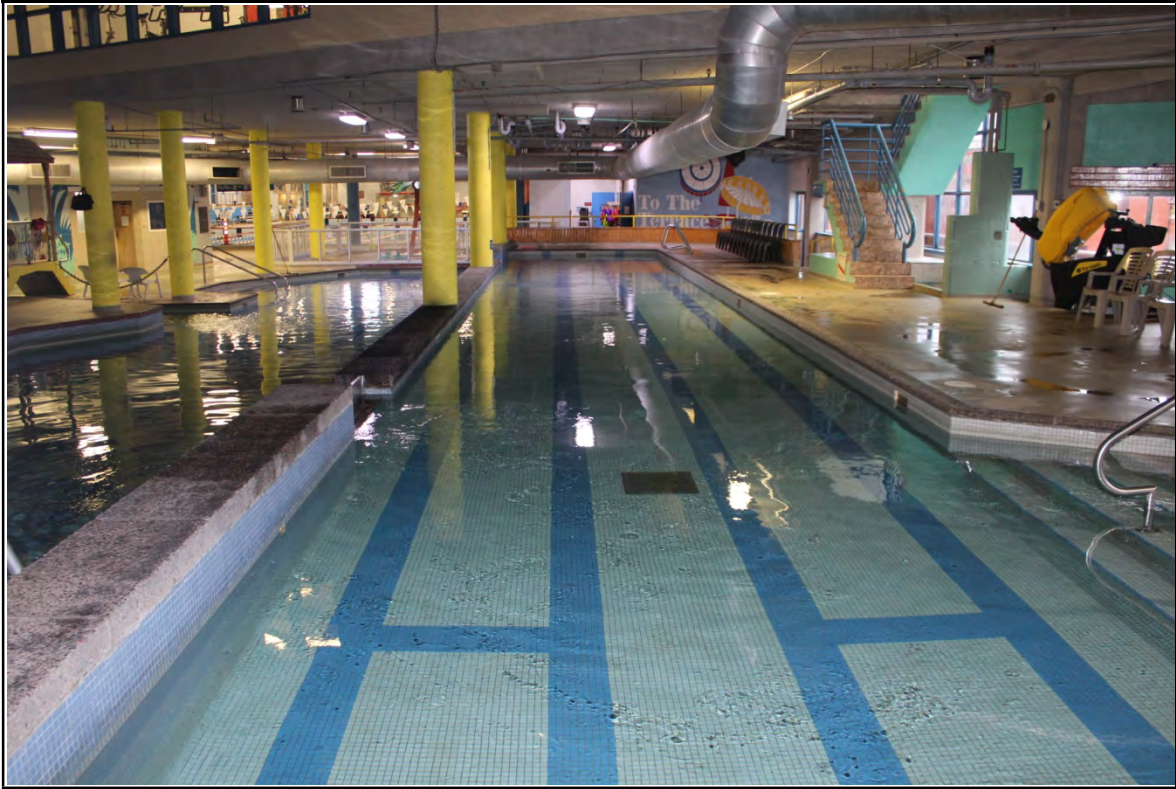
Photo 15: Leisure Pool

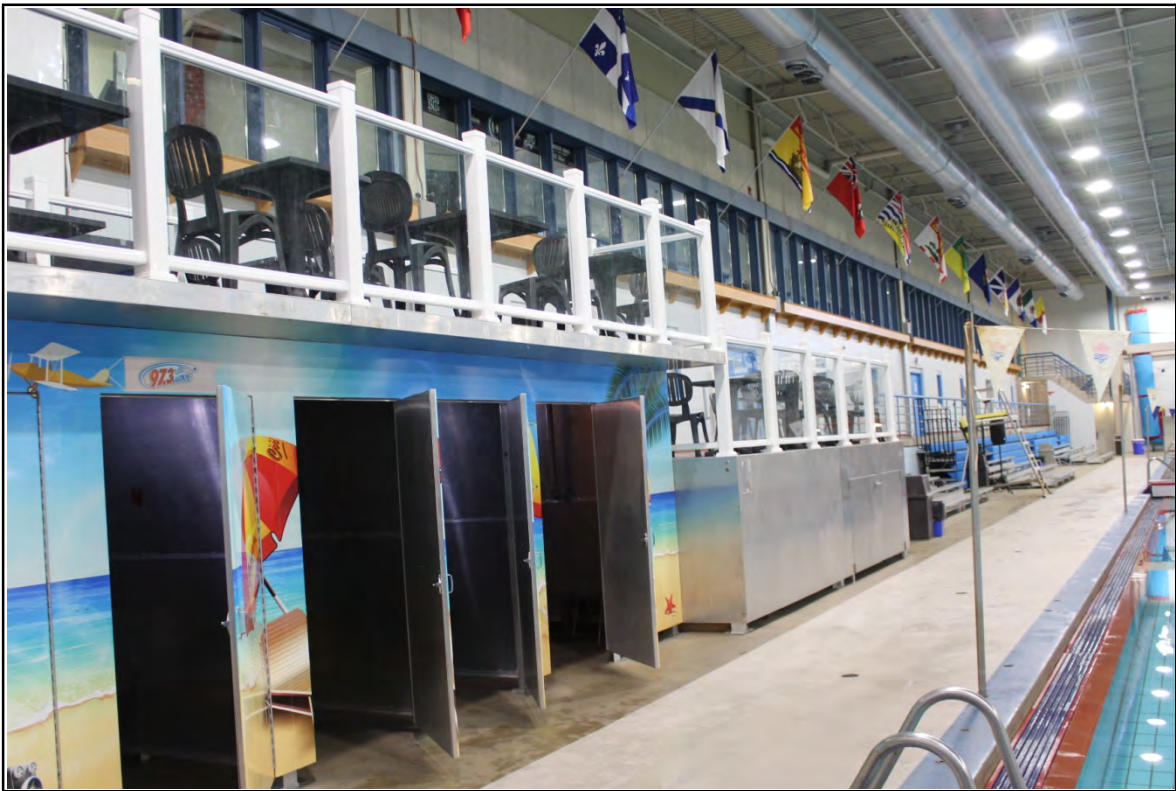
Photo 16: Aluminum Pool Side Change Rooms And Mezzanine

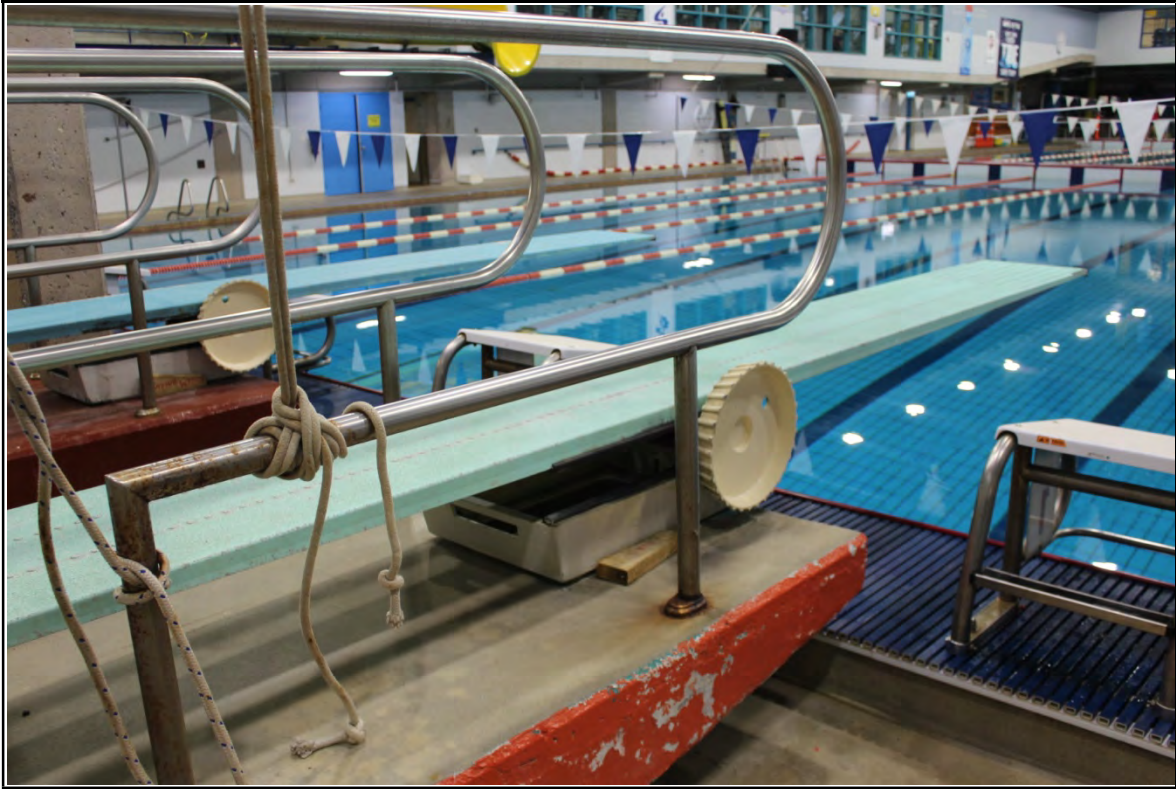
Photo 17: Spalling Concrete On The Base Of Diving Board

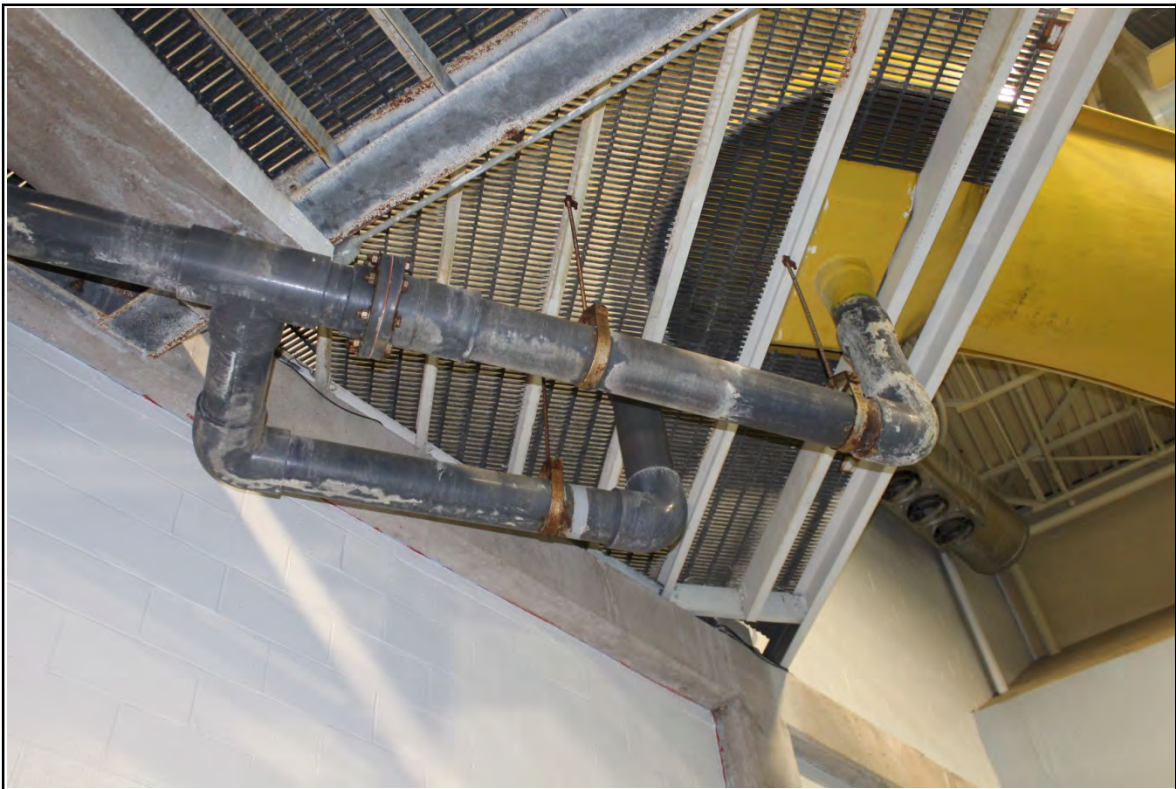
Photo 18: Corrosion And Rust On Piping And Hanging Pipe Clamps

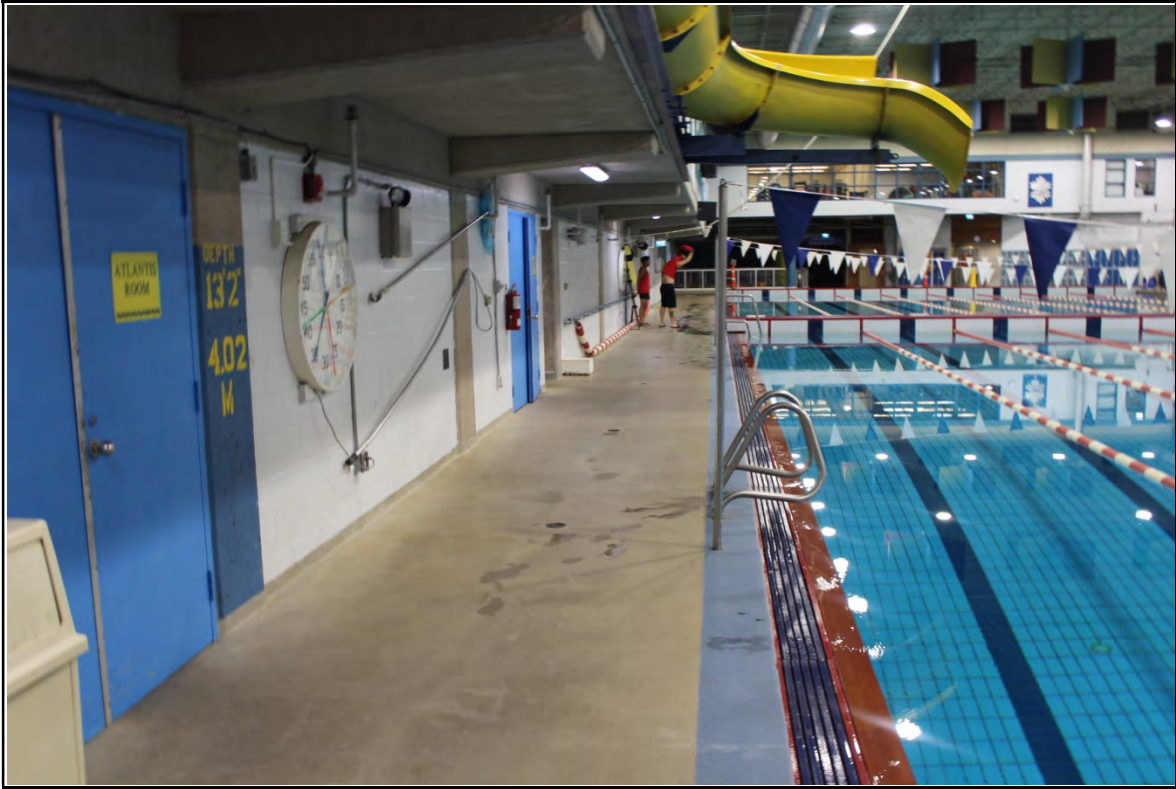
Photo 19: Typical Pool Deck Conditions, Slight Rusting On Bottom Of The Waterslide

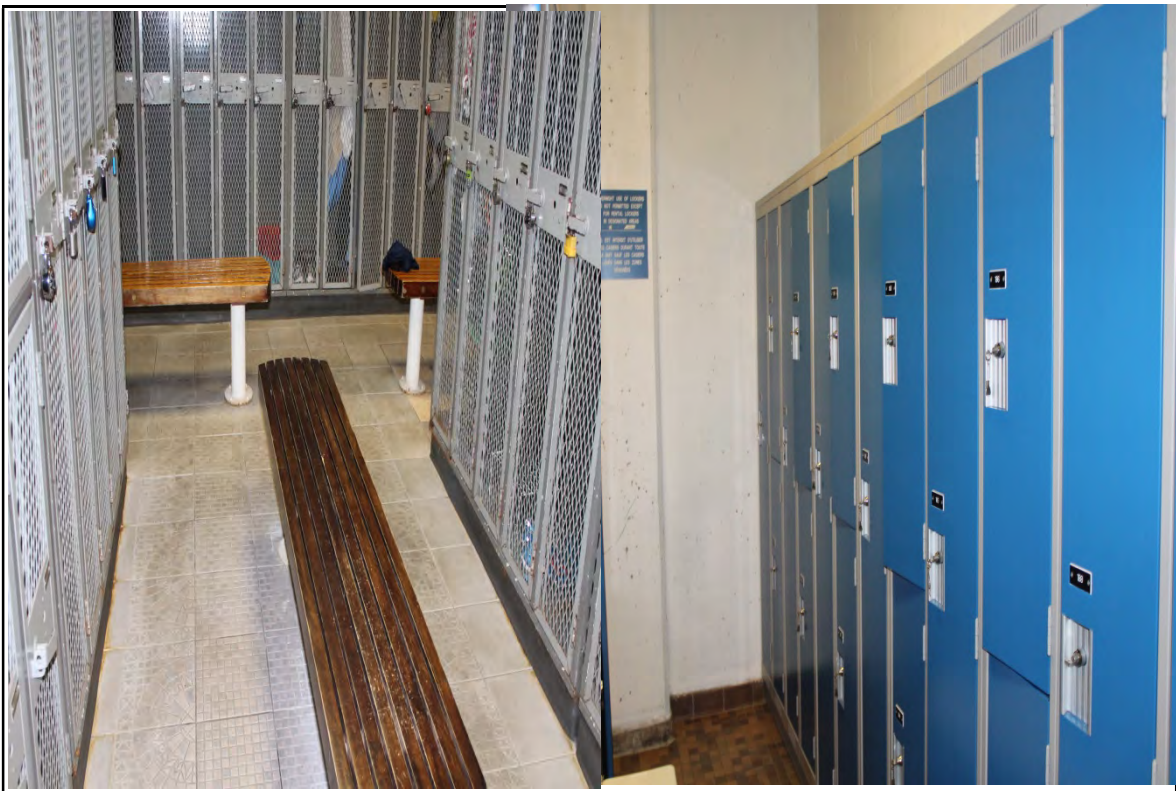
The ceramic tile flooring in the locker rooms was reported to have been installed in approximately 2000 and appeared to be in fair condition with some localized cracking. Ceramic tile flooring will have an expected useful life of forty years although can depend on the quality of the original installation. Replacement of damaged tiles is expected to be completed as part of operations and maintenance budgets. Based on the observed condition and estimated remaining useful life it is expected that the tile will require replacement during the long term of the evaluation period. The estimated cost and timing of the replacement has been included in the Cost Table.

Photo 20: Typical Locker-room Finishes

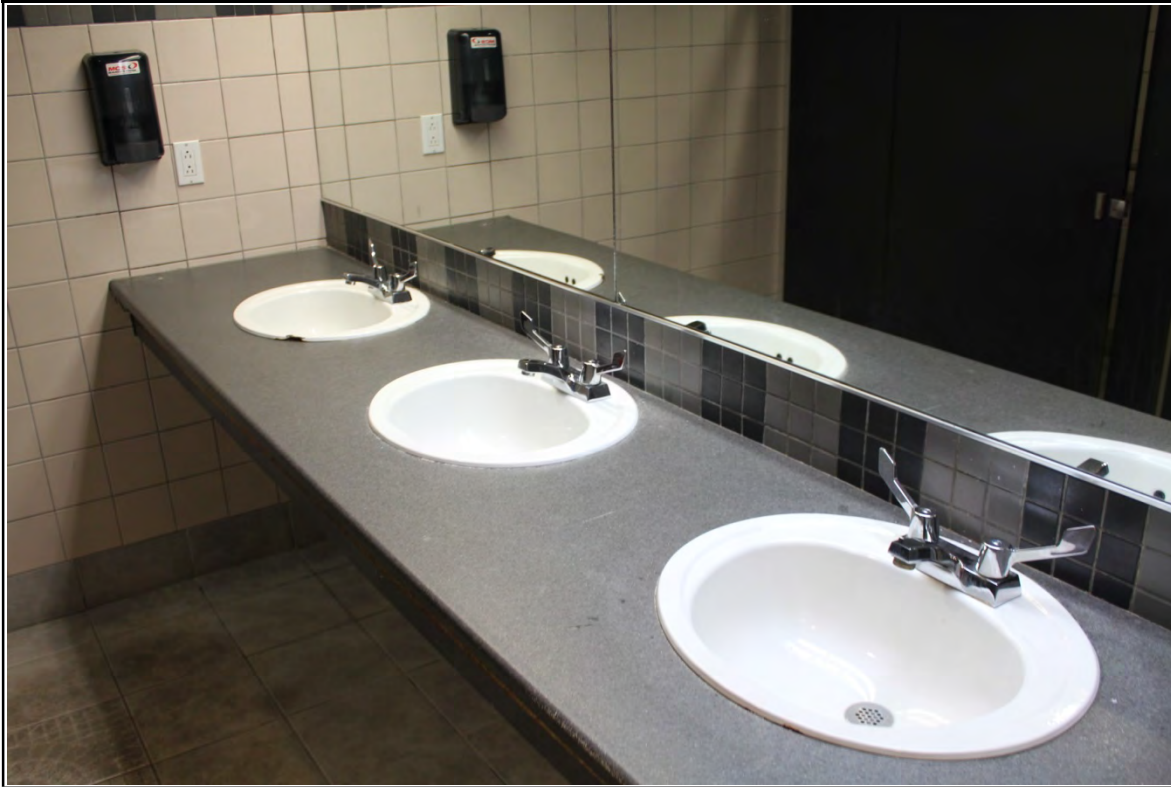
Photo 21: Common Washroom Finishes

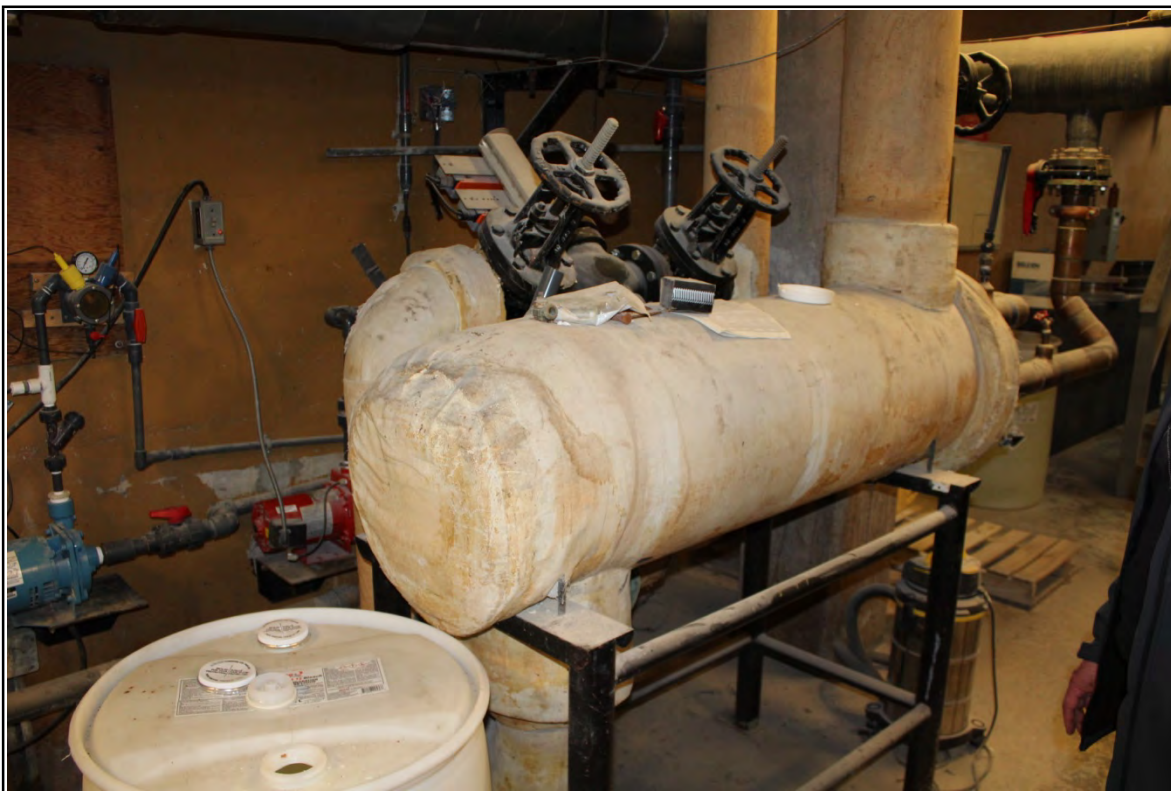
Photo 22: Shell And Tube Heat Exchanger (Main Pool)

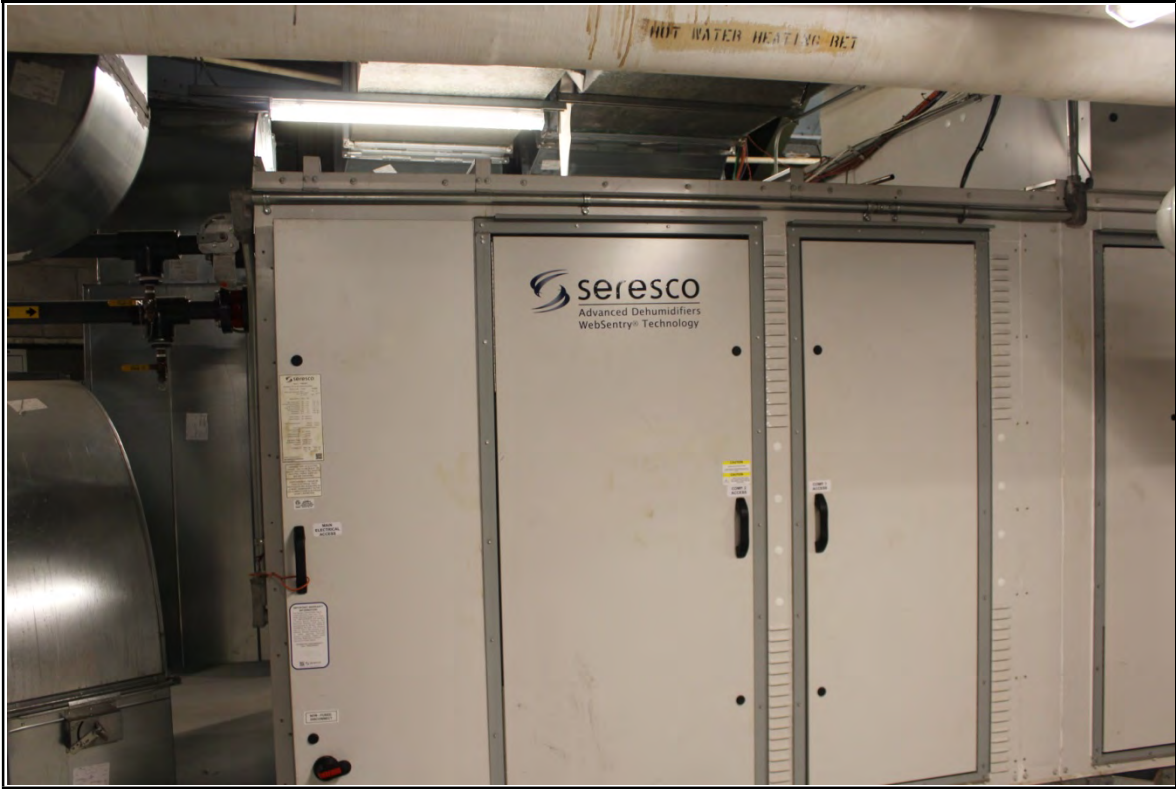
Photo 23: Facilities Dehumidifier System
