**Capital Management
Engineering Limited**

**Capital Plan
Building Condition and Energy Assessment
Canada Games Aquatic Centre
50 Union Street
Saint John, New Brunswick**

Final Report

**April 2020
Project Number 1901028**

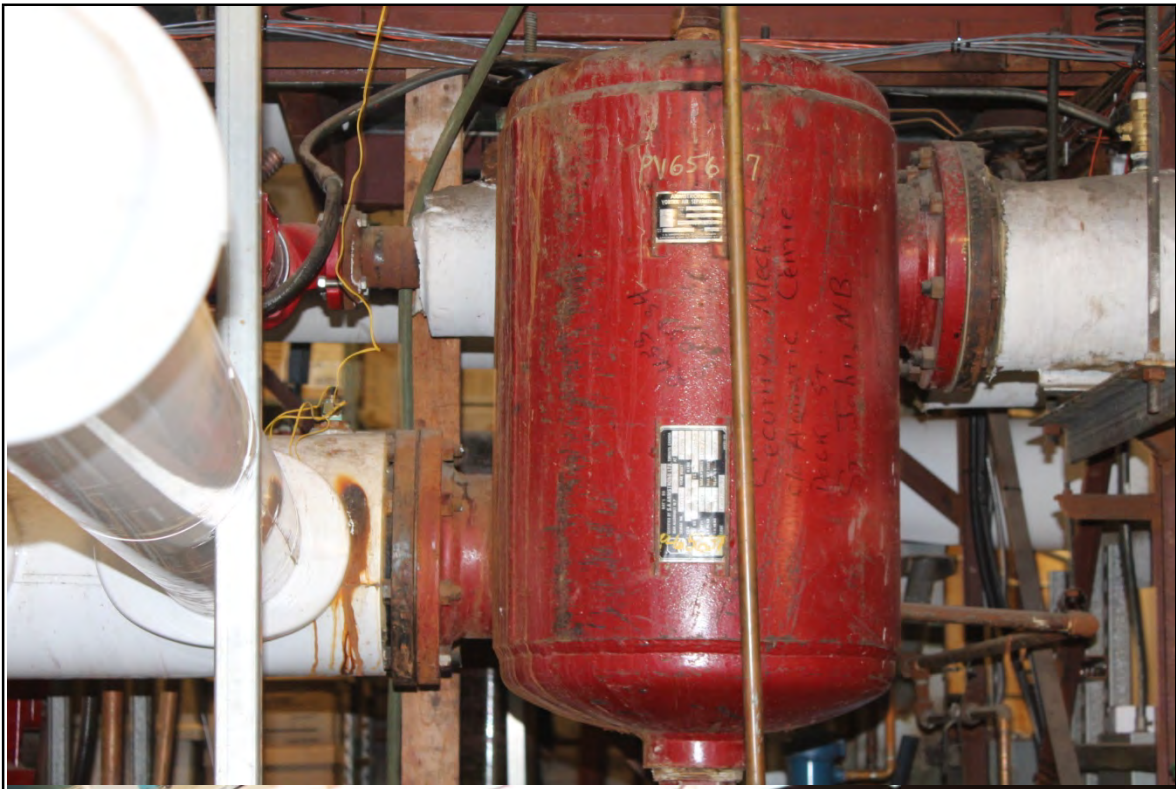
Photo 24: Vortex Air Separator

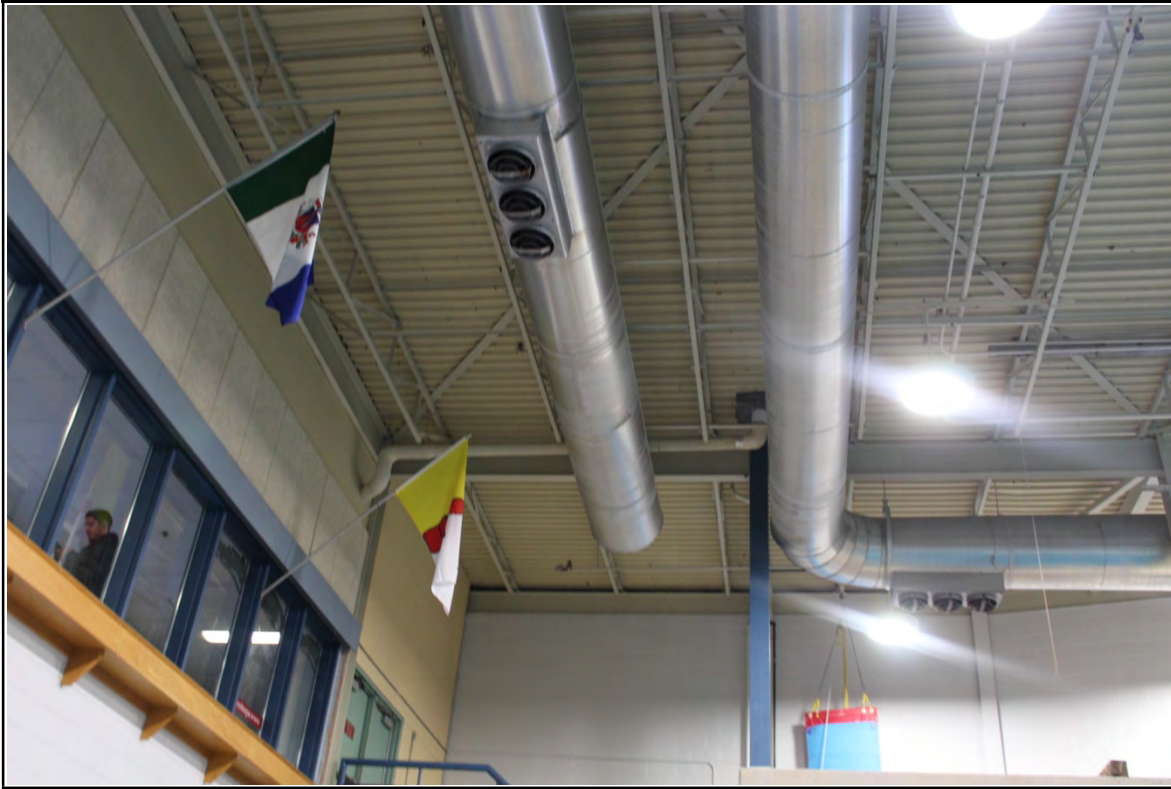
Photo 25: Swimming Pool Ventilation System

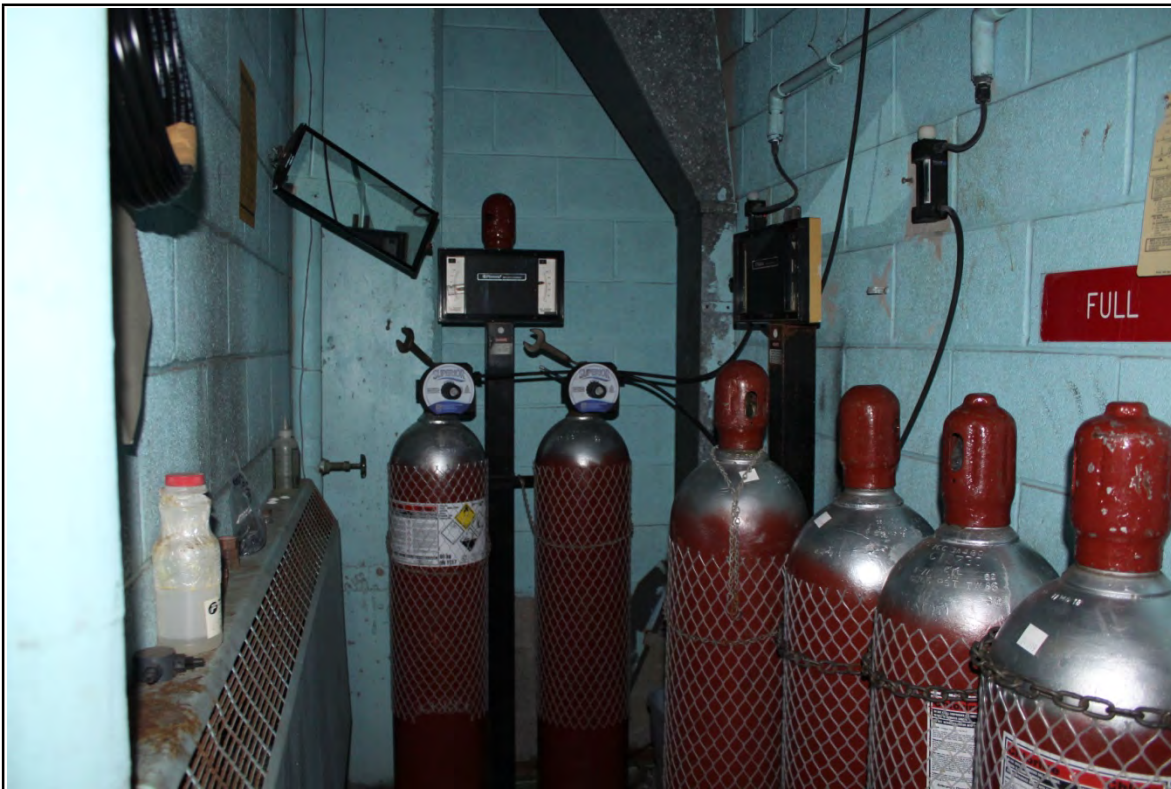
Photo 26: Chlorine Tanks And Detectors/Gauges

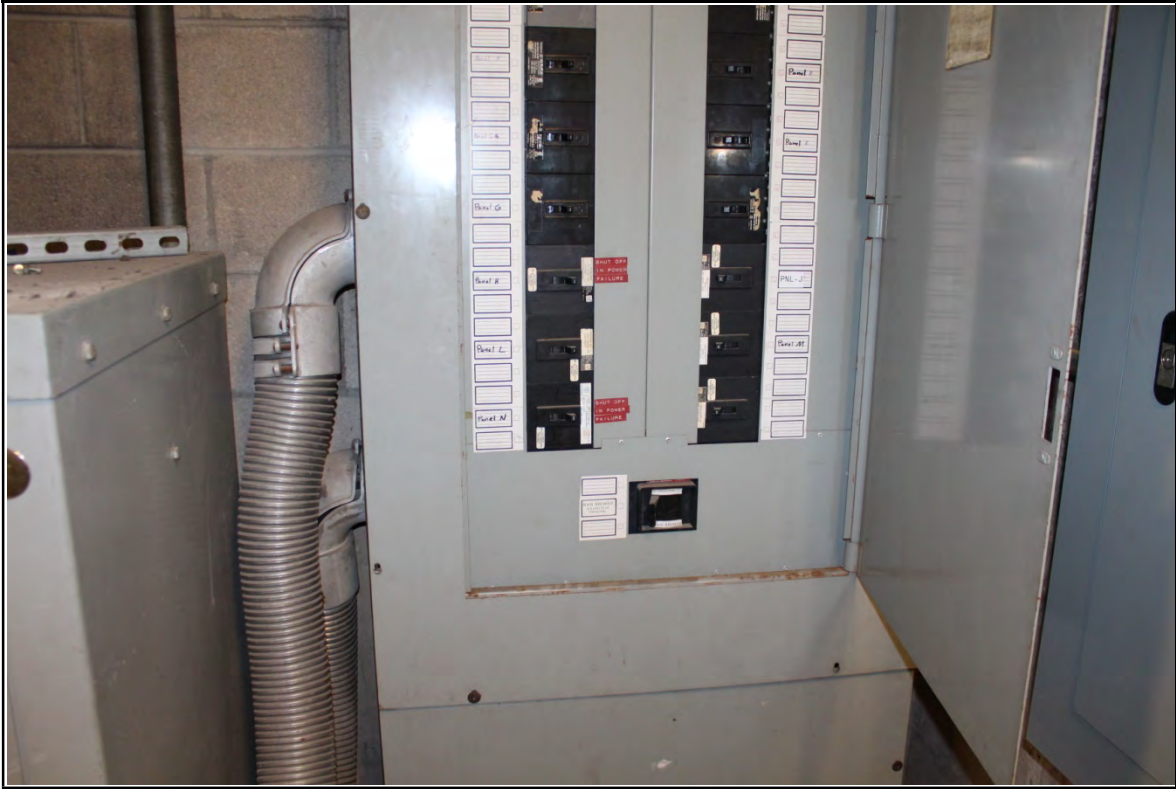
Photo 27: Circuit Breaker Panel

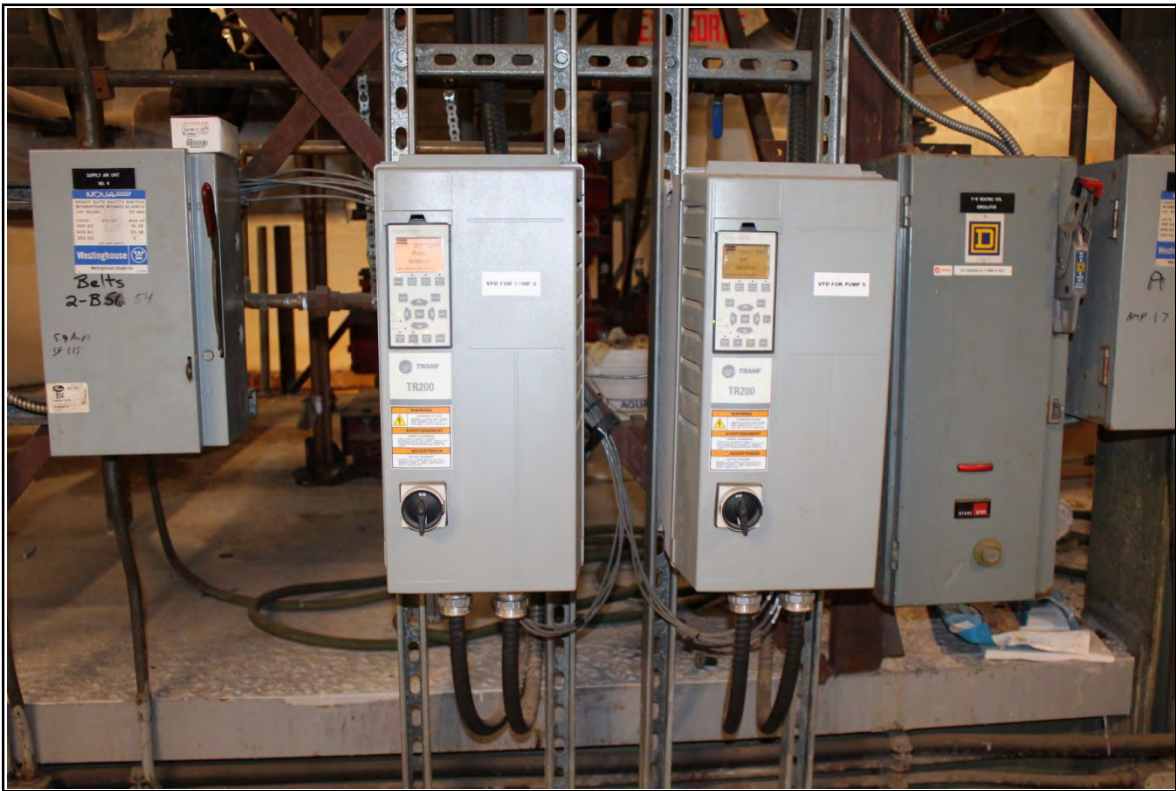
Photo 28: Variable Frequency Drives

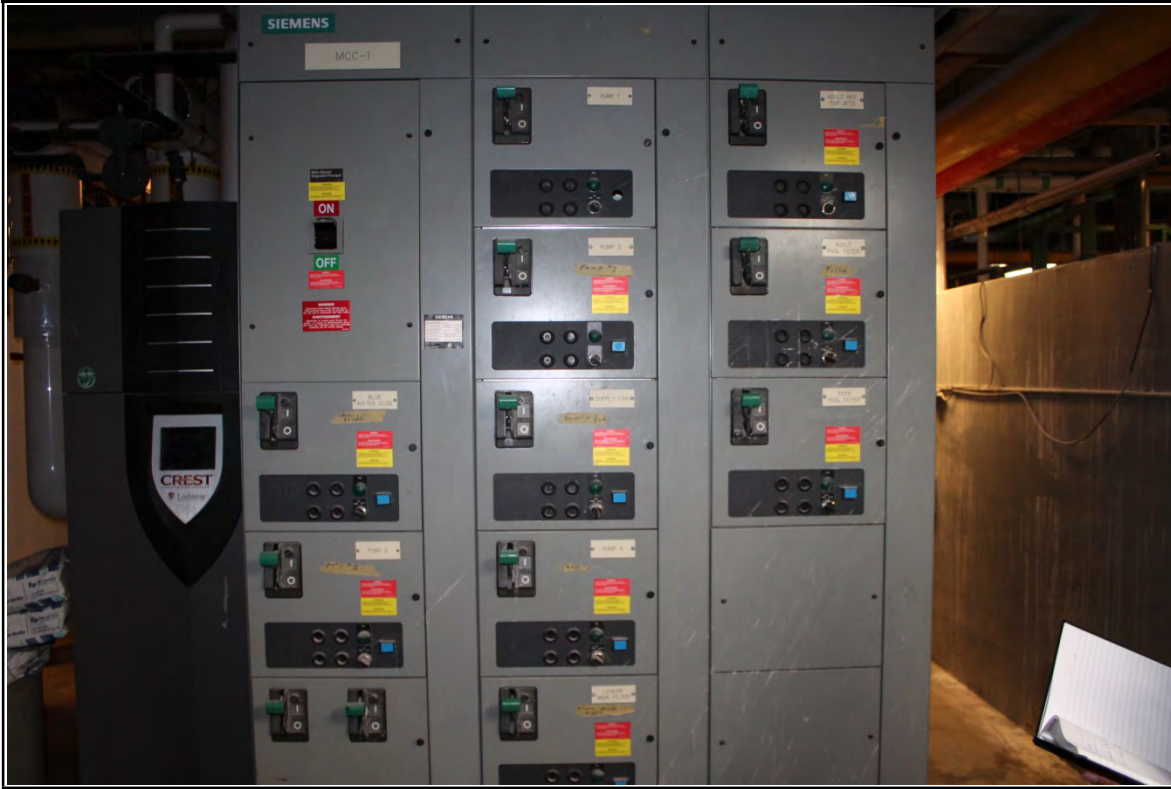
Photo 29: Motor Control Center

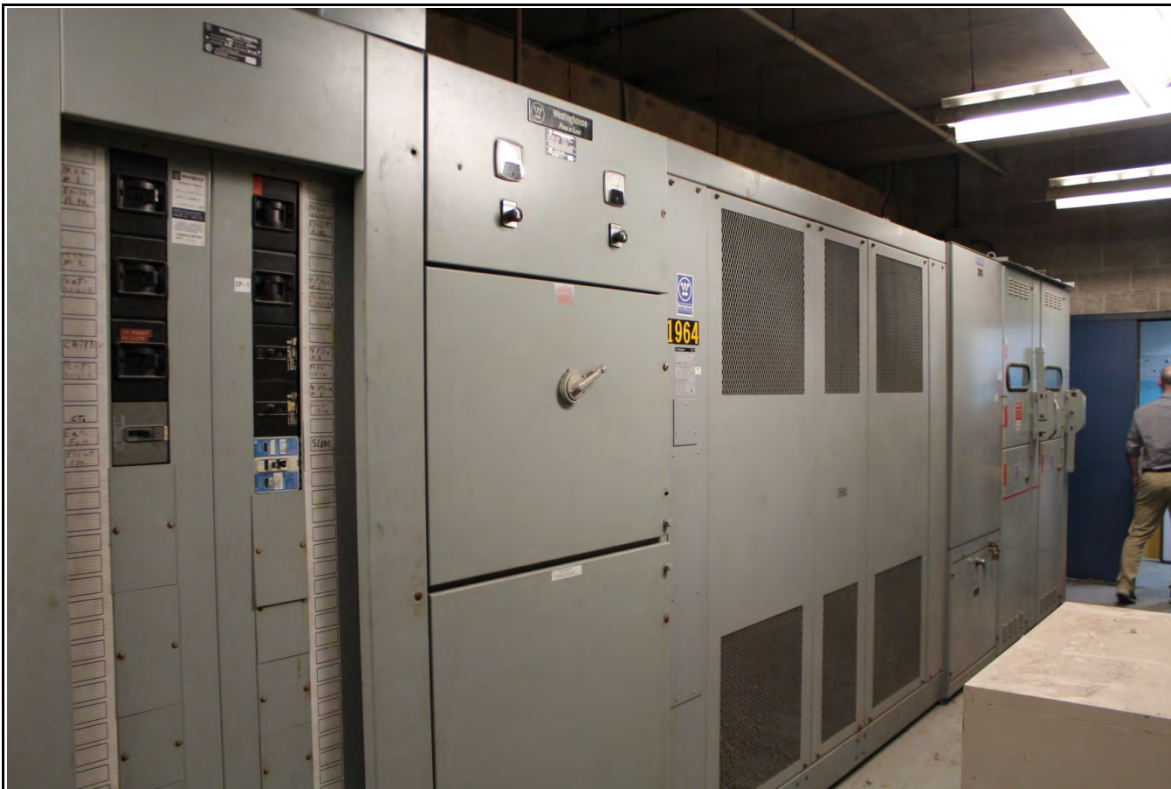
Photo 30: Main Power Supply

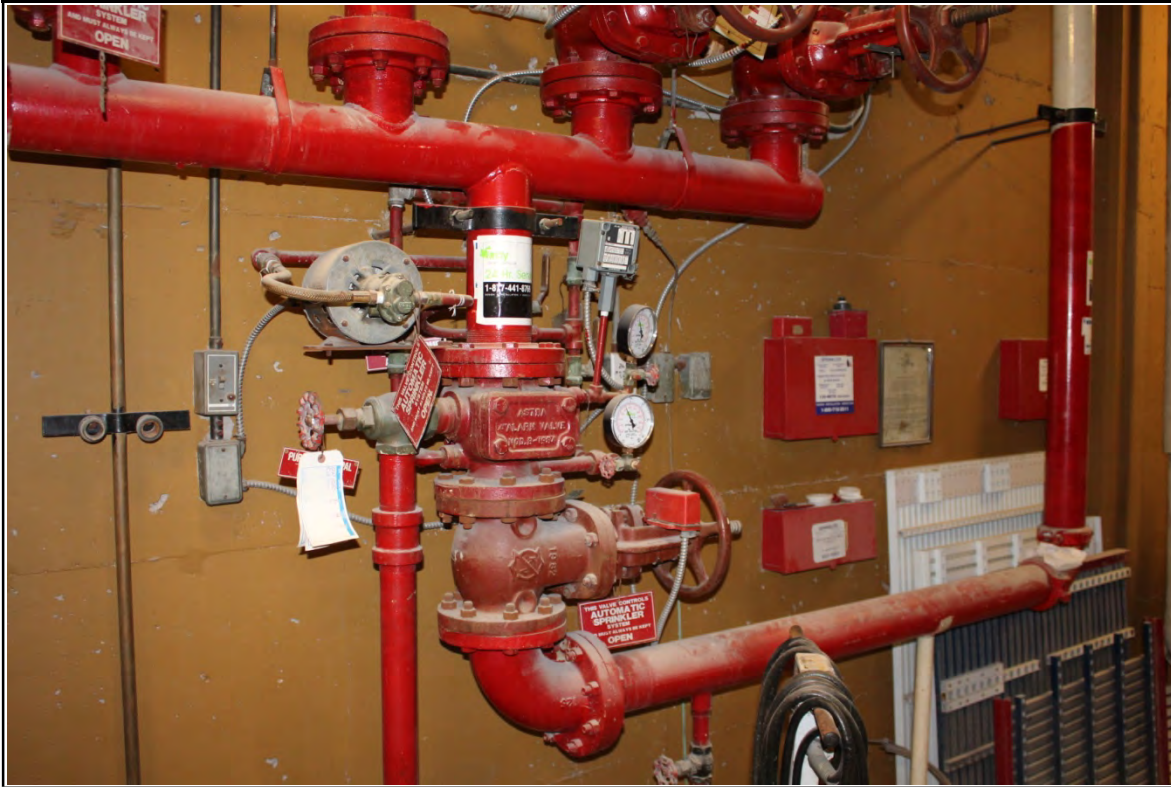
Photo 31: Sprinkler Tree

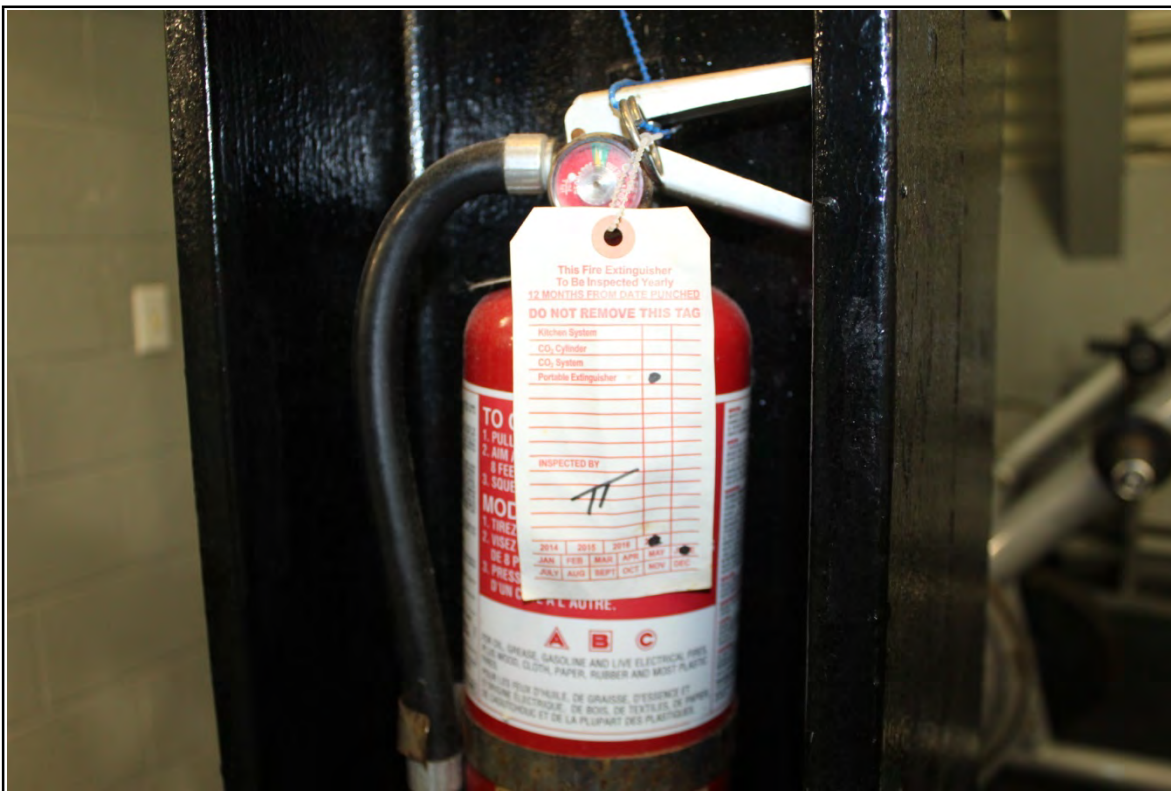
Photo 32: Fire Extinguisher
