# City of Saint John Overflow Mitigation Strategy

**Final Report**

202919.00 • March 2021

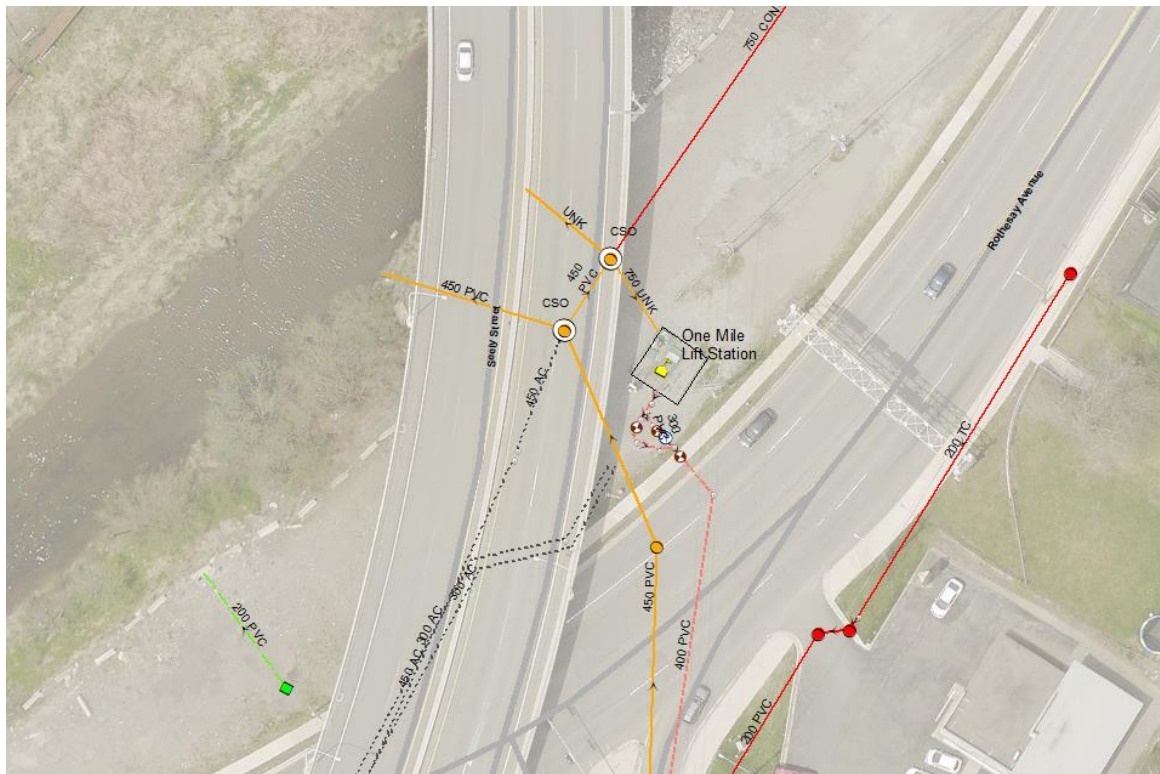
**Figure 2: Existing One Mile SLS Configuration**

The One Mile SLS overflow(s) were ranked as category 2 for cost-benefit under its current configuration. This lift station however is currently undergoing re-design. Overflow monitoring associated with this sanitary lift station can be addressed through the design process. The City's GIS currently shows two CSOs, WWN-CSOMH-78845 and WWN-CSOMH-64819, directly upstream of the One Mile SLS. Records regarding the overflow structures are conflicting as it is unclear whether both of these structures are active. Due to hydraulic losses over these two structures, all overflows on this property can not be easily correlated to the levels within the current configuration. It is recommended that the CSOs directly upstream of the lift station undergo review to determine if one of the overflow structures can be abandoned. The overflow structure(s) should be designed to include level monitoring equipment, along with connections to SCADA.

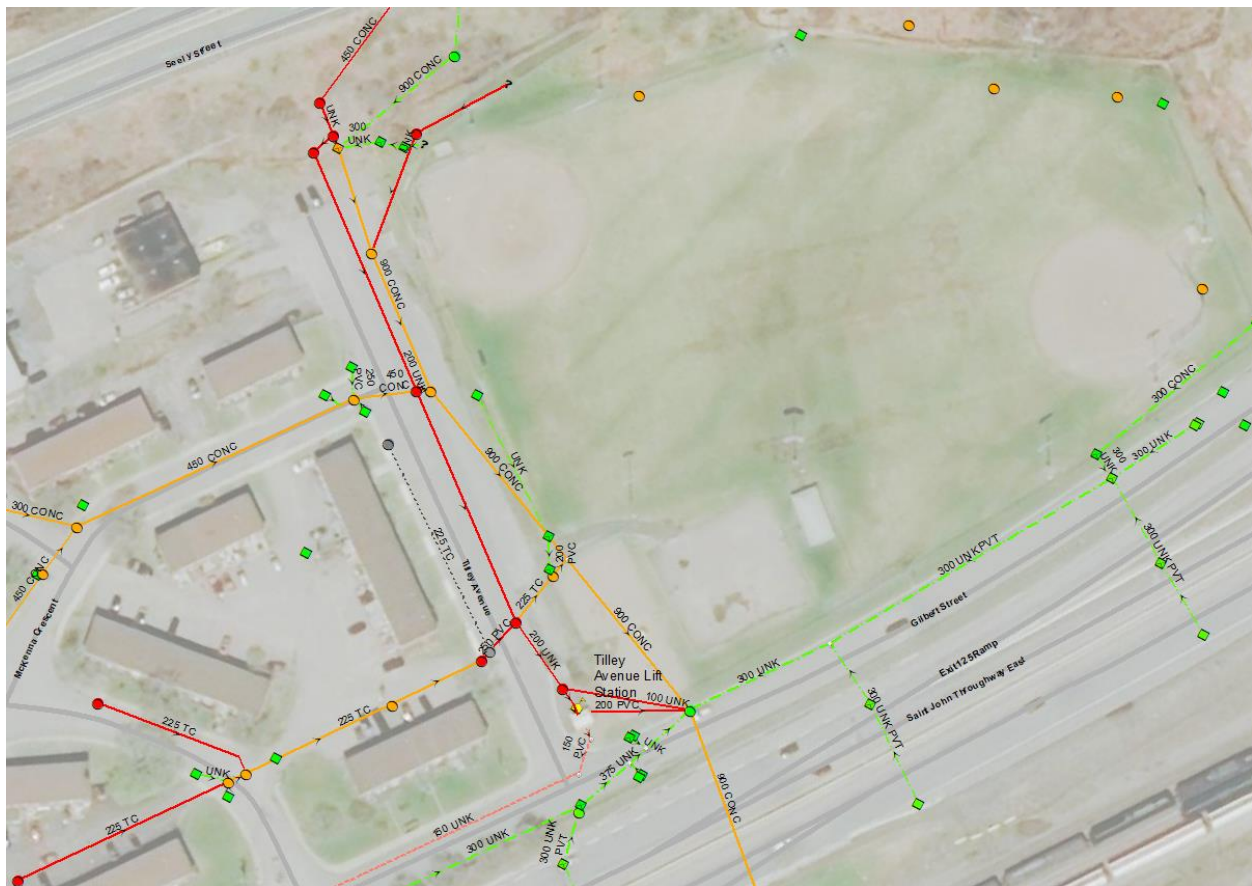
Figure A-1: Allison Grounds Overflow Structures

In the East side of the city along Tilley Avenue and connected streets, there are a total of 3 overflow structures as well as one sanitary pipe that discharges into a storm sewer causing it to become a combined sewer which by-passes Tilley Avenue SLS. This lift station also has an emergency overflow within the lift station that flows into this combined sewer towards flowing towards Municipal Operations SLS 6 (M.O. SLS #6). Prior to reaching M.O. SLS 6, there is another overflow structure that discharges into Marsh Creek during high rainfall events. This combined sewer takes on storm water from the Provincial Highway and is all pumped at Municipal Operations SLS 6.

It is recommended that this sewer network be placed on the Capital program for sewer separation rather than installing level sensors and SCADA infrastructure. The separation of this combined sewer will not only reduce the discharge of untreated sanitary effluent, but also reduce the pumping demand at the down stream M.O. SLS #6

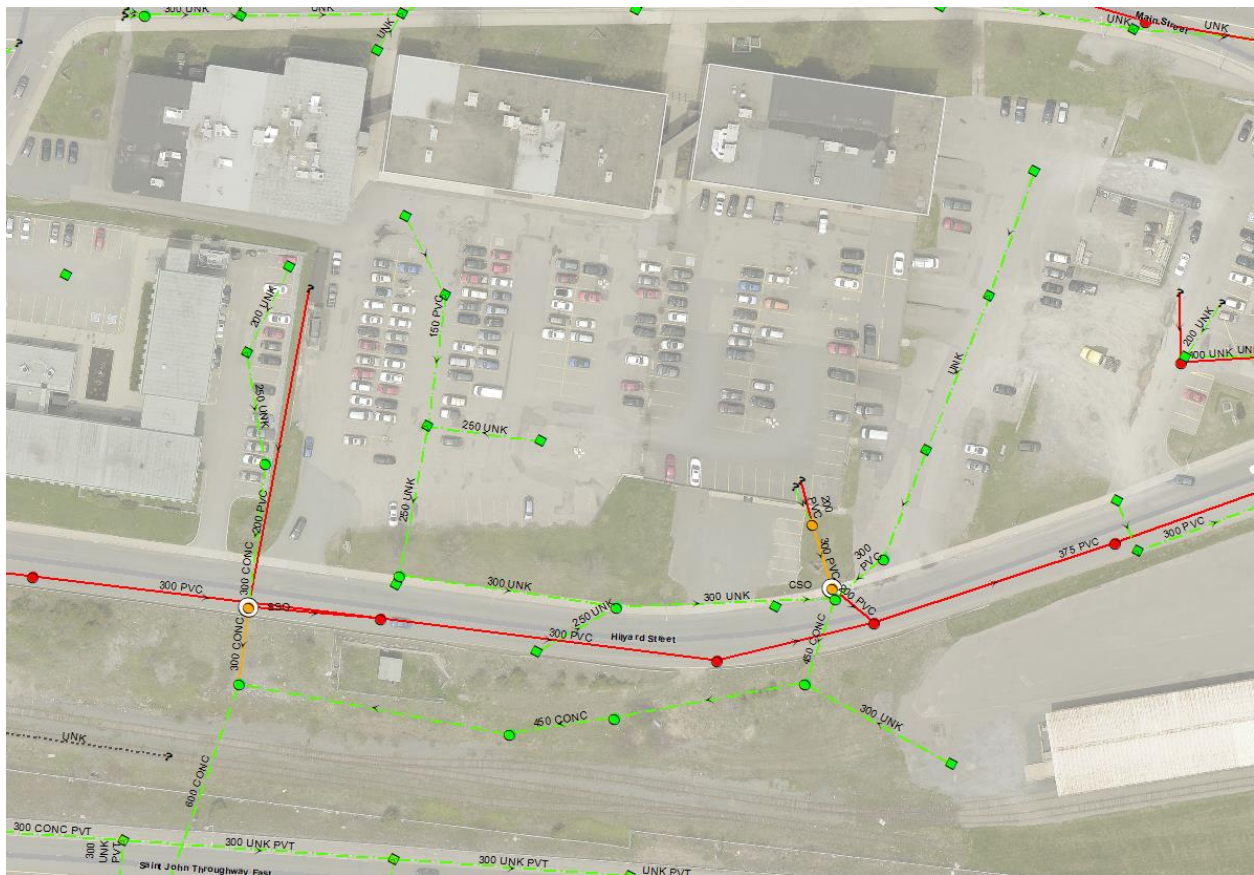
Figure A-3: Hillyard Street Overflow Structures

The two overflow structures located on Hillyard Street, WWN-SSOMH-63186 and WWN-CSOMH-63187, appear to have been installed as a second phase to the sewer network of the property between Hillyard Street and Main Street. A flow study could be completed to determine if the flows created from this property cause the sanitary main on Hillyard Street to become surcharged. If this study indicated that the sewer main could take these flows, the two overflows at this location could be abandoned in place. Prior to the removal of WWN-SSOMH-63186, the storm and sanitary system entering this structure would need to be separated and an additional structure would likely be required.

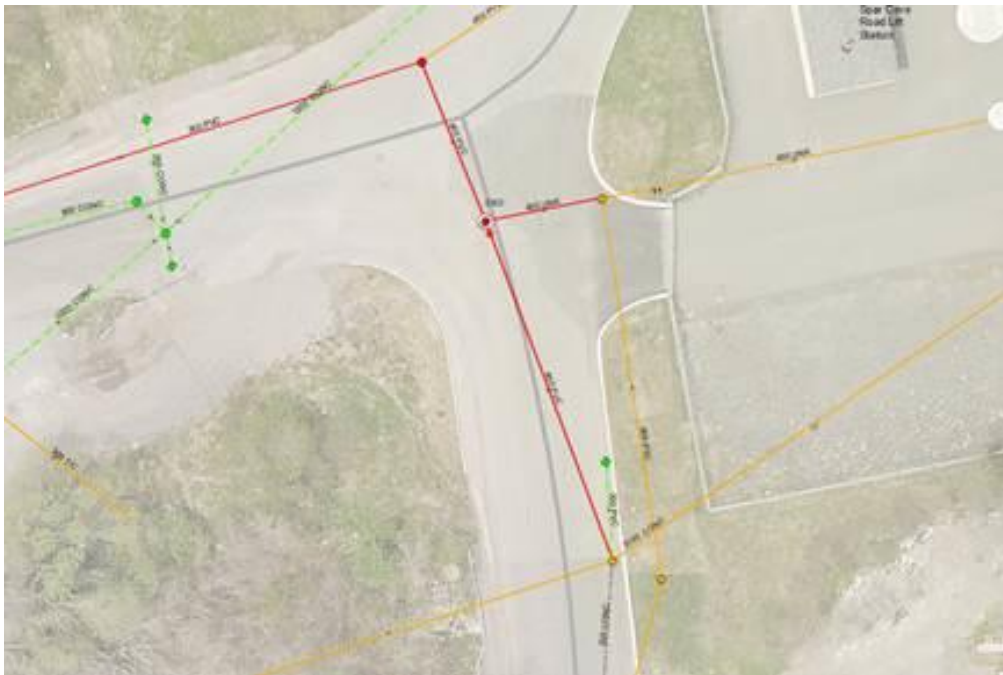
**Figure A-4: Spar Cove SLS**

An in-depth investigation and strategy for overflow monitoring upstream of the Spar Cove Road SLS may prove that sewer separation is preferred. The SCR overflow structures were included within the 108 structures analyzed in this report.
