City of Saint John

2021-091001P

ENGINEERING SERVICES: SITE WORKS – FUNDY QUAY

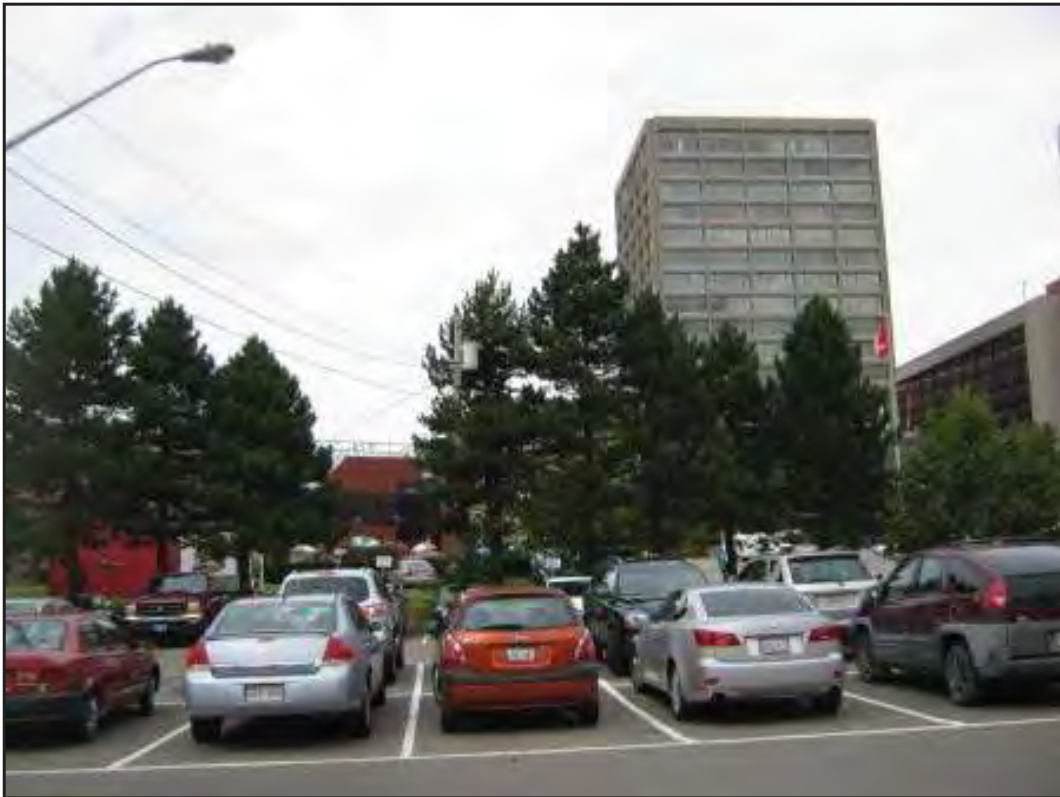
The Site. Photo looking north.

The surfaces of the Site consist of asphalt. It is assumed that stormwater drains to on-site catch basins, which are connected to the municipal stormwater sewer system. No catch basins were observed during the site visit, however, the parking lot was full of vehicles. Stormwater is also anticipated to drain by infiltration and/or overland flow.

Minor hydrocarbon staining was observed on asphalt surfaces throughout the parking lot likely associated with parked vehicles. A visual survey of the asphalt revealed slight cracks in proximity of the stains. The hydrocarbon stains likely do not represent an environmental concern to the Site.

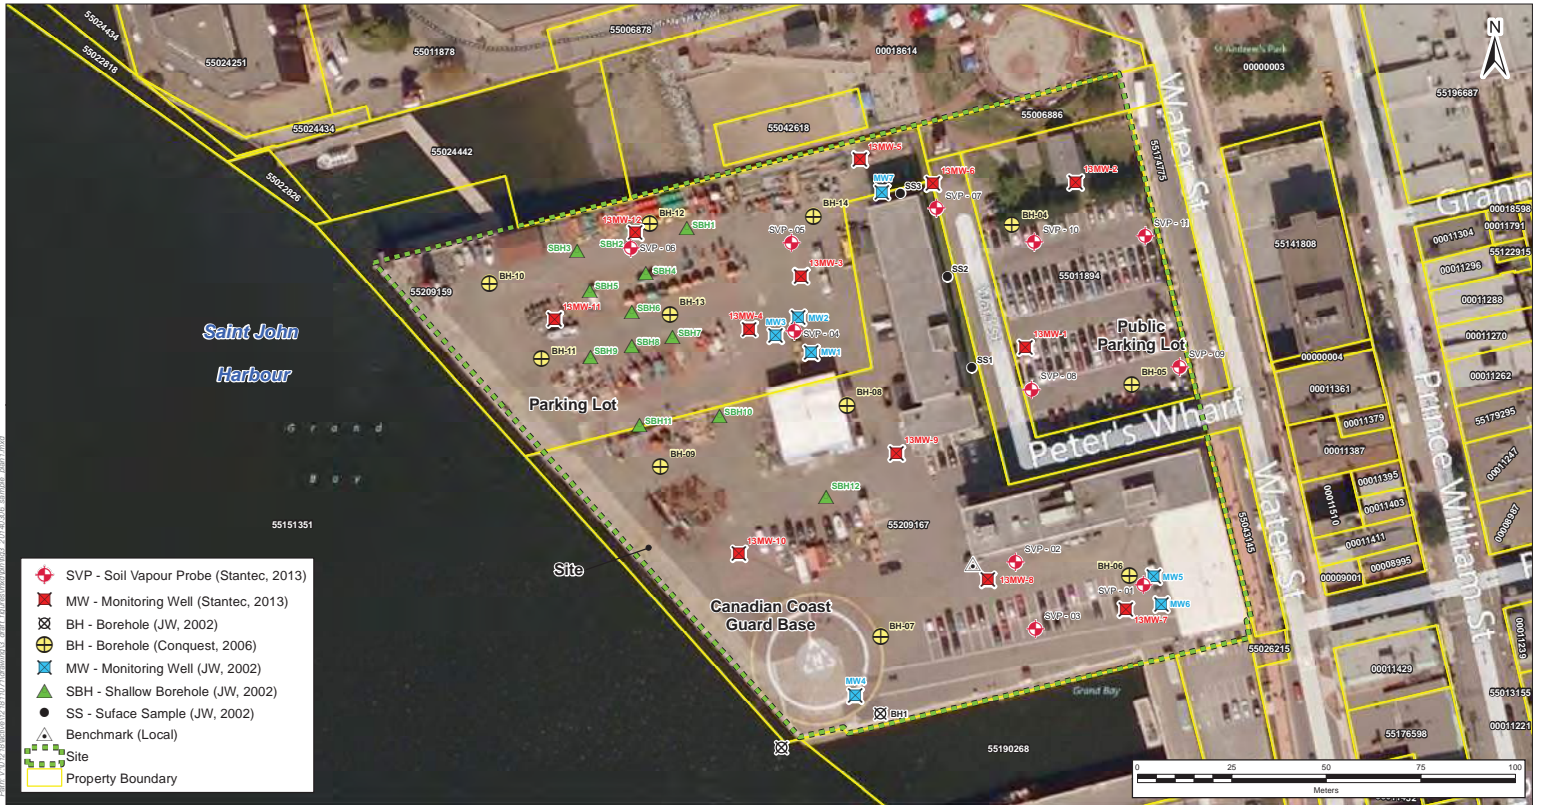
- SVP - Soil Vapour Probe (Stantec, 2013)
- MW - Monitoring Well (Stantec, 2013)
- BH - Borehole (JW, 2002)
- BH - Borehole (Conquest, 2006)
- MW - Monitoring Well (JW, 2002)
- SBH - Shallow Borehole (JW, 2002)
- SS - Surface Sample (JW, 2002)
- Benchmark (Local)
- Site
- Property Boundary

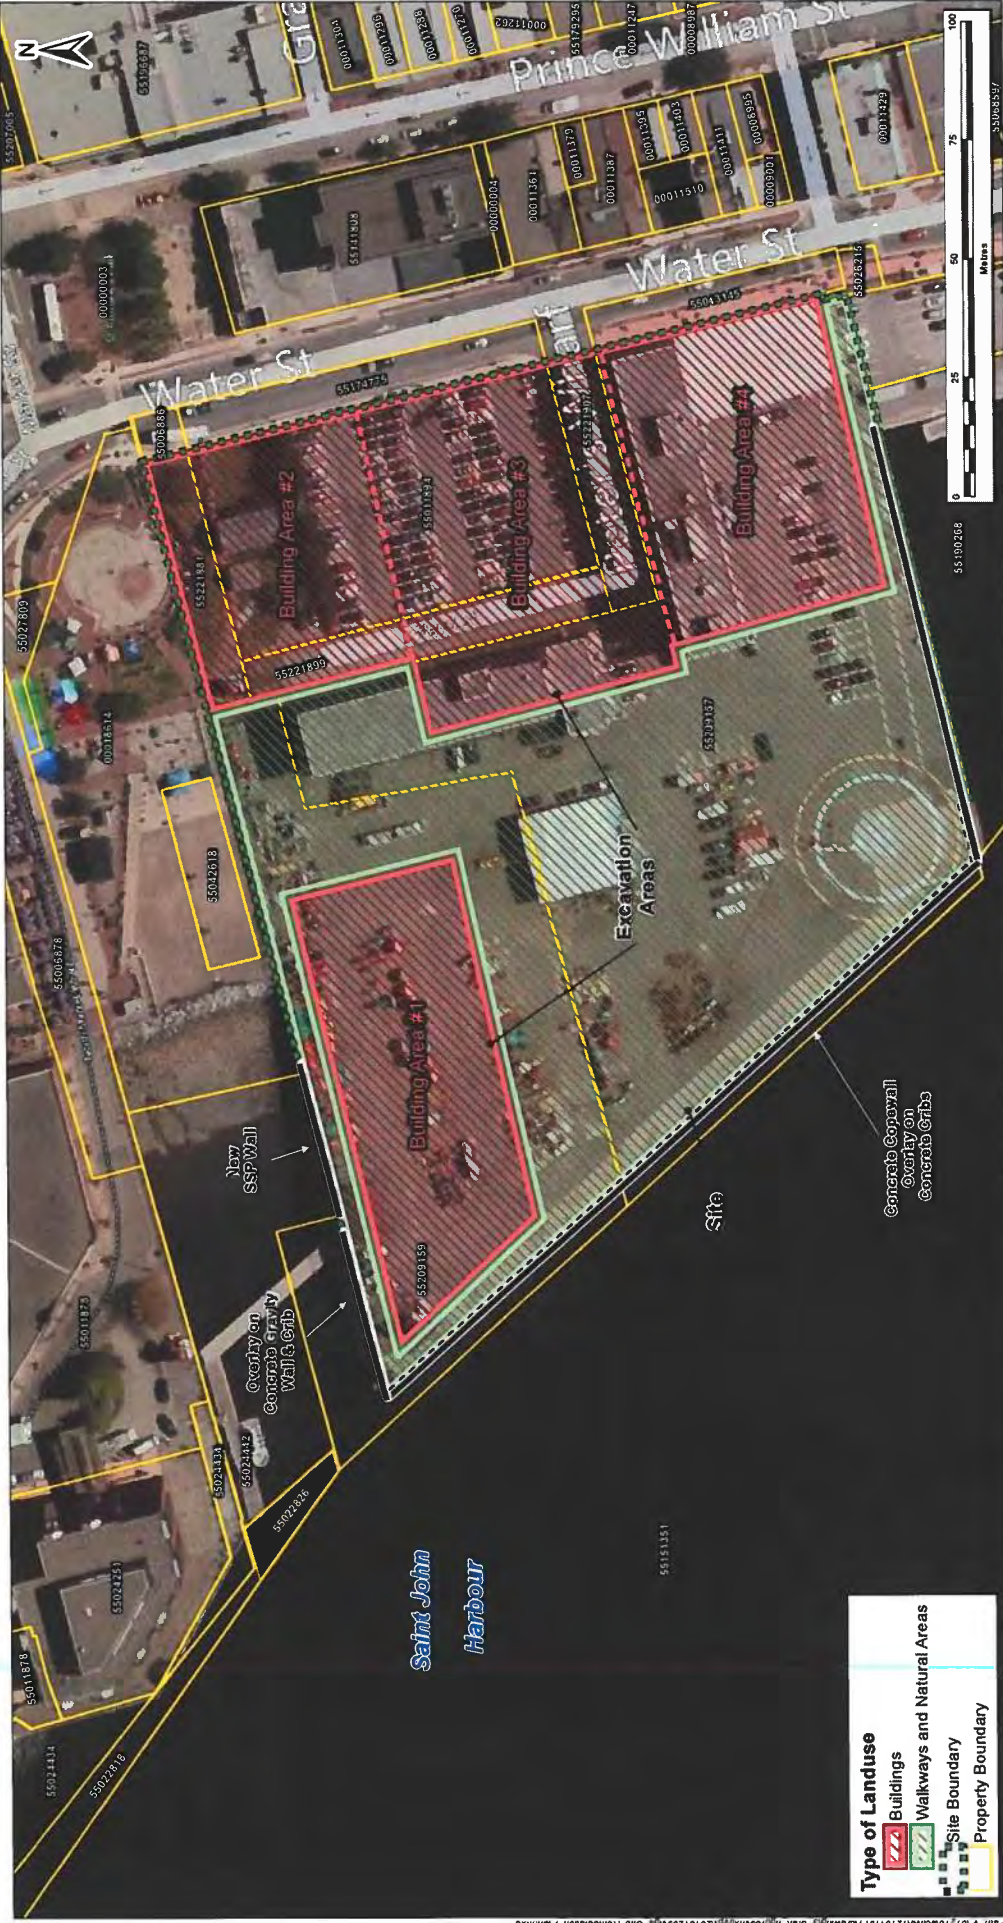
Scale: 1:1,000		Project No.: 121811071		Date Sources: SNB, ArcGIS Online Bing Imagery, Microsoft product screen shot(s) reprinted with permission from Microsoft Corporation		Dwg. No.: 4	
Date (mm/dd/yyyy): 09/12/2015		Fig. By: CP		Appd. By: RSF		Coordinate System: NAD 1983 CSRS New Brunswick Stereographic	
<h3>Site Remediation Plan</h3> <p>Saint John, N.B.</p>				<p>Saint John Development Corporation</p>			
Client: Saint John Development Corporation

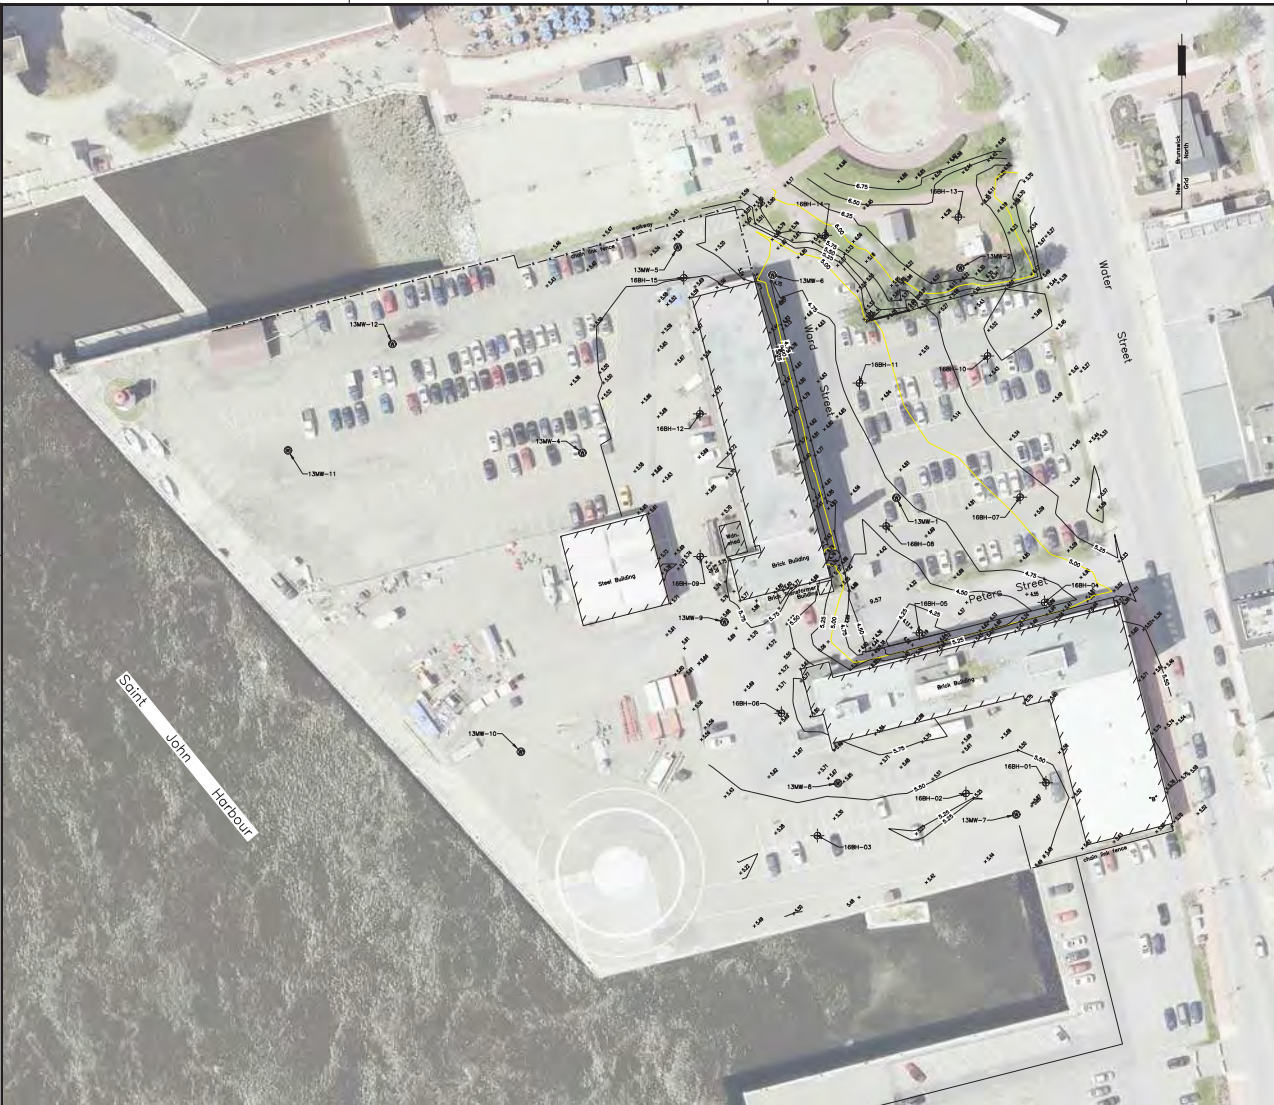
Ground Elevation Survey

- Field survey completed on Sept 12, 2016.
- Elevations are Geodetic Datum in metres referred to New Brunswick Grid Monument Number 28160 having an elevation of 20.738 metres and are shown thus: \odot
