2022-091006P

**“ENGINEERING SERVICES – MENZIES LAKE DAMS AND ACCESS ROAD
DRAINAGE UPGRADES”
SAINT JOHN, NB**

City of Saint John Menzies Lake Dam - Cost Update Final Report

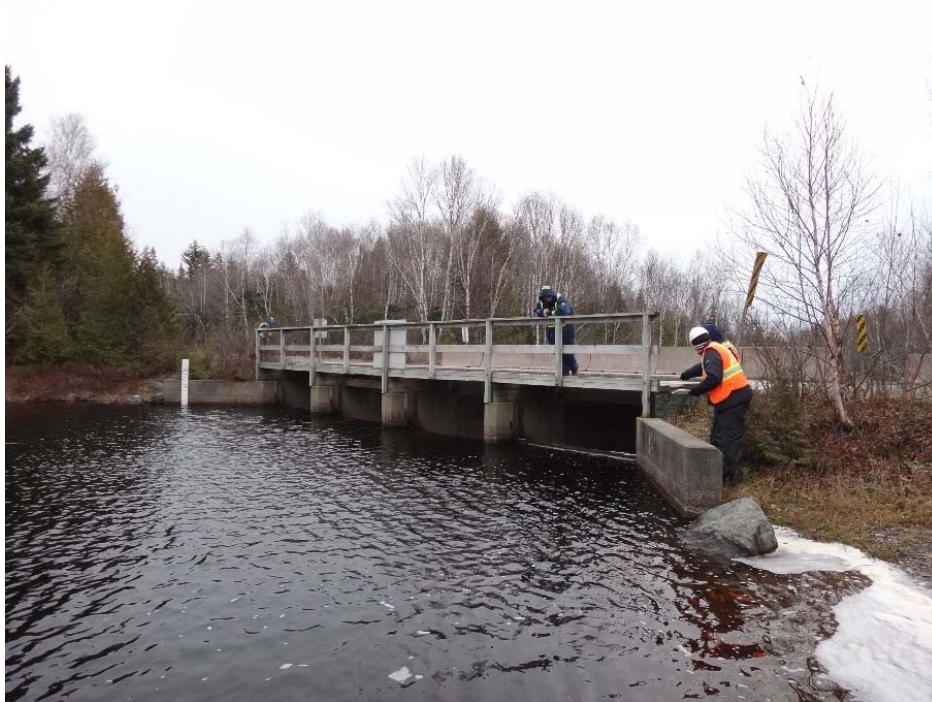
Menzies Lake Control Structure

Date of Construction:	1973
Dam Type:	Concrete Gravity
Dam Height:	4.3 m
Dam Length:	13.7 m excluding wing walls
Abutments:	Concrete on bedrock
Spillway Type:	4-bay sluiceway
Sluiceway Control:	Stoplogs
Sluiceway Length:	13.7m including end walls
Other Outlets:	None
Drainage Area:	3.6 km ²
Elevations:	
Top of Dam:	76.5 m (top of roadway)
Spillway Crest:	76.8 m (top of curb)
Sluiceway Invert:	73.1 m
Dam Foundations:	72.8 m (approximately)
Major Repairs:	None since construction.
Drawings Available:	No. 7006-35 (Box Culvert – Site Plan and Approaches Miscellaneous Details, Eastern Designers and Company Ltd. April 1971) No. 7006-36 (Box Culvert - Concrete and Reinforcing Details Eastern Designers and Company Ltd. April 1971)

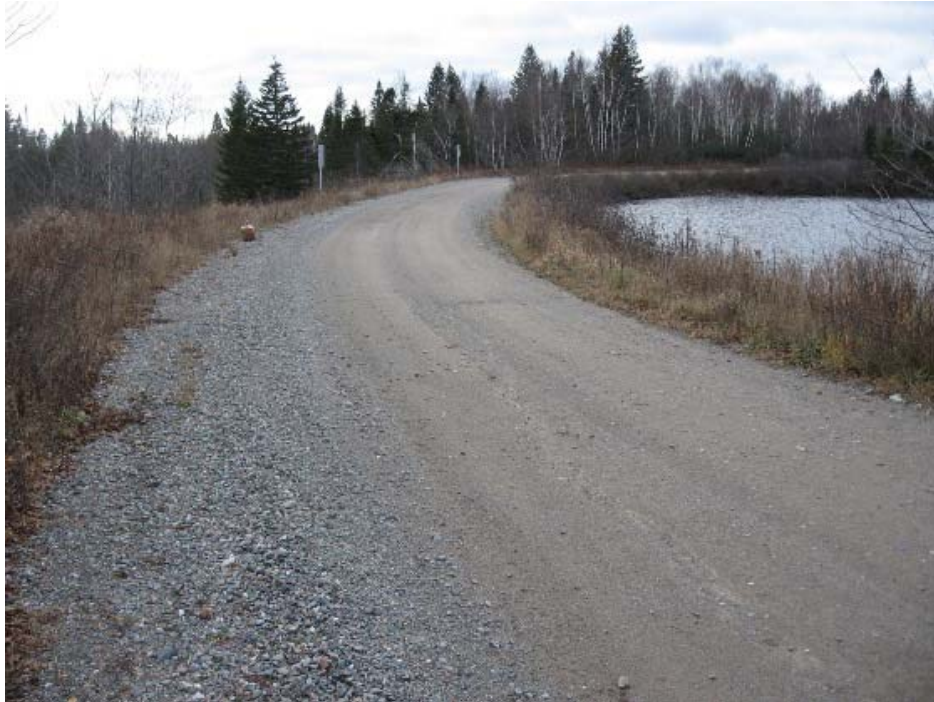
Menzie's Lake Saddle Dyke 1

Date of Construction:	1973
Dam Type:	Earth
Drainage Area:	3.6 km ²
Dam Height:	5 m
Dam Length:	100 m
Elevations:	
Top of Dam:	77.25 m (minimum centerline elevation)
Dam Foundations:	72.3 m (approximately)
Major Repairs:	Work done on the saddle dykes in the 1970s and there appears to have been structures at this location since 1937.
Drawings Available:	One drawing from 1937 showing Saddle Dyke 1

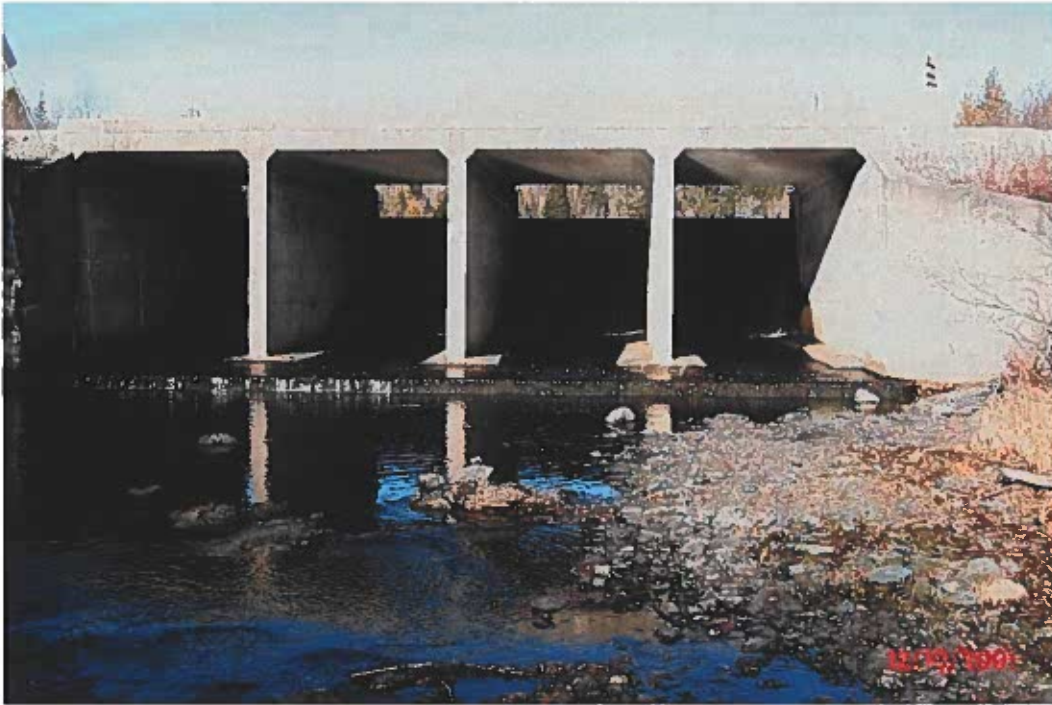
Menzies Lake Control Structure Looking from Downstream

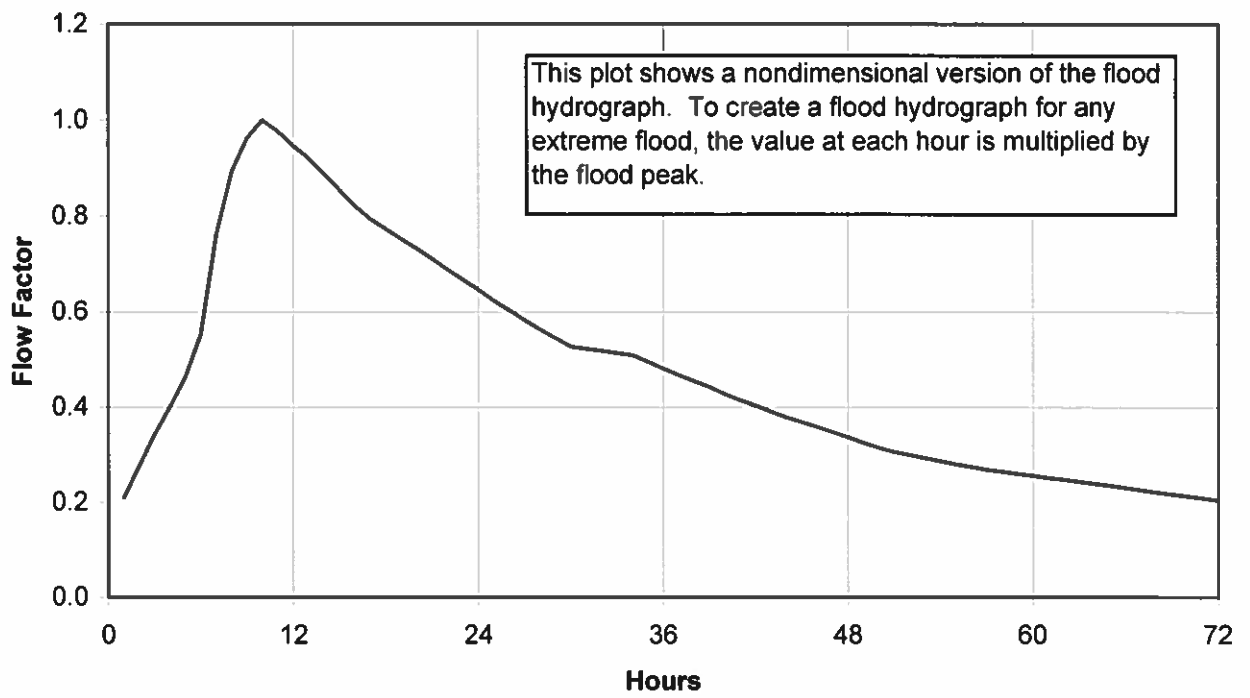
Fig. 4.1

City of Saint John
Menziess Lake Dam Safety Assessment
Flood Hydrograph Shape

The shape of the flood hydrograph was also obtained from data on the Lepreau River. Hourly data were obtained for several of the largest floods on record, for both spring (snowmelt) and fall floods, and the hydrographs were plotted. It was found that the hydrograph shape was similar for all events and was independent of the time of year so an average shape was selected. A non-dimensional version of the hydrograph shape is plotted in Figure 4.1.

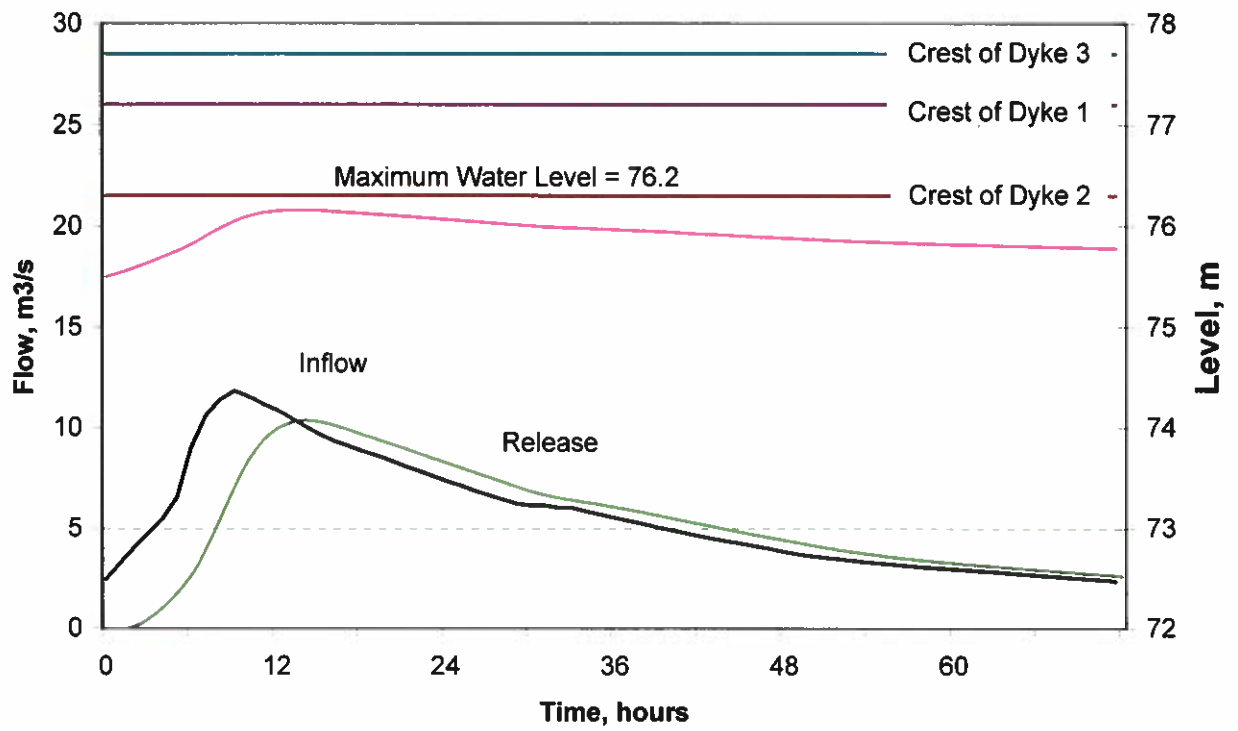
Fig. 4.2

City of Saint John
 Menzies Lake Dam Safety Assessment
 Flood Routing

Routing the IDF under the conditions described above led to a maximum flood level of el. 76.2 m, and a maximum hourly spill of 10.4 m³/s. Figure 4.2 shows the reservoir level and discharge from the lake during the event.

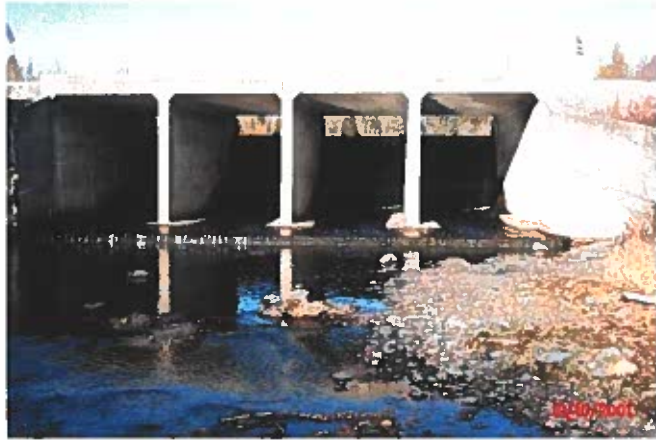
Photo 1 – View from downstream

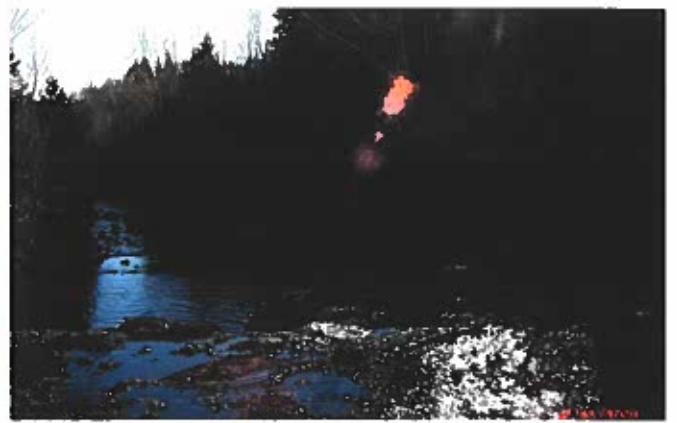
Photo 2 – Looking downstream

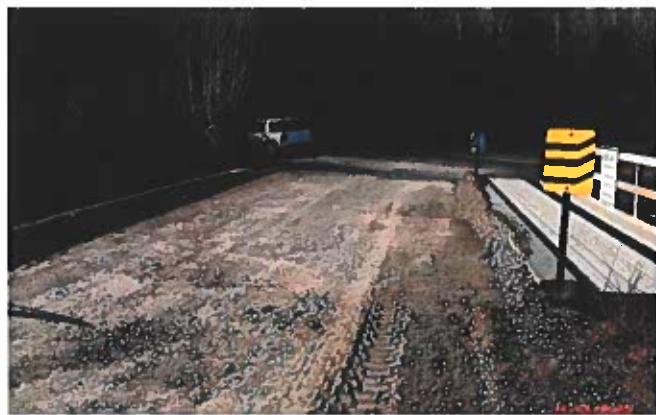
Photo 3 – Control structure deck

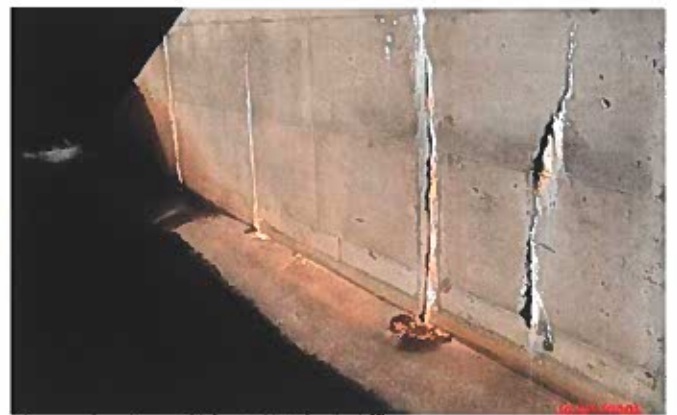
Photo 4 – Left endwall

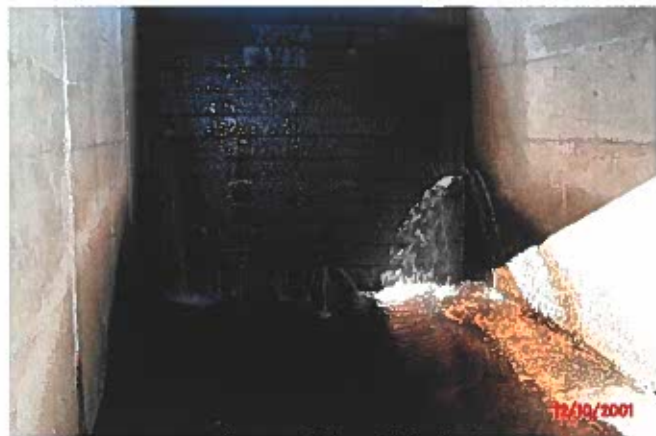
Photo 5 – Bay 1 - Stoplogs.

The Menzies Lake Control Structure is a concrete structure which consists of a 4-bay sluiceway. The sluiceways are controlled with timber stoplogs. At the time of the site visit, stoplogs were installed to the full height in bays one, three and four with one log removed from the second (from left) bay. During the inspection, an underwater camera was used to examine the upstream face of the structure. No significant deterioration was noted and only limited debris consisting of small sticks was found at the bottom of the walls.

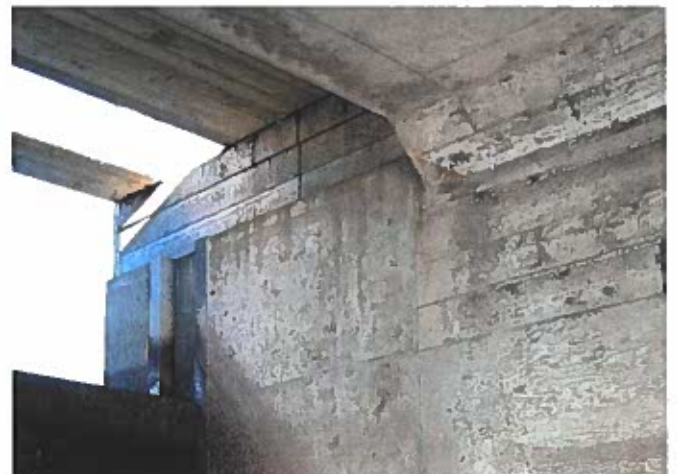
Photo 6 – Bay 2 – Underside of stoplog deck.

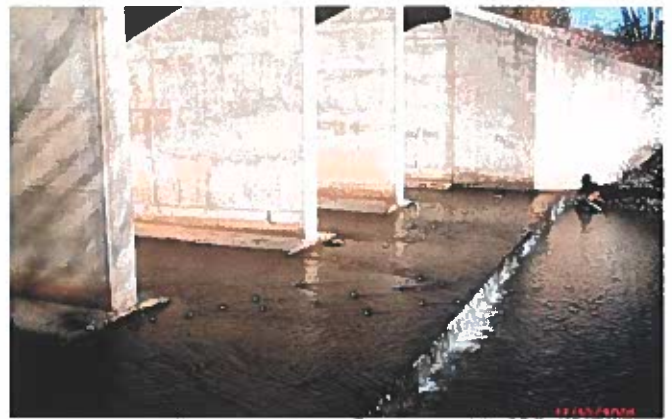
Photo 8 – End of piers and slab extension

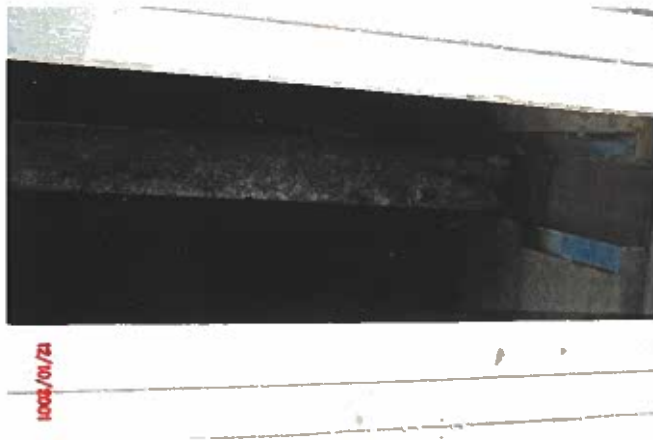
Photo 9 – Stop log and slot

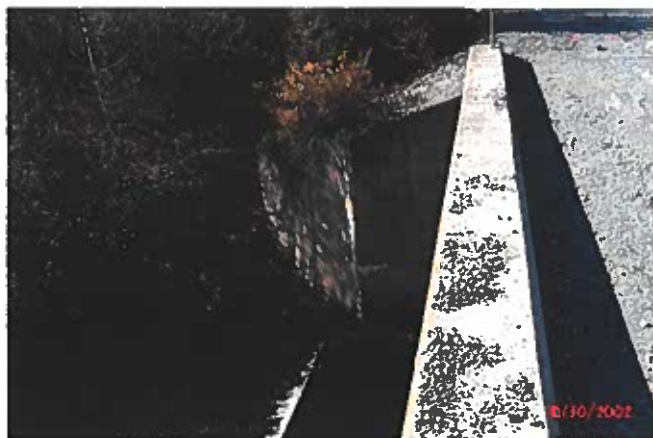
Photo 11 – Right downstream wingwall

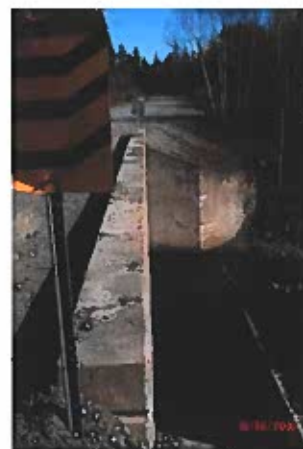
Photo 12 – Left downstream wingwall

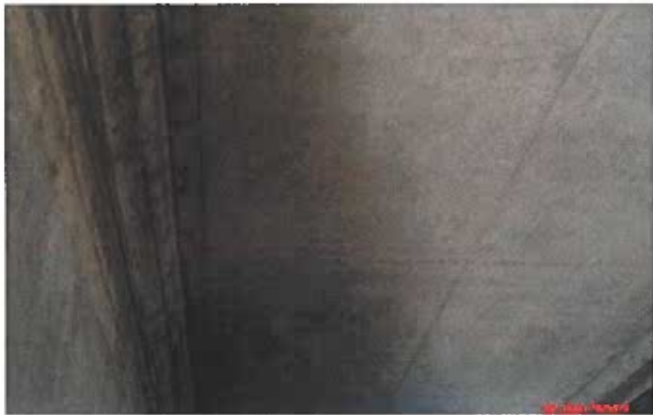
Photo 13 – Underside of concrete deck

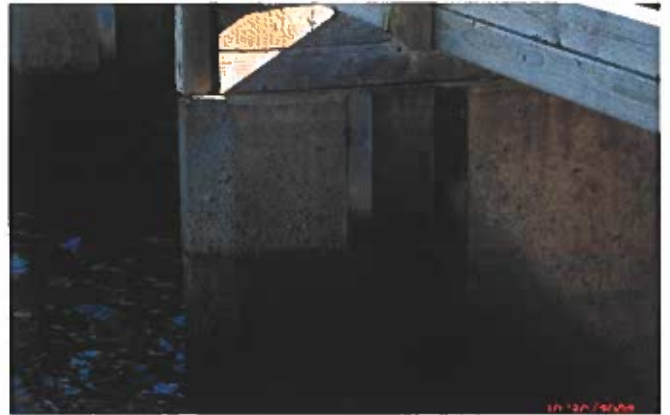
Photo 14 – Pier nose

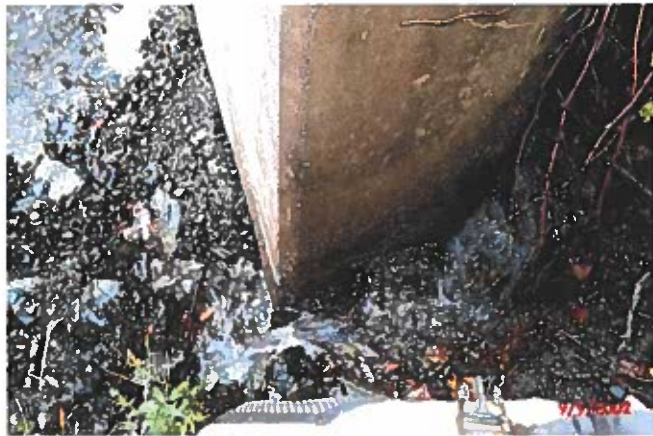
Photo 15 – Leakage at left downstream wingwall

note: leakage observed at downstream end of wingwall at earth fill interface.

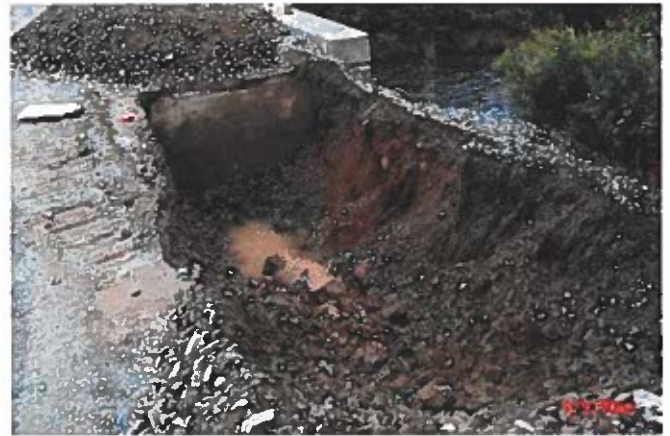
Photo 16 – Test pit in right abutment

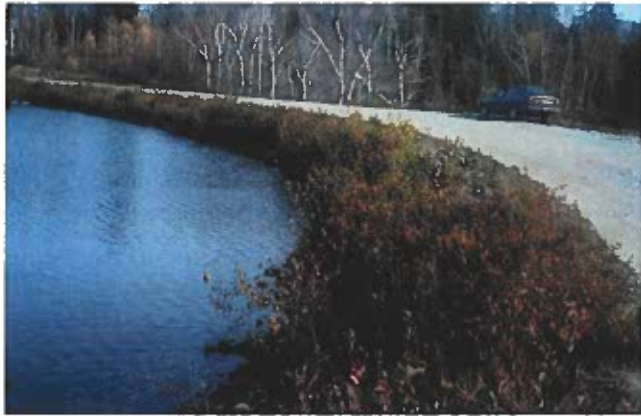
Photo 1 – Saddle Dyke 1 from Upstream Right

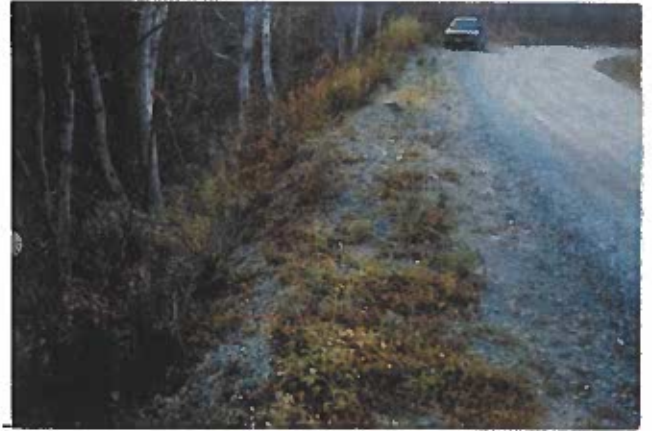
Photo 2 – Saddle Dyke 1 - Downstream Crest

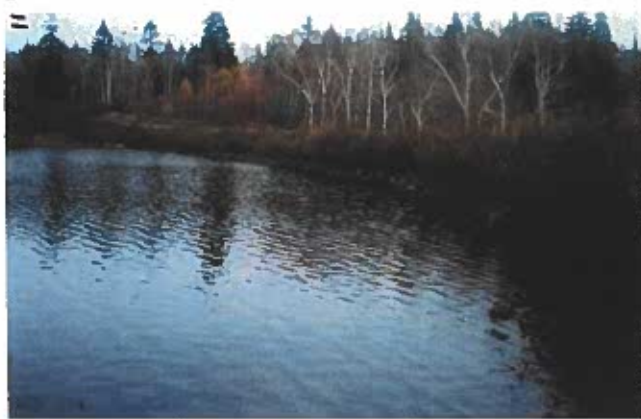
Photo 3 – Saddle Dyke 1 showing slope protection.

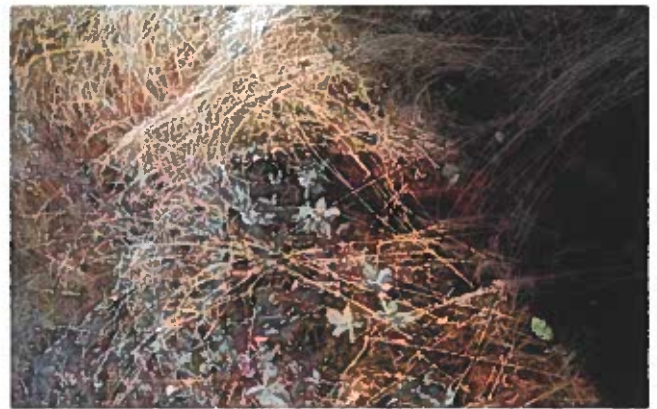
Photo 4 – Saddle Dyke 1 – wet area at downstream toe

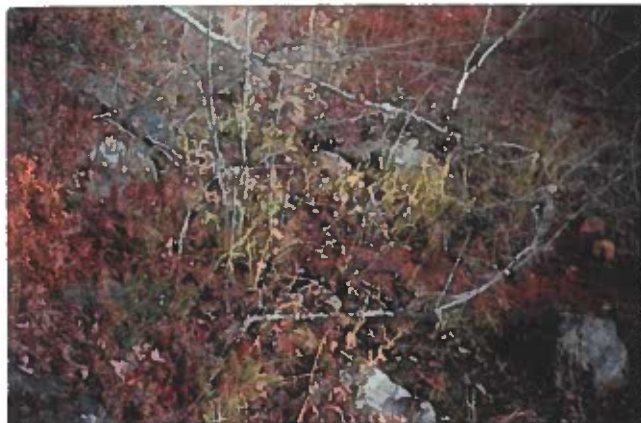
Photo 5 – Saddle Dyke 1 – Seepage at left abutment toe.

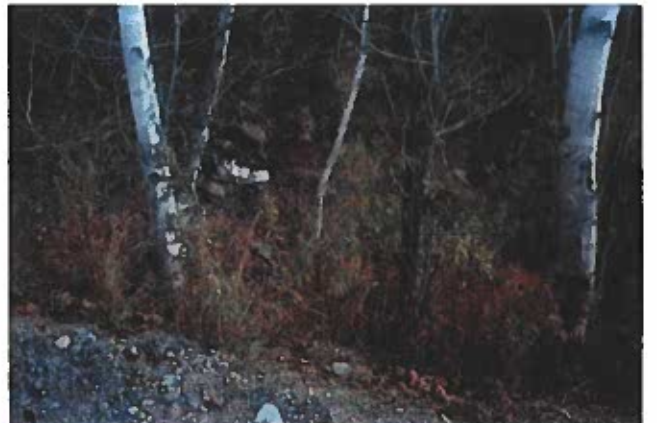
Photo 6 – Saddle Dyke 1 – Seepage at left abutment toe and trees on slope.

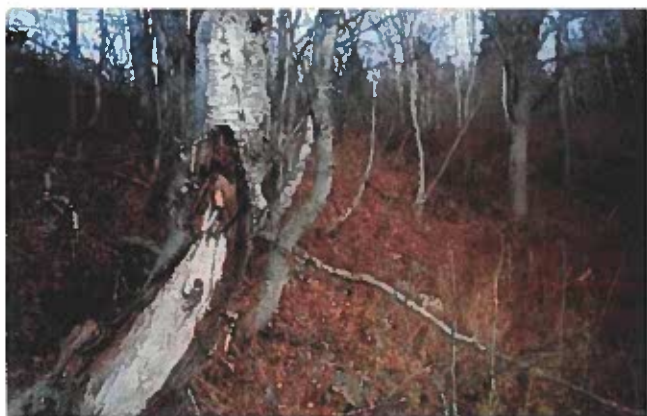
Photo 7 – Saddle Dyke 1 – tree growth on slope looking left from centre of dam

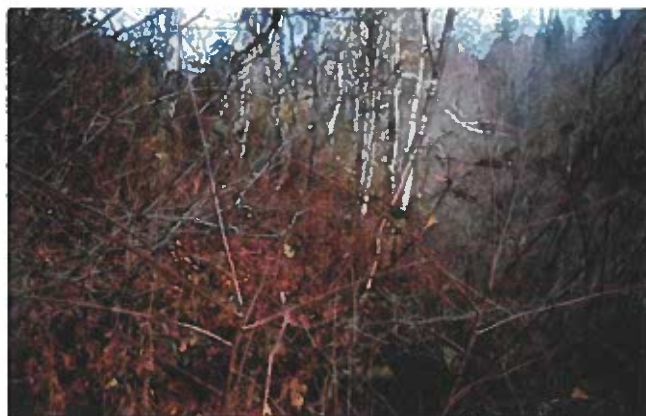
Photo 8 – Saddle Dyke 1 – tree growth on slope

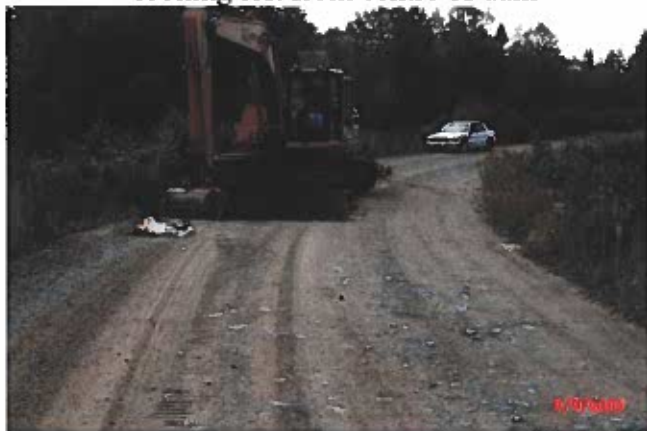
Photo 9 – Saddle Dyke 1 – Test pit on crest

Test pits TP3, 4, and 5 were located at the crest of Saddle Dyke 1. These test pits were excavated to search for the 1 m wide impermeable core identified on an old drawing. The 1 m wide impermeable core was not found. The test pitting was limited in both depth and width in order to maintain the stability of the structure during excavation. The depth of the test pits ranged from 1.75 m to 2.9 m.

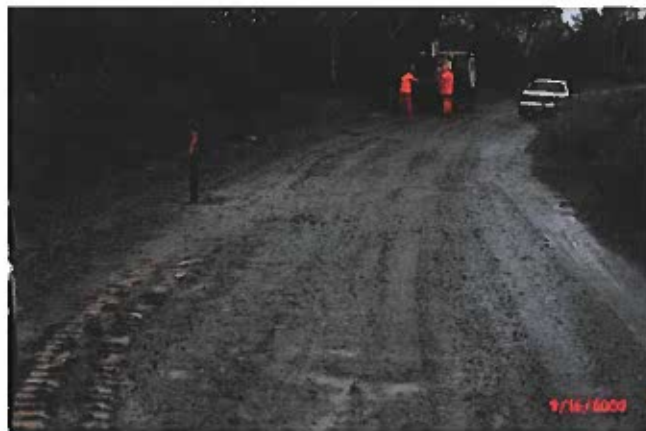
Photo 10 – Saddle Dyke 1 – Probe holes on crest

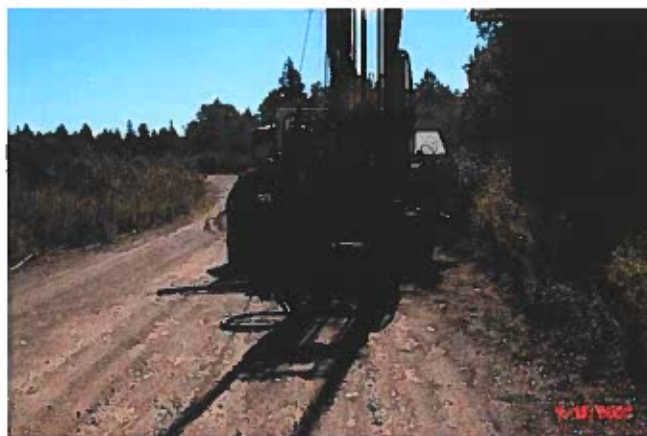
Photo 11 – Saddle Dyke 2 – Probe hole on crest

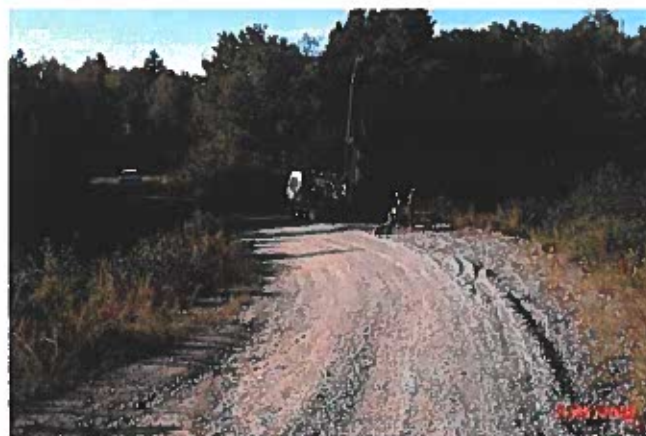
Photo 12 – Saddle Dyke 3 – Probe hole on crest

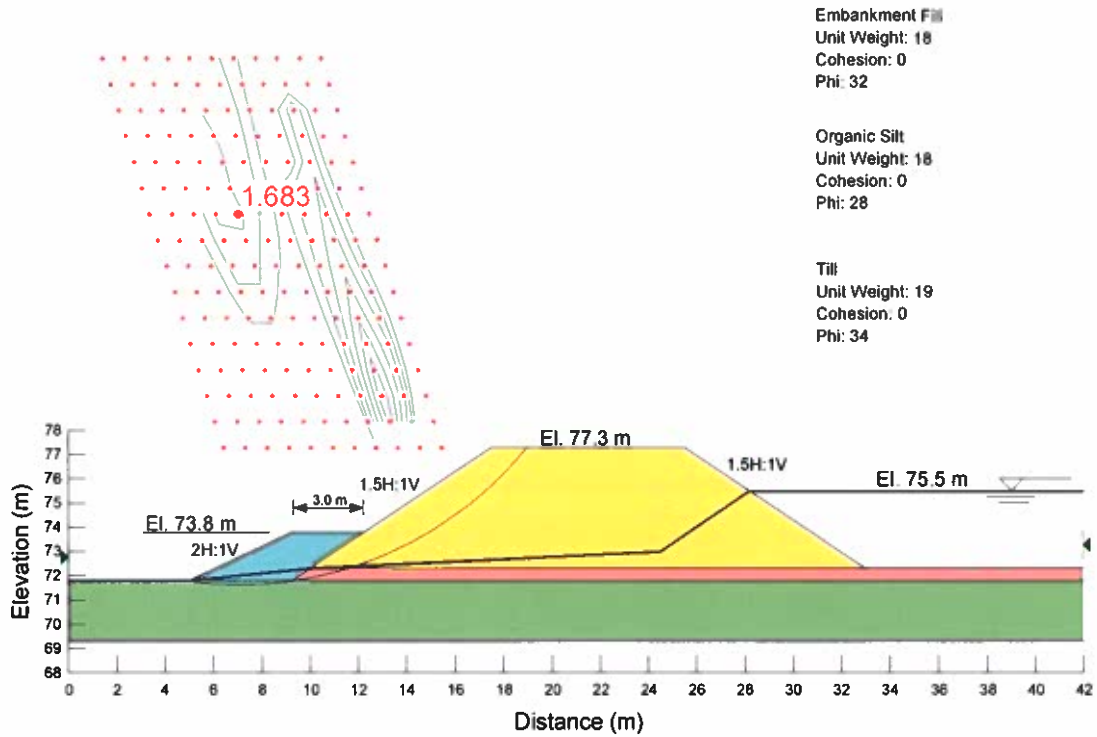
**Figure D-6 Stability Analysis Results – Saddle Dyke 1 Remediation
Normal Water Level – Upstream Stability**

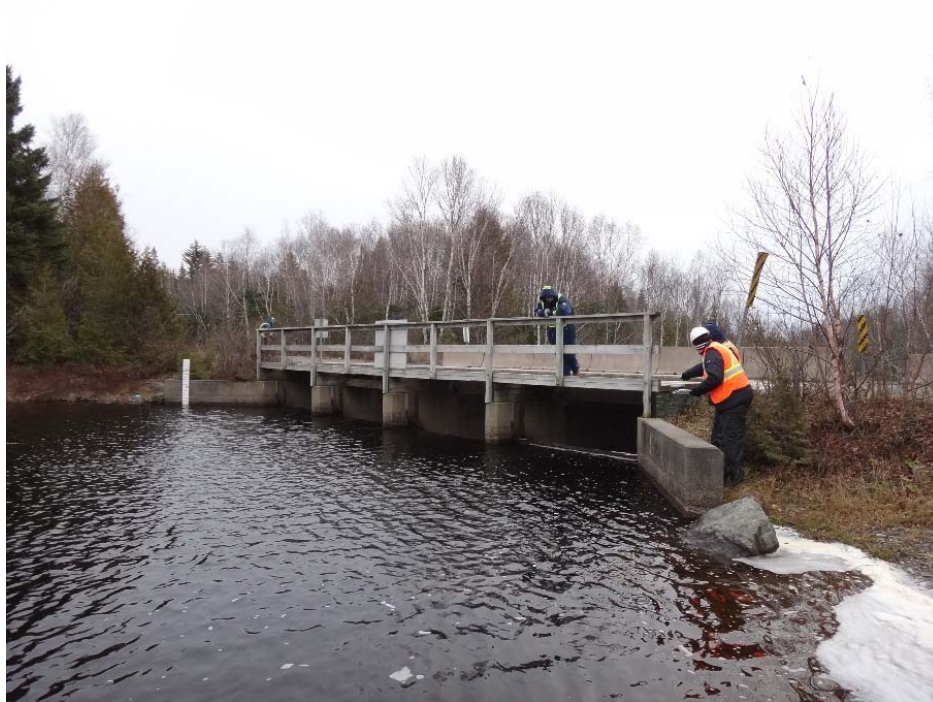
Menzies Lake Control Structure

Date of Construction:	1973
Dam Type:	Concrete Gravity
Dam Height:	4.3 m
Dam Length:	13.7 m excluding wing walls
Abutments:	Concrete on bedrock
Spillway Type:	4-bay sluiceway
Sluiceway Control:	Stoplogs
Sluiceway Length:	13.7m including end walls
Other Outlets:	None
Drainage Area:	3.6 km ²
Elevations:	
Top of Dam:	76.5 m (top of roadway)
Spillway Crest:	76.8 m (top of curb)
Sluiceway Invert:	73.1 m
Dam Foundations:	72.8 m (approximately)
Major Repairs:	None since construction.
Drawings Available:	No. 7006-35 (Box Culvert – Site Plan and Approaches Miscellaneous Details, Eastern Designers and Company Ltd. April 1971) No. 7006-36 (Box Culvert - Concrete and Reinforcing Details Easter Designers and Company Ltd. April 1971)

The upstream of the wing walls and piers showed surface weathering of concrete with exposed aggregate along the waterline. There was no rockfill bank protection adjacent to the upstream wing walls and some settlement/erosion of the fill was noted in this area.

The downstream wingwalls showed some cracking with efflorescence however there were no signs of movement.

Water was spilling over the stoplogs at the time of the inspection in 2 of the bays. Leakage was noted through the stoplogs in the other two bays. The downstream apron and stilling basin at the toe was not visible due to the flow of water.

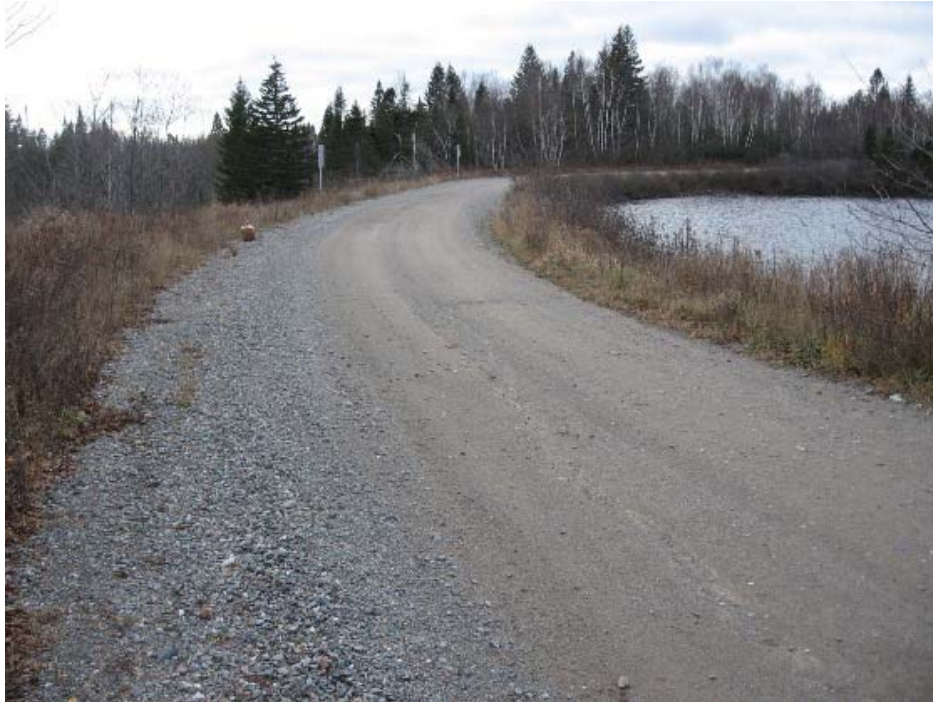
Menzie's Lake Saddle Dyke 1

Date of Construction:	1973
Dam Type:	Earth
Drainage Area:	3.6 km ²
Dam Height:	5 m
Dam Length:	100 m
Elevations:	
Top of Dam:	77.25 m (minimum centerline elevation)
Dam Foundations:	72.3 m (approximately)
Major Repairs:	Work done on the saddle dykes in the 1970s and there appears to have been structures at this location since 1937.
Drawings Available:	One drawing from 1937 showing Saddle Dyke 1

The downstream slope is also steep and is grass and brush covered with small trees. Large tree stumps were also noted and cut trees and brush was left on the downstream slope and at the toe of the structure. The condition and steepness of the downstream slope made the structure difficult to inspect however some unevenness of the slope was noted. The downstream toe of the structure was wet and there is a wetland type area downstream. Seepage at the toe was visible during the inspection but was not measured. It was noted by SJW that seepage at this structure has increased in the last decade.

The crest of the structure is a gravel roadway and is sloped towards the upstream shoulder. Large rocks were noted in the crest. Windrows at the upstream and downstream crest of the slopes were noted; this structure is plowed regularly during the winter because it forms part of the access road to SJW's pumping station. There were two traffic signs on the crest (to act as a warning to drivers of the downstream edge of the crest) and additional damaged signs were noted on the downstream slope which appeared to have been previously installed on the crest.

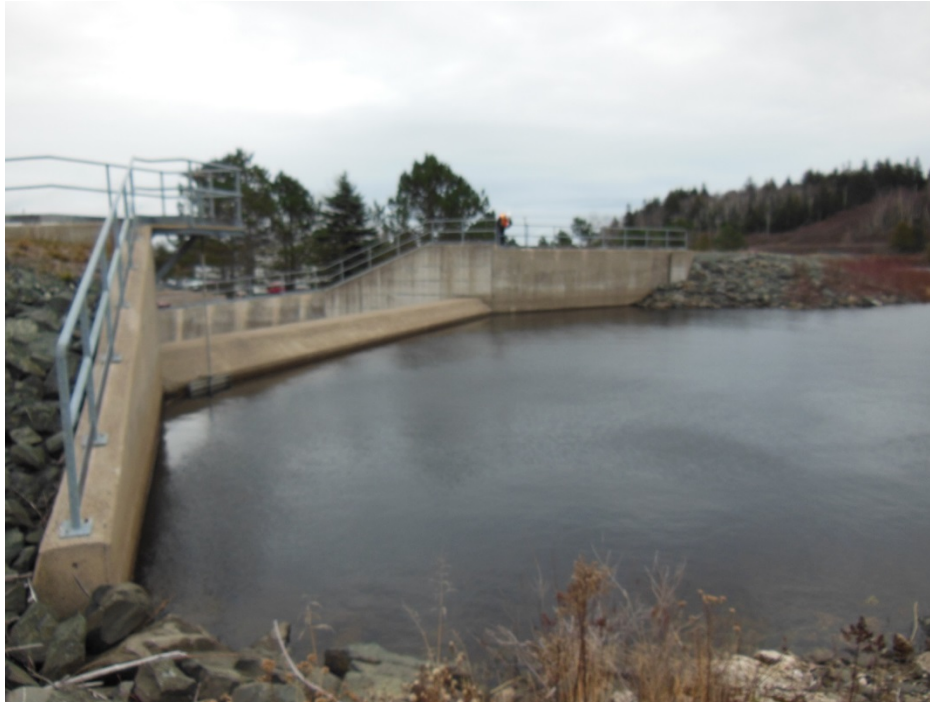
Spruce Lake Dam

Date of Construction: Reconstructed 2002, originally constructed 1898 (approximately),

Dam Type: Concrete structure with earth embankments

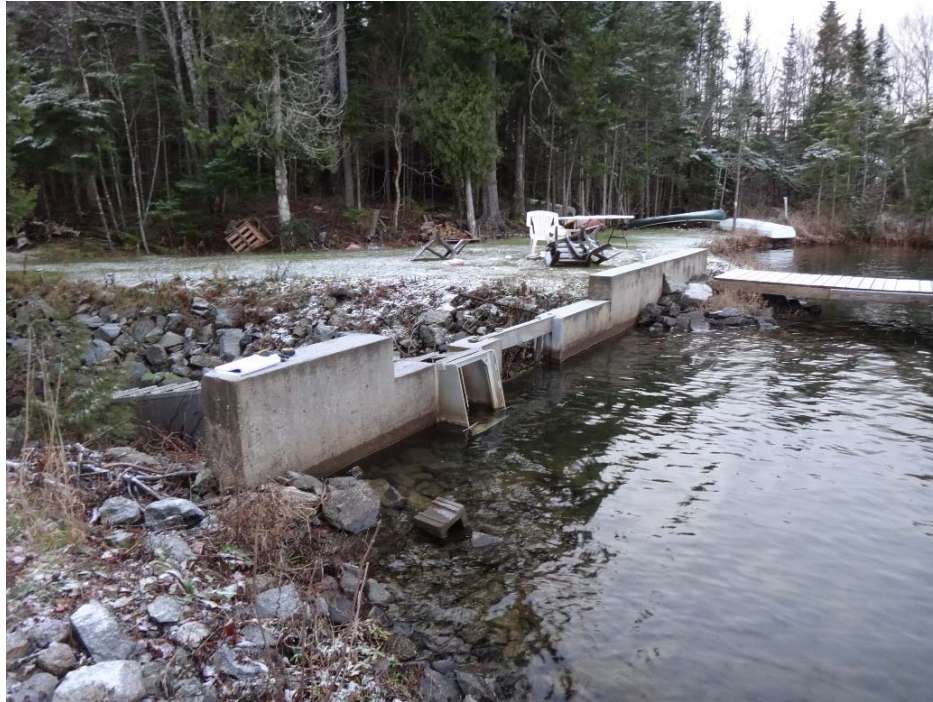
Date of Construction:	Reconstructed in 2000, originally constructed during 1961
Dam Type:	Concrete structure with earth embankments
Dam Height (max):	2.2 m
Dam Length:	10.5 m
Abutments:	Earth embankments with concrete cores
Spillway Type:	Concrete overflow spillway
Spillway Length:	4.2 m
Other Outlets:	1.2 m x 1.2 m stoplog bay located in spillway 6.1m long stainless steel fish ladder
Elevations:	
Top of Dam:	122.53 m (402.0 ft local datum)
Overflow Spillway:	122.22 m (401.0 ft local datum)
Major Repairs:	Reconstructed in 2000
Drawings Available:	H-082-002 Hunter Lake Control Dam – Plan, Sections, and Details As Built, Dated Sept. 2000 – Sheet 1 of 2 H-082-002 Hunter Lake Control Dam – Fish Ladder Details As Built, Dated Sept. 2000 – Sheet 2 of 2 H-082-004 Hunter Lake Control Dam – Plan, Sections, and Details Issued For Tender, Dated May 2000 – Sheet 1 of 2 H-082-004 Hunter Lake Control Dam – Fish Ladder Details Issued For Construction, Dated May 2000 – Sheet 2 of 2 H-082-001 Hunter Lake Dam – Existing Conditions Dated Aug. 18, 1998 – Sheet 1 of 1 H-082-003 Hunter Lake Control Dam – Existing Plan, Profile and Section - Dated 1961

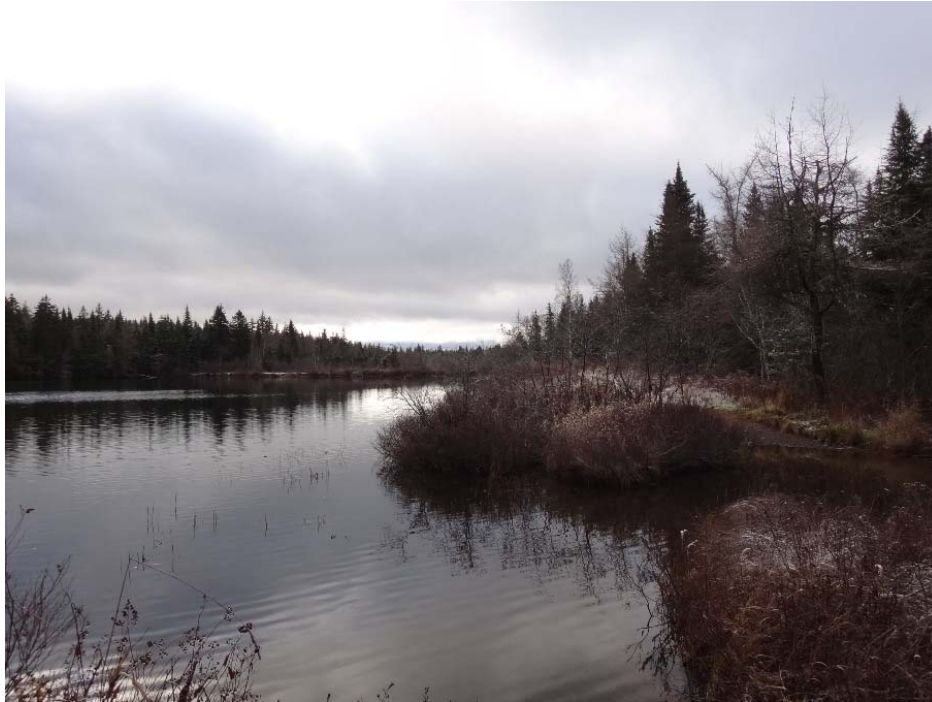
McBrien Lake Southwest Dam

Date of Construction:	1964
Dam Type:	Earth Embankment
Dam Height (max):	4.9 m
Dam Length:	182.9 m
Abutments:	Earth Embankments
Spillway Type:	None. An opening exists at the northwest (right) end of the dam
Other Outlets	Concrete decant structure connected to an outlet pipe
Elevations:	Top of Dam 109.42 m (359.0 ft local datum)
Operating Levels:	Normal Operation 108.20 m (355.0 ft local datum)
Major Repairs:	No record of any repairs
Drawings Available:	None

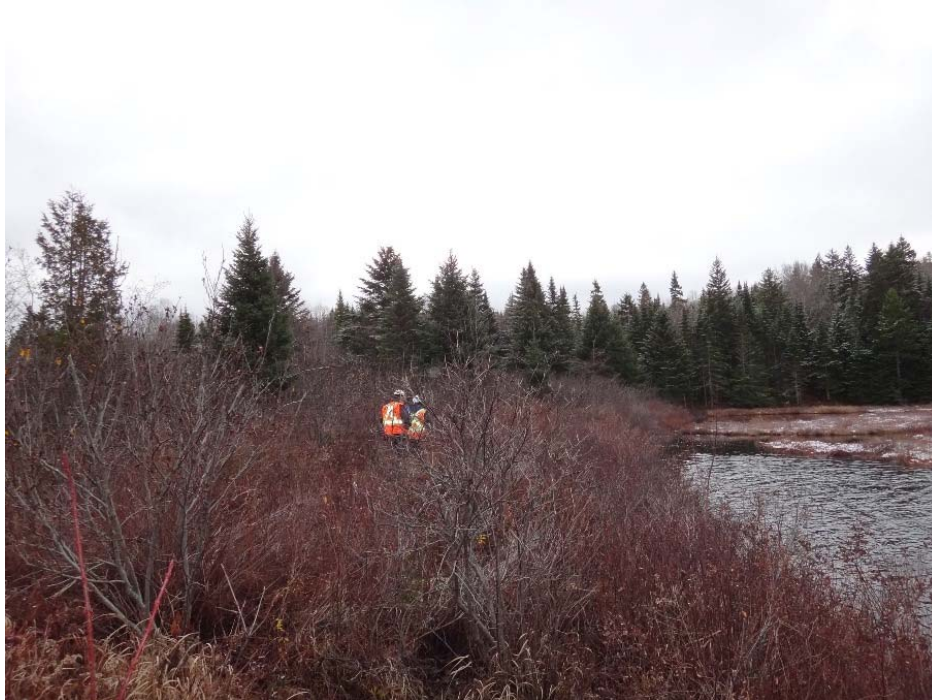
McBrien Southeast Dam

Date of Construction:	1964
Dam Type:	Earth Embankment
Dam Height (max):	4.3 m
Dam Length:	91.4 m
Abutments:	Earth Embankments
Spillway Type:	None
Other Outlets:	None
Elevations:	Top of Dam 109.42 m (359.0 ft local datum)
Operating Levels:	Normal Operation 108.20 m (355.0 ft local datum)
Major Repairs:	Unknown
Drawings Available:	Lake South Dam Site – Plan, Profile, and Cross Sections Dwg I-621, Dated April 14, 1964

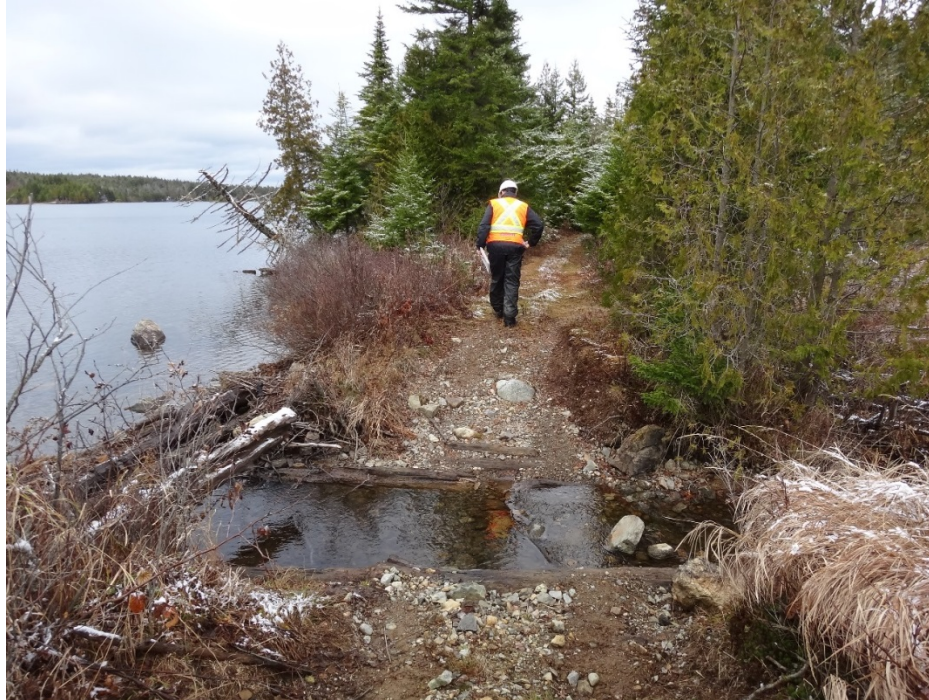
Terreo Lake Dam

Date of Construction:	1880s
Dam Type:	Earth Embankment
Dam Height (max):	1.0 m
Dam Length:	24 m
Abutments:	Earth
Spillway Type:	Timber Crib (no longer exists)
Other Outlets:	None
Elevations:	Top of dam elevation unknown
Operating Levels:	Unknown
Major Repairs:	Unknown
Drawings Available:	None available, A sketch of possible dam replacement is available

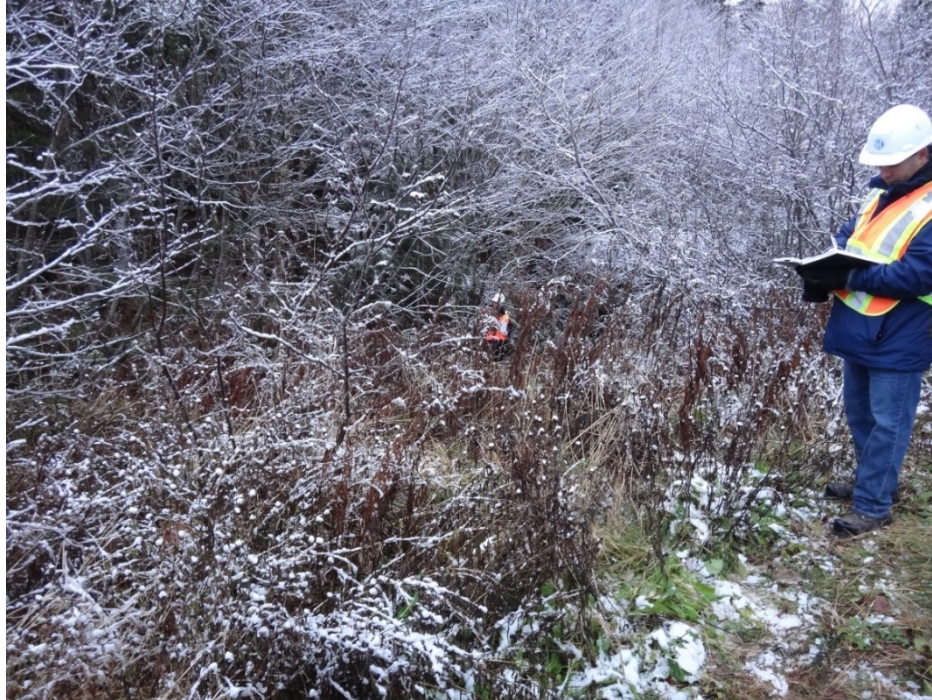
Taylor Lake Dam

Date of construction:	ca 1990s structure backfilled. Original construction ca. 1961
Dam Type:	Earth embankment (buried concrete control structure)
Dam Height (max):	3.3 m
Dam Length:	9 m
Abutments:	Earth
Spillway Type:	None
Other Outlets:	None
Elevations:	Top of dam elevation unknown
Operating Levels:	Normal operating levels unknown
Major Repairs:	Unknown
Drawings Available:	None available

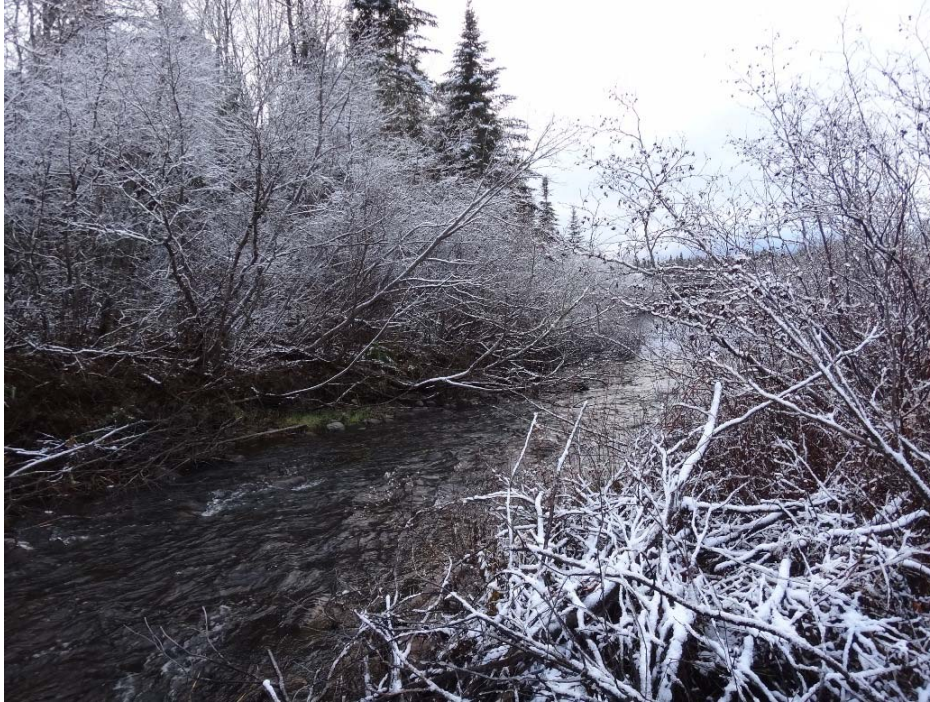
Otter Lake Dam

Date of construction:	1961
Dam Type:	Breached earth embankment (the site is free flowing)
Dam Height (max):	3.3 m
Dam Length:	24 m
Abutments:	Earth
Spillway Type:	None. The control structure at Otter Lake has been removed
Other Outlets	None
Elevations:	Top of dam elevation unknown
Operating Levels:	Natural levels
Major Repairs:	Unknown
Drawings Available:	Sketch of Otter lake Timber Crib dam

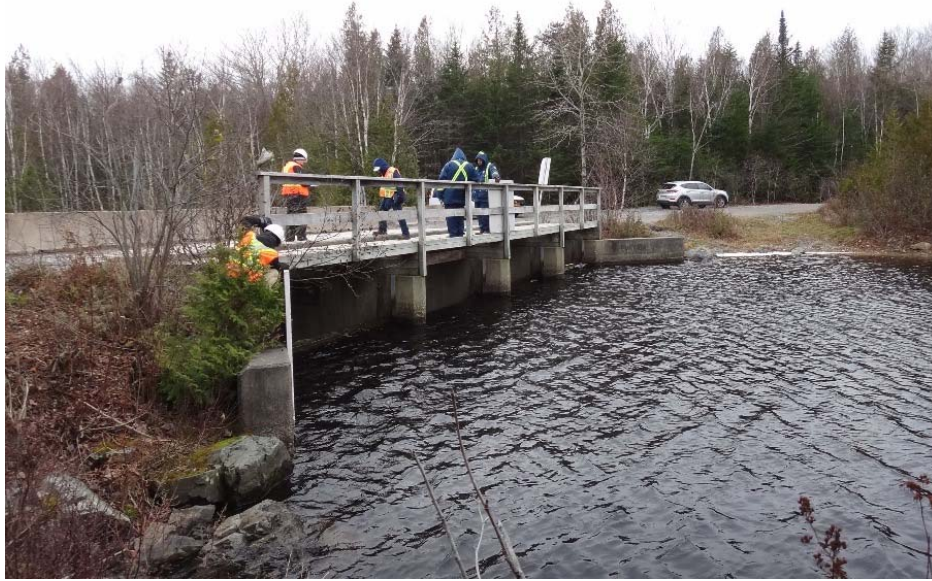
**Photo 1: Menzies Lake Control Structure
View from upstream of left abutment**

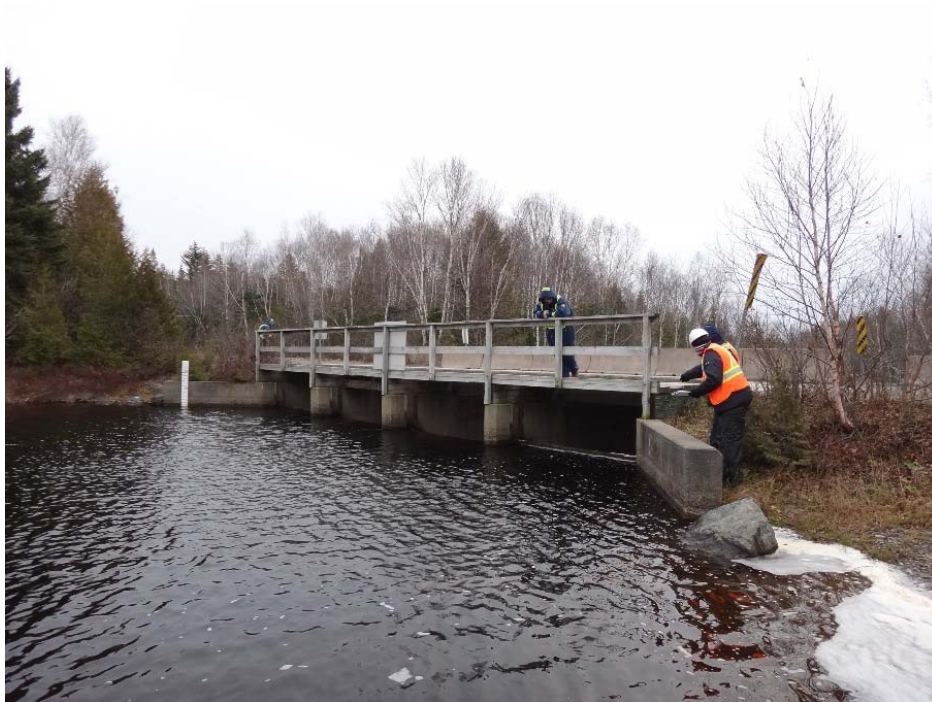
**Photo 2: Menzies Lake Control Structure
View from upstream of right abutment**

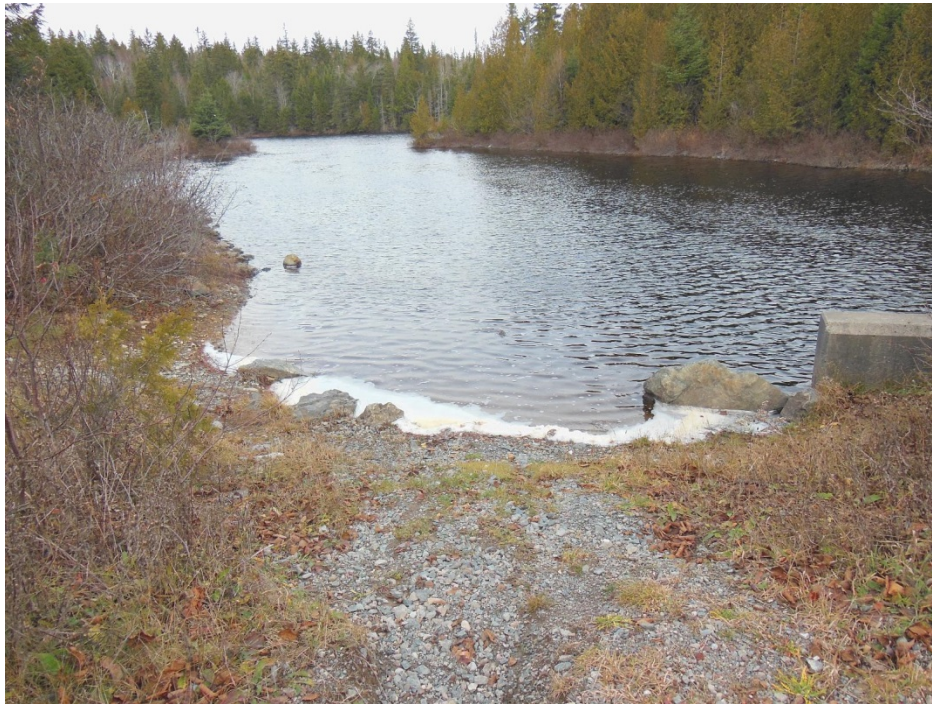
Photo 3: Menzies Lake Control Structure
Looking upstream from the right abutment of the structure
