2022-091006P

**“ENGINEERING SERVICES – MENZIES LAKE DAMS AND ACCESS ROAD
DRAINAGE UPGRADES”
SAINT JOHN, NB**

City of Saint John Menzies Lake Dam - Cost Update Final Report

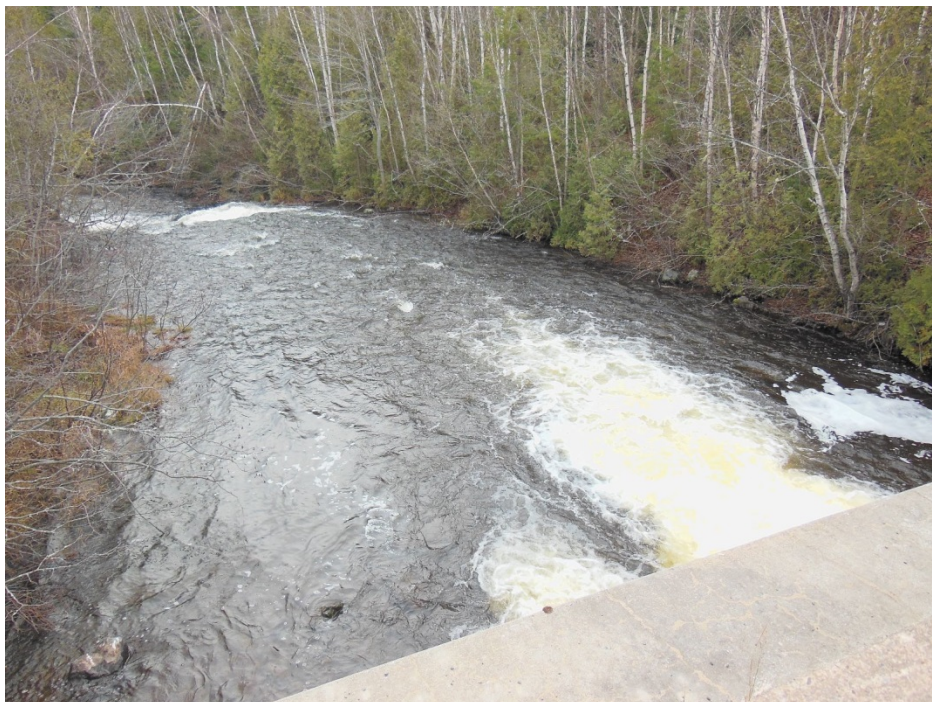
Photo 4: Menzies Lake Control Structure
Looking downstream from the structure

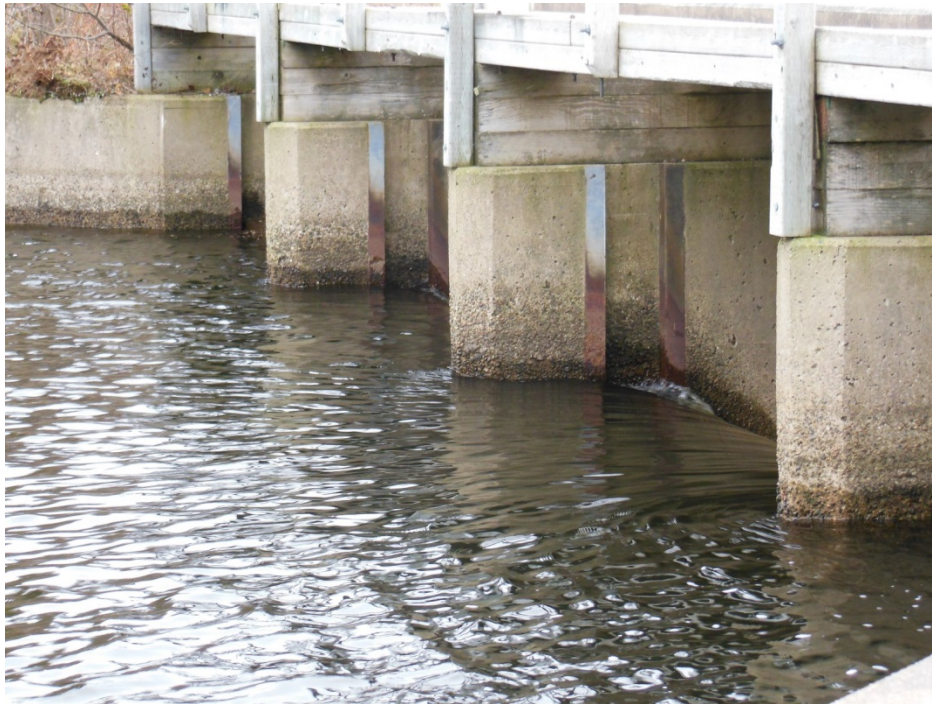
**Photo 5: Menzies Lake Control Structure
Upstream piers**

The upstream of the wing walls and piers showed surface weathering of concrete with exposed aggregate along the waterline. There was no rockfill bank protection adjacent to the upstream wing walls and some settlement/erosion of the fill was noted in this area.

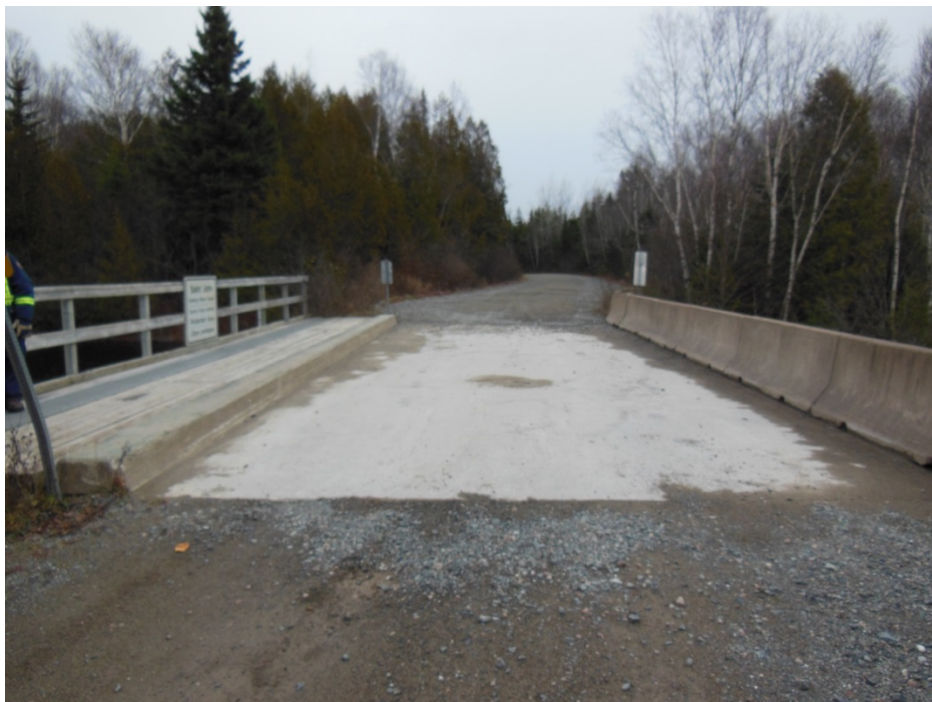
**Photo 6: Menzies Lake Control Structure
Looking at the crest from the right abutment of the structure**

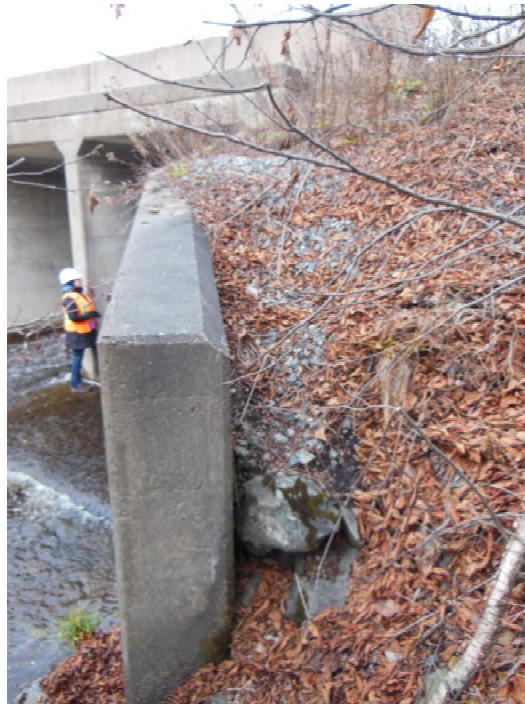
**Photo 7: Menzies Lake Control Structure
Left downstream wingwall**

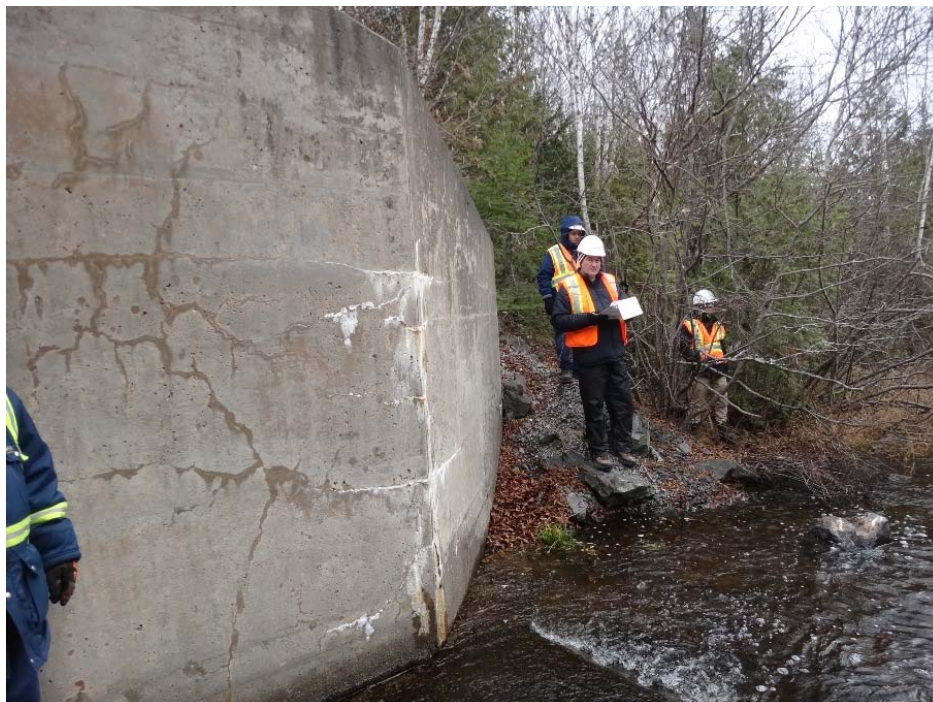
**Photo 8: Menzies Lake Control Structure
Left downstream wingwall**

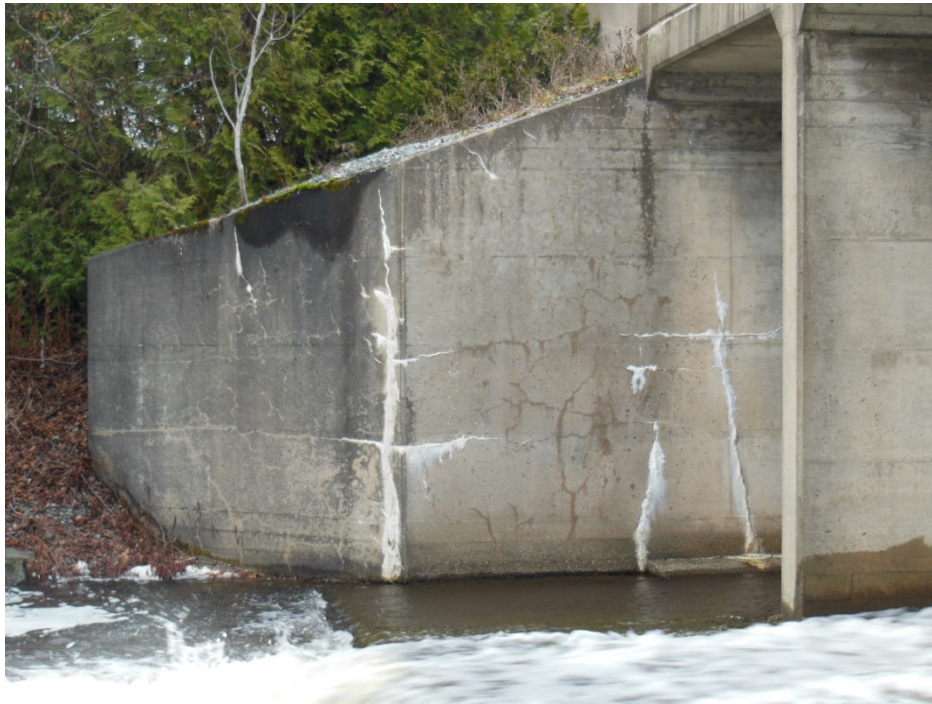
**Photo 9: Menzies Lake Control Structure
Right downstream wingwall**

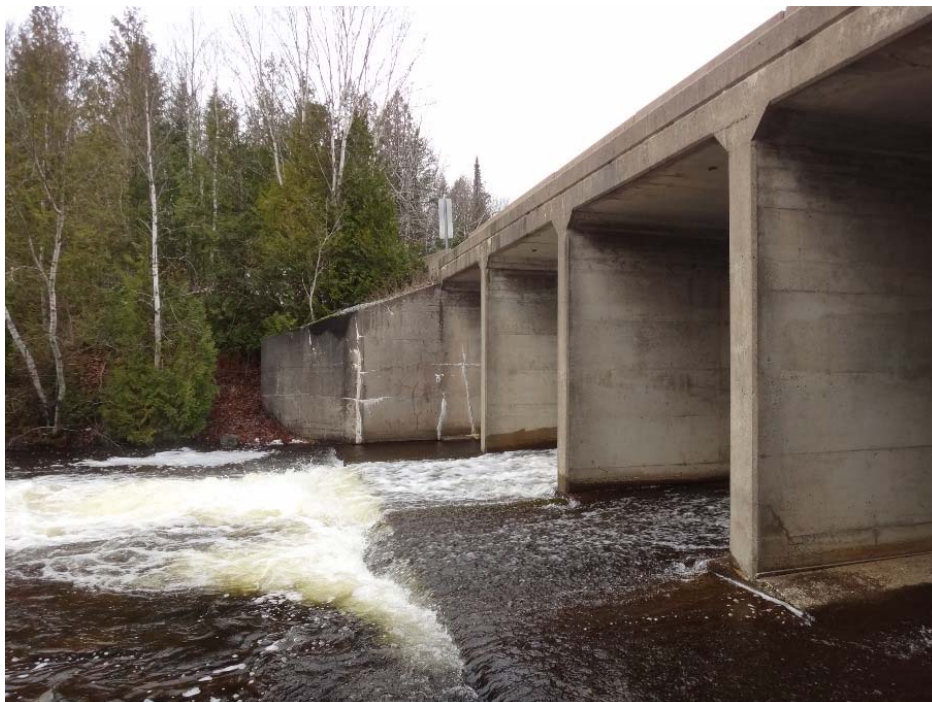
**Photo 10: Menzies Lake Control Structure
View of structure from downstream left wingwall**

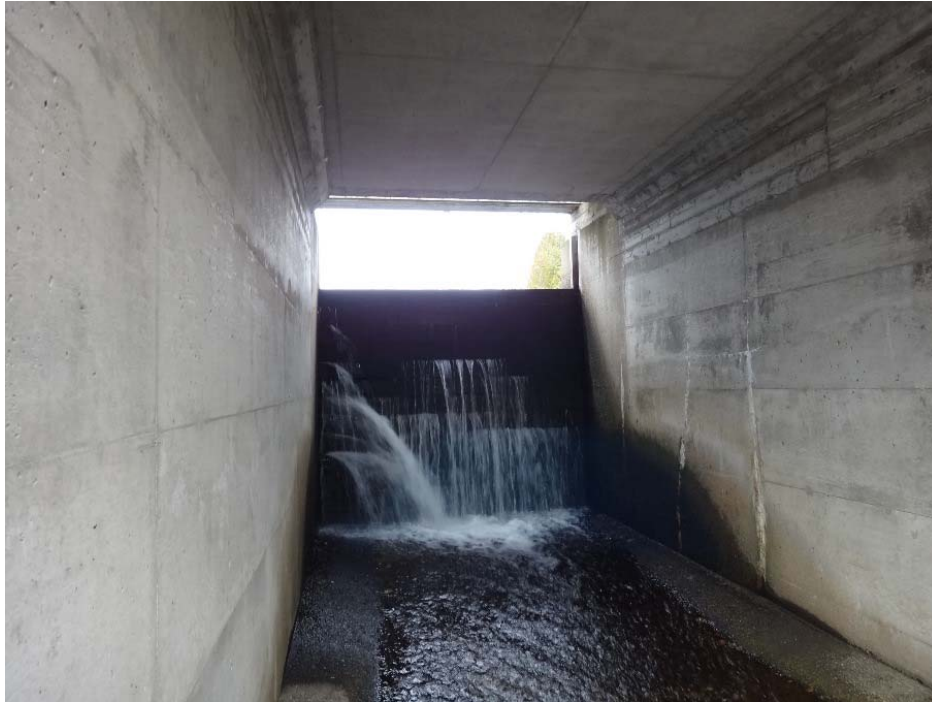
**Photo 11: Menzies Lake Control Structure
Leakage through stoplogs**

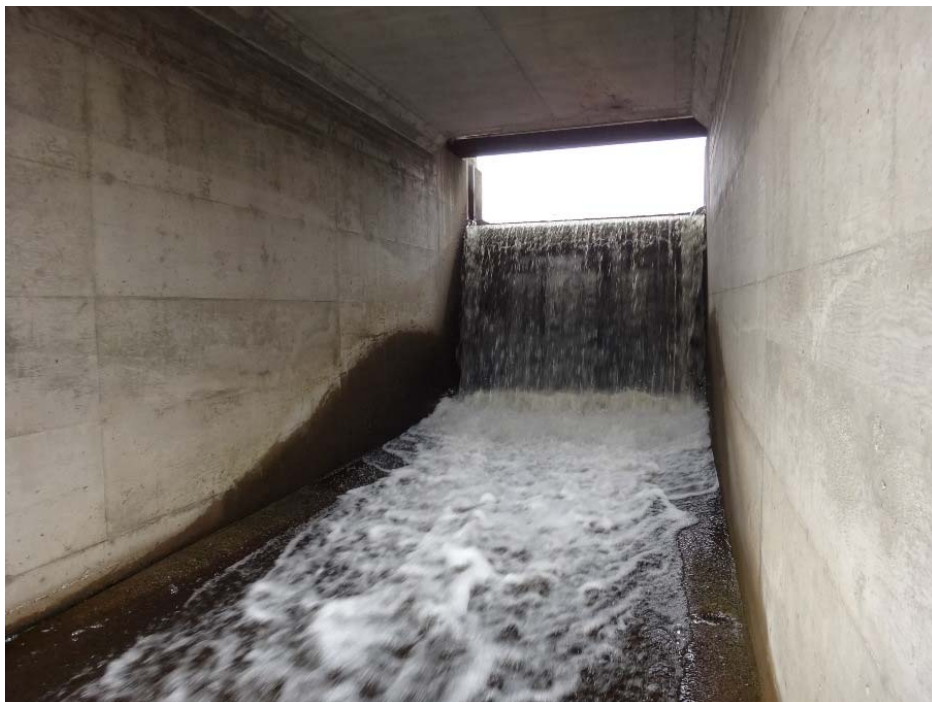
**Photo 12: Menzies Lake Control Structure
Flow over stoplogs**

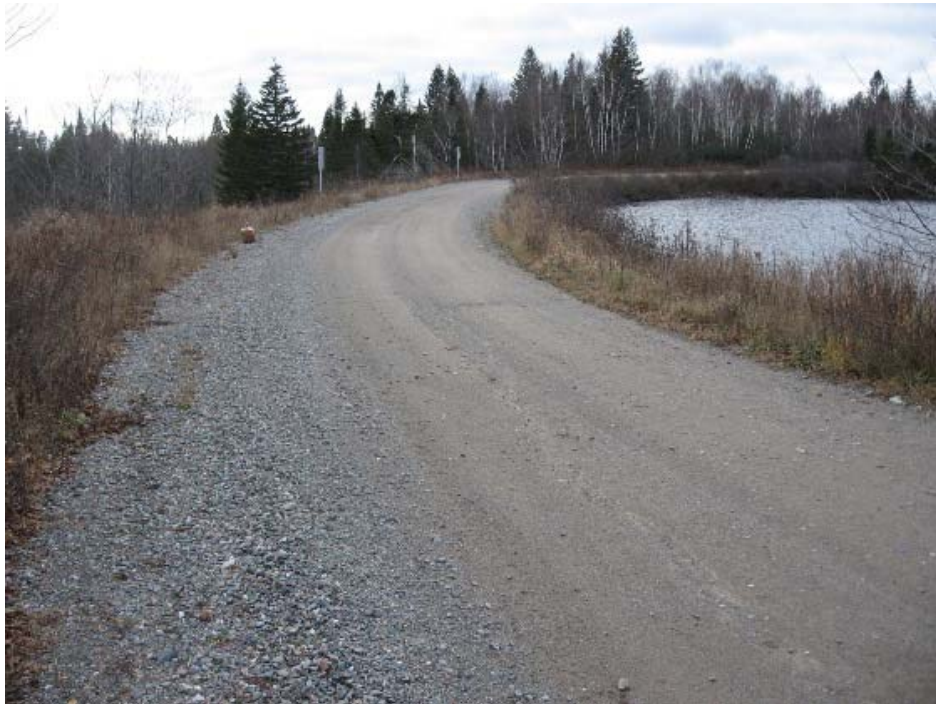
**Photo 13: Menzies Lake Saddle Dyke 1
Crest of dam, from left abutment looking West**

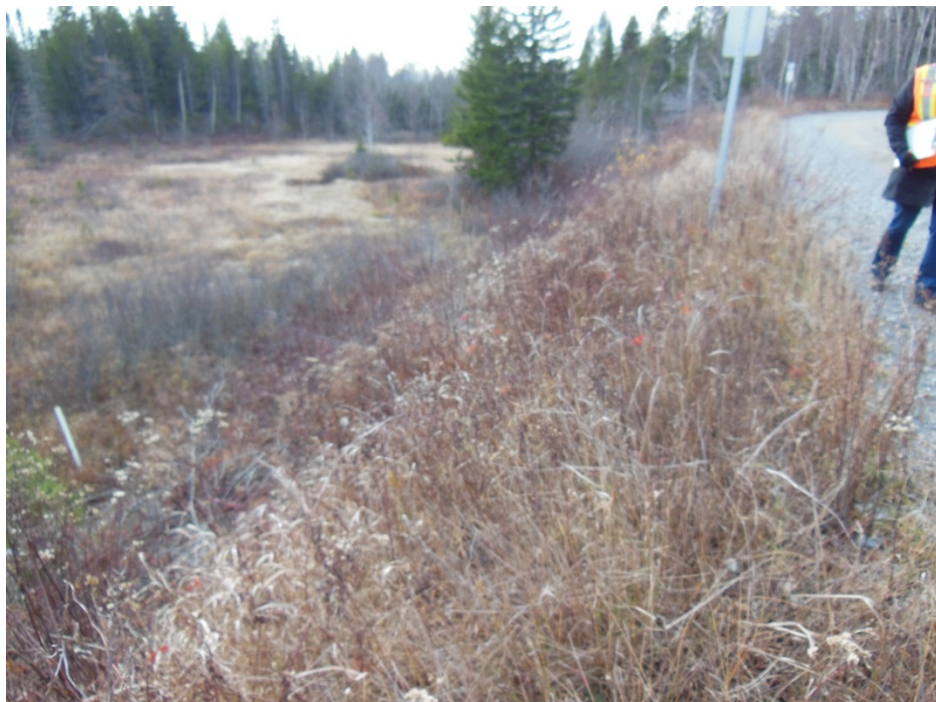
**Photo 14: Menzies Lake Saddle Dyke 1
Downstream slope and wetland type area downstream.**

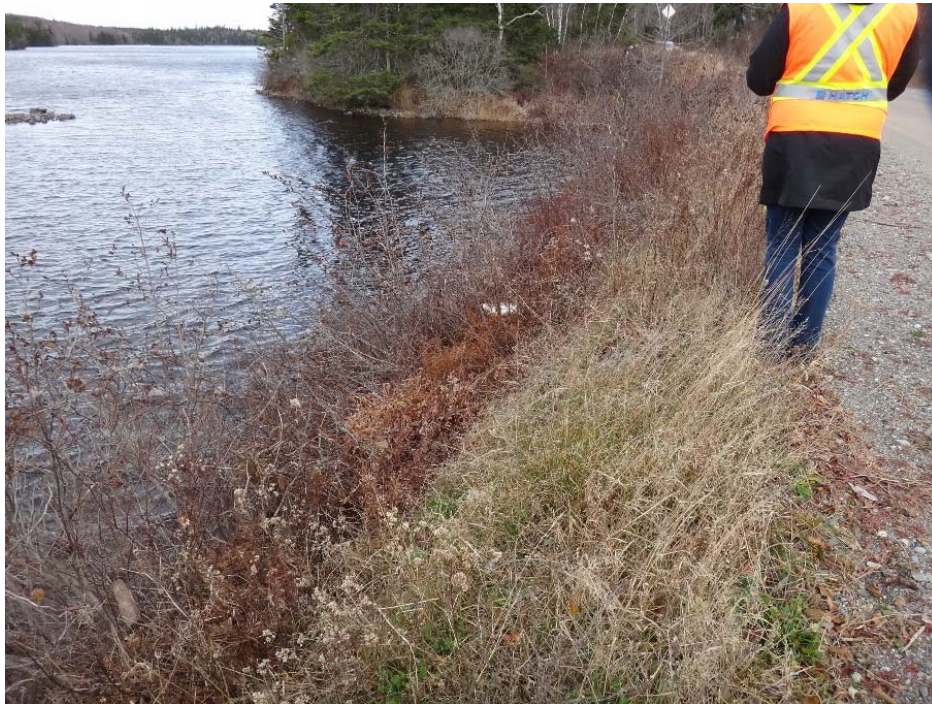
**Photo 15: Menzies Lake Saddle Dyke1
Upstream slope**

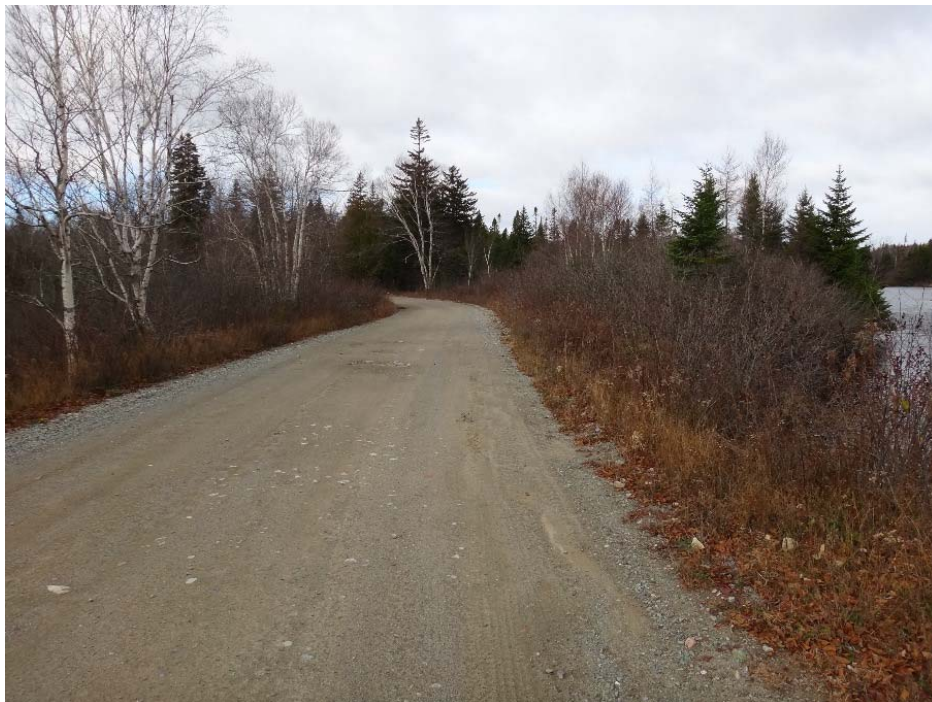
**Photo 16: Menzies Lake Saddle Dyke 2
View from left abutment looking West**

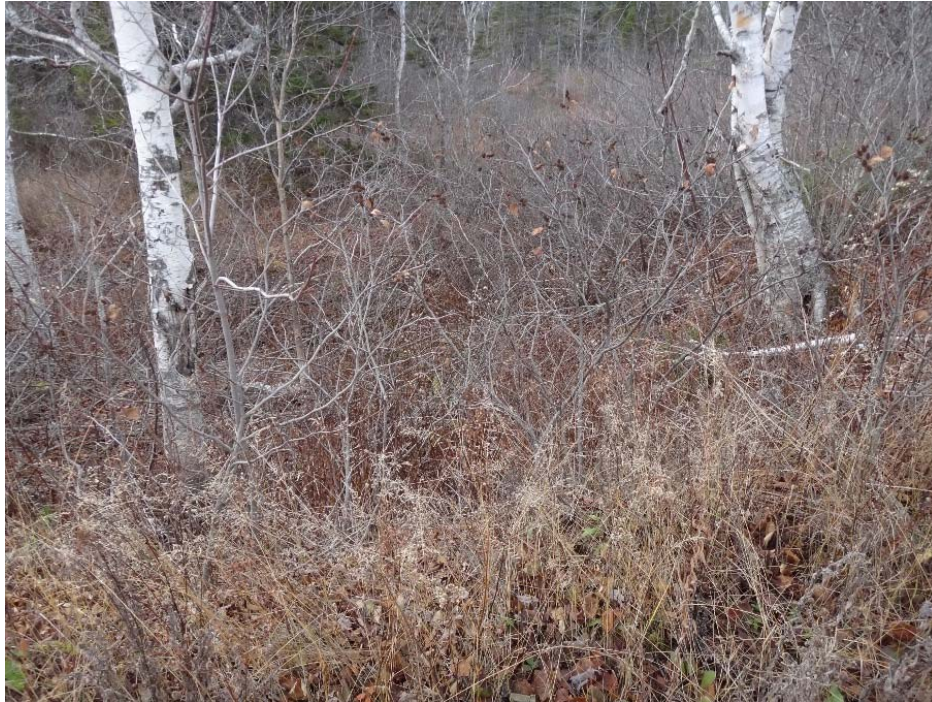
**Photo 17: Menzies Lake Saddle Dyke 2
Trees and brush on downstream slope**

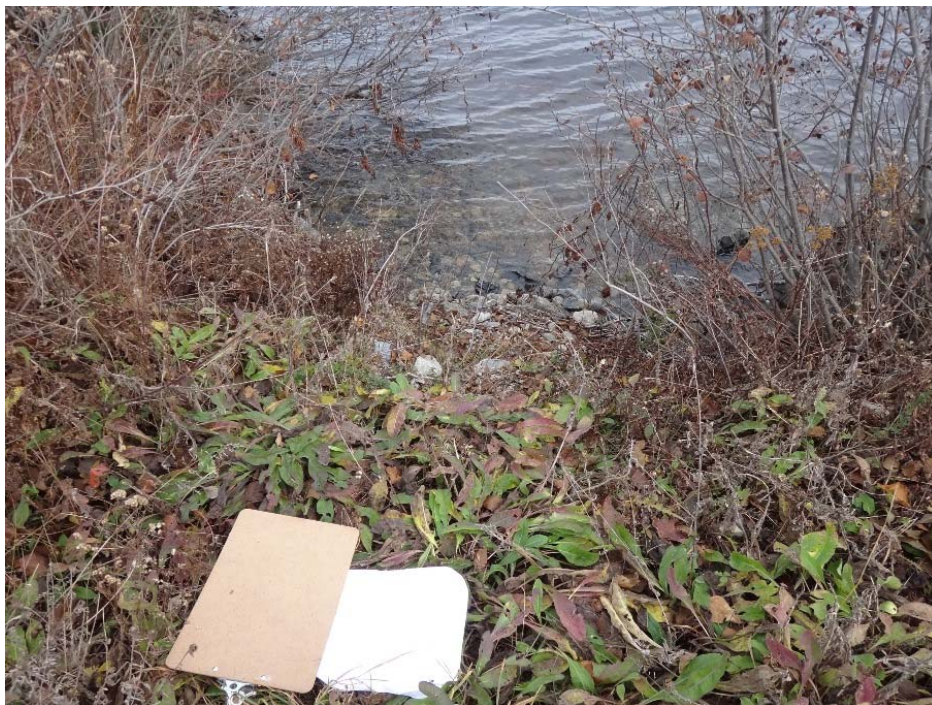
**Photo 18: Menzies Lake Saddle Dyke 2
Erosion/beaching at upstream waterline**

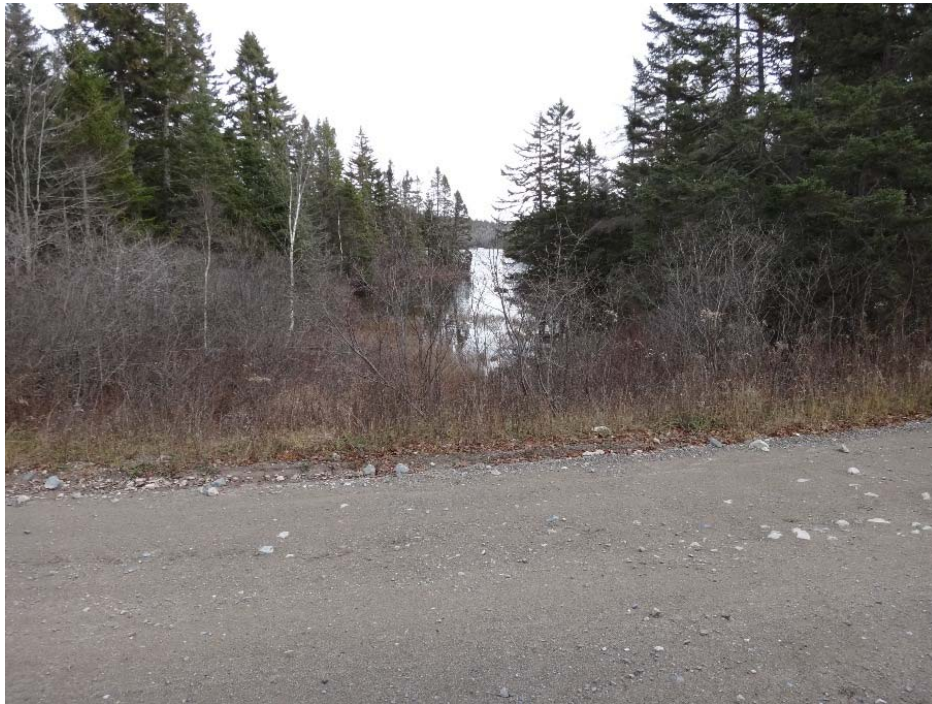
**Photo 19: Menzies Lake Saddle Dyke 3
View from crest looking upstream**

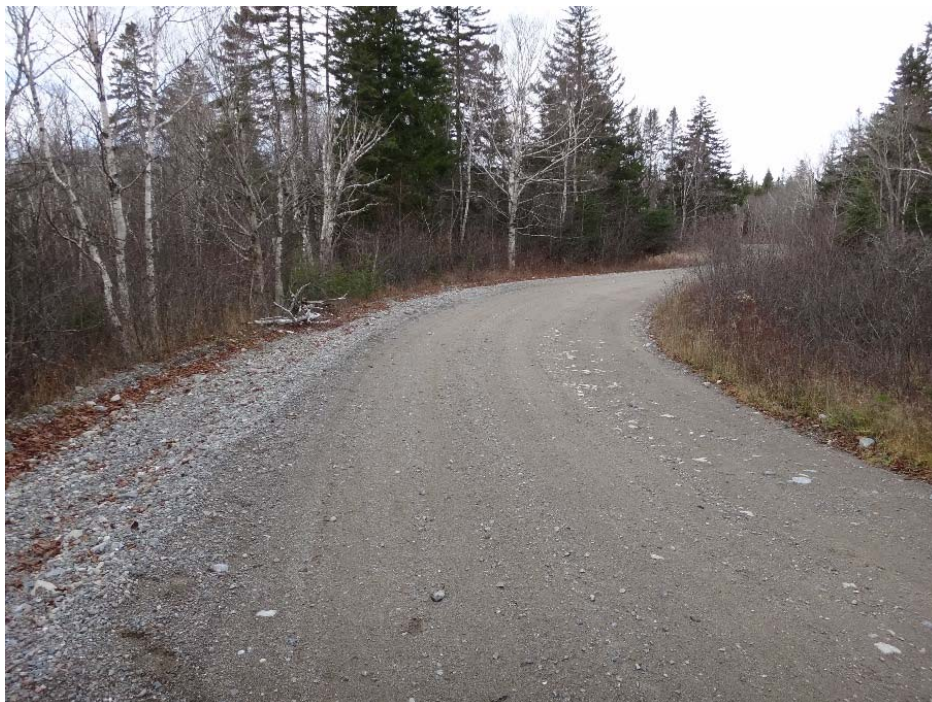
**Photo 20: Menzies Lake Saddle Dyke 3
At left abutment crest looking North**

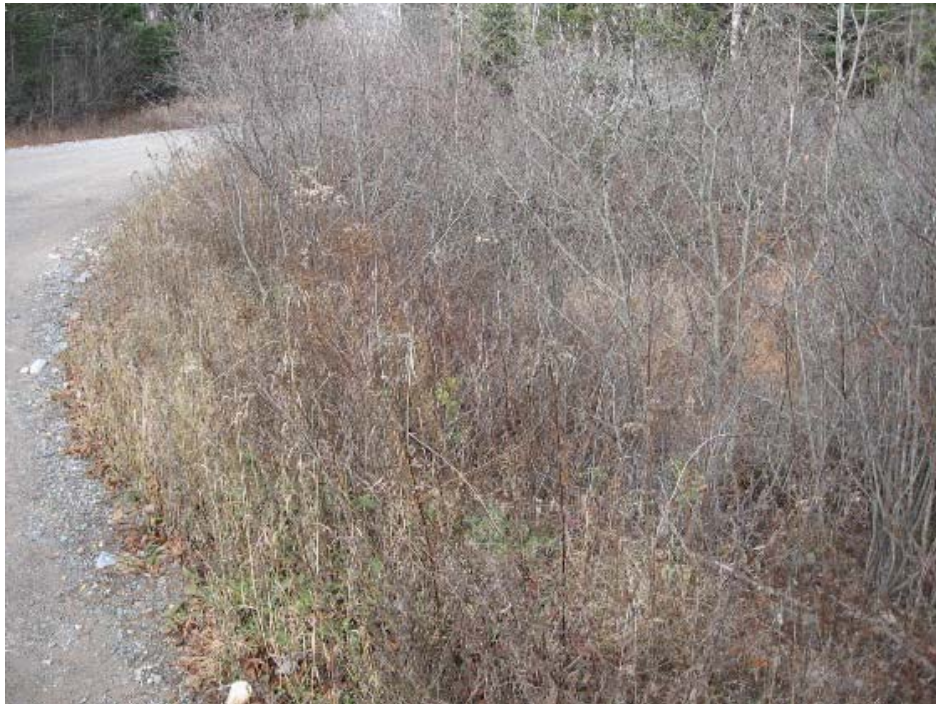
**Photo 21: Menzies Lake Saddle Dyke 3
Upstream slope**

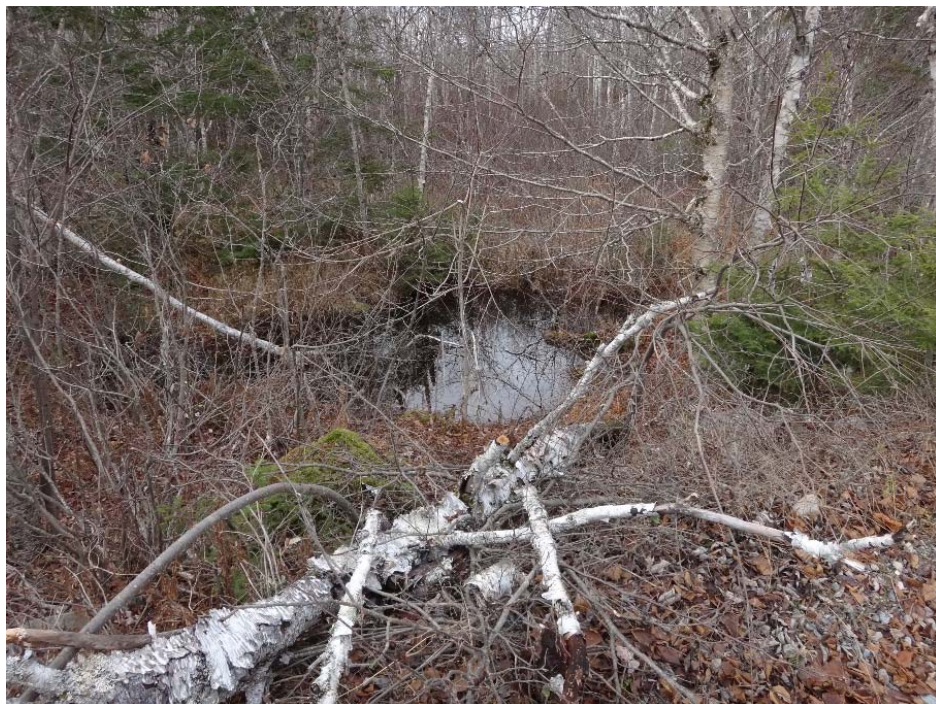
**Photo 22: Menzies Lake Saddle Dyke 3
Downstream slope and ponded water downstream**

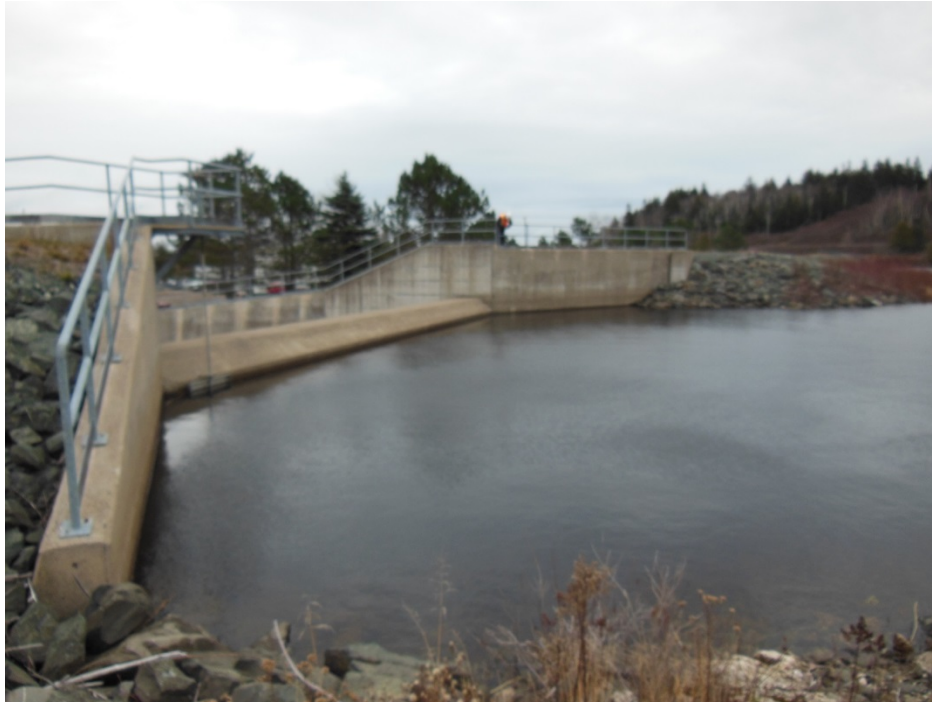
**Photo 23: Spruce Lake Dam – Concrete Spillway
View from upstream toe of left wingwall**

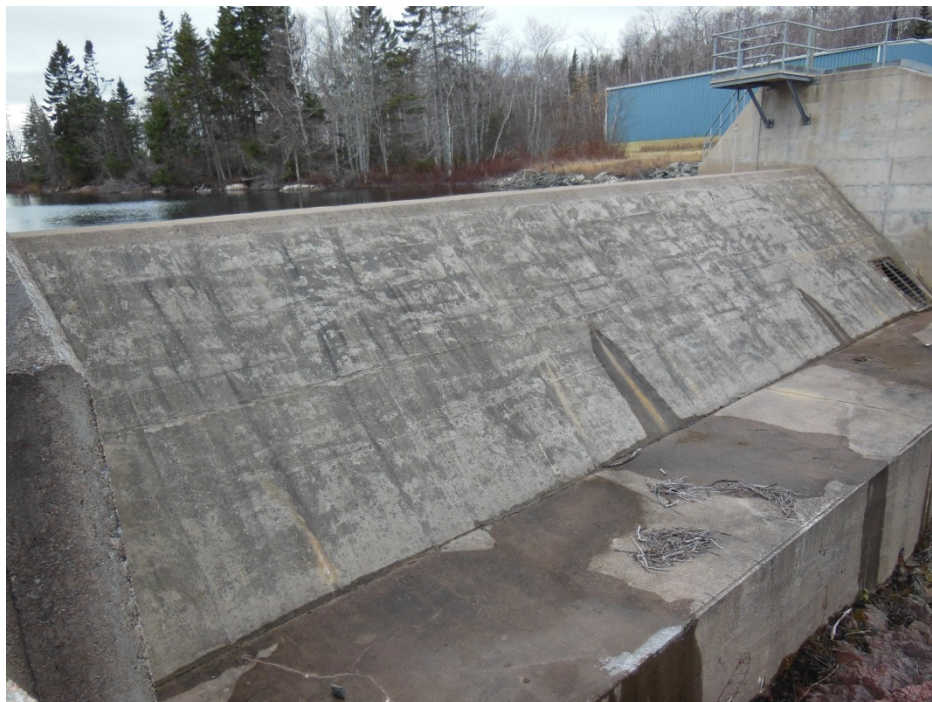
**Photo 24: Spruce Lake Dam – Concrete Spillway
Downstream face of spillway**

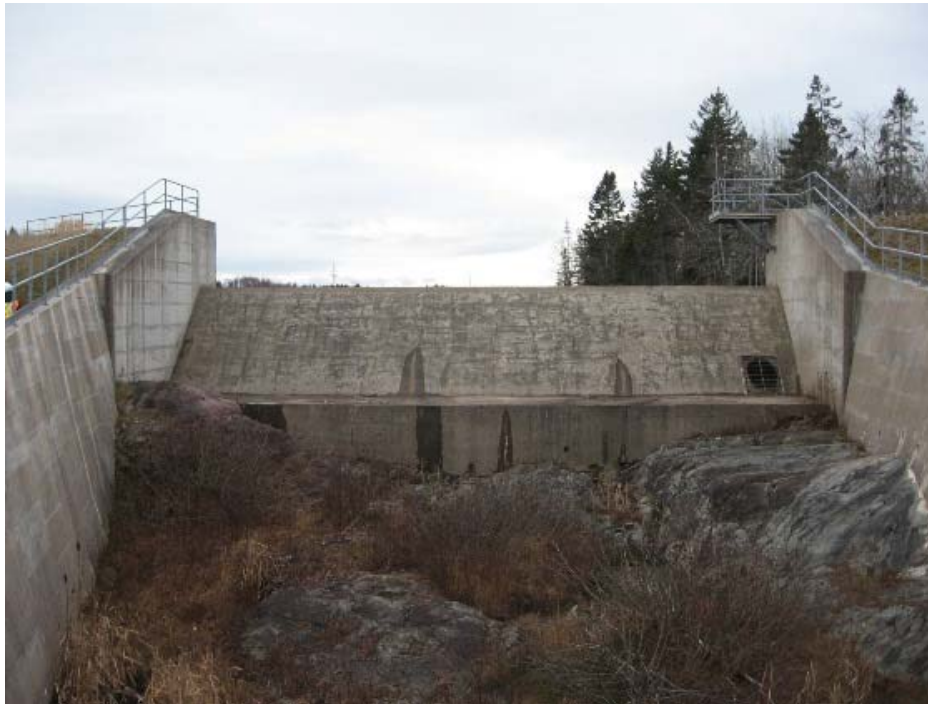
Photo 25: Spruce Lake Dam – Concrete Spillway
Downstream face of spillway structure and retaining walls

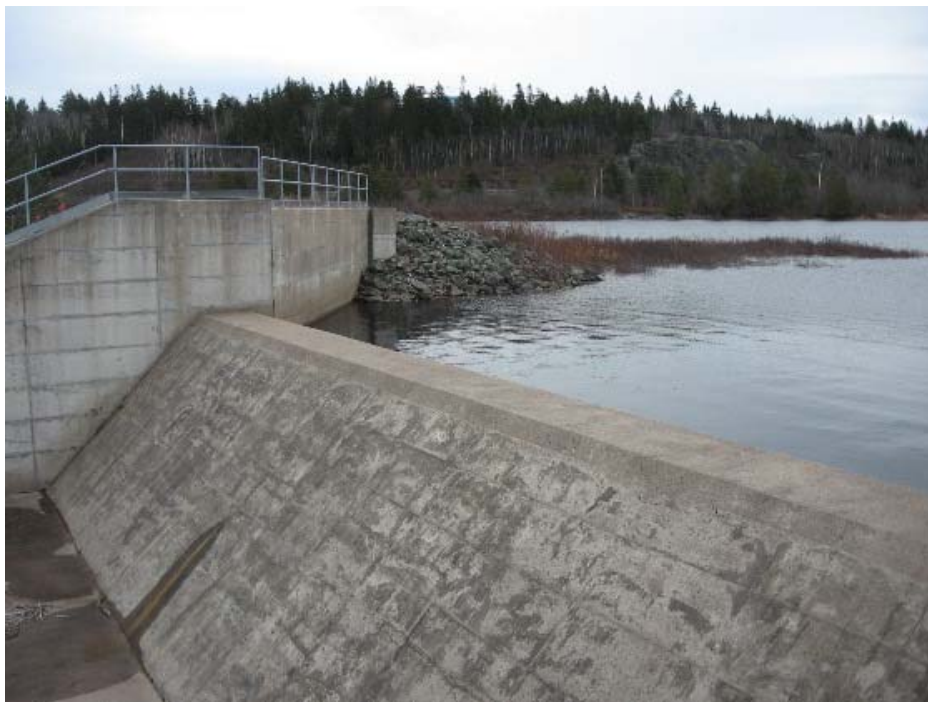
Photo 26: Spruce Lake Dam – Concrete Spillway
View of downstream slope and crest

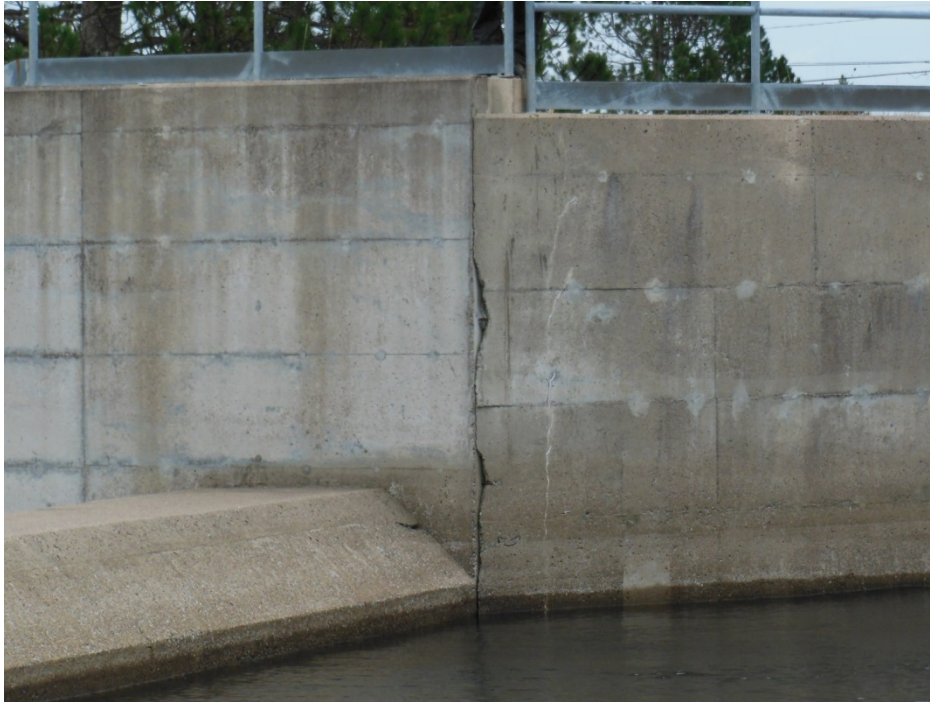
**Photo 27: Spruce Lake Dam – Concrete Spillway
Joint of right abutment wall and wing wall**

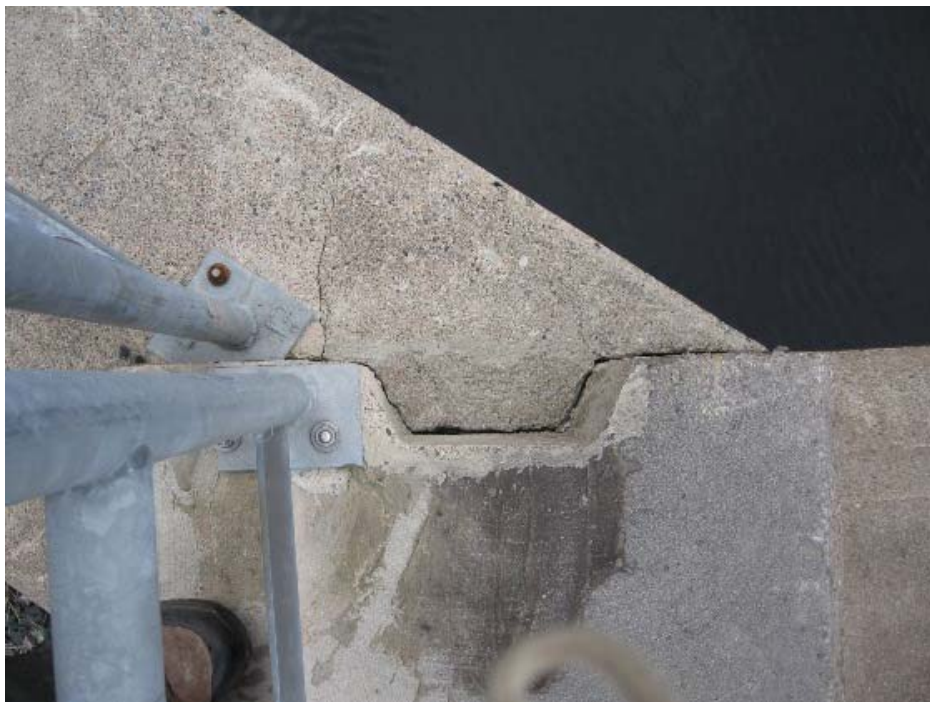
**Photo 28: Spruce Lake Dam – Concrete Spillway
Joint of right abutment wall and wing wall**

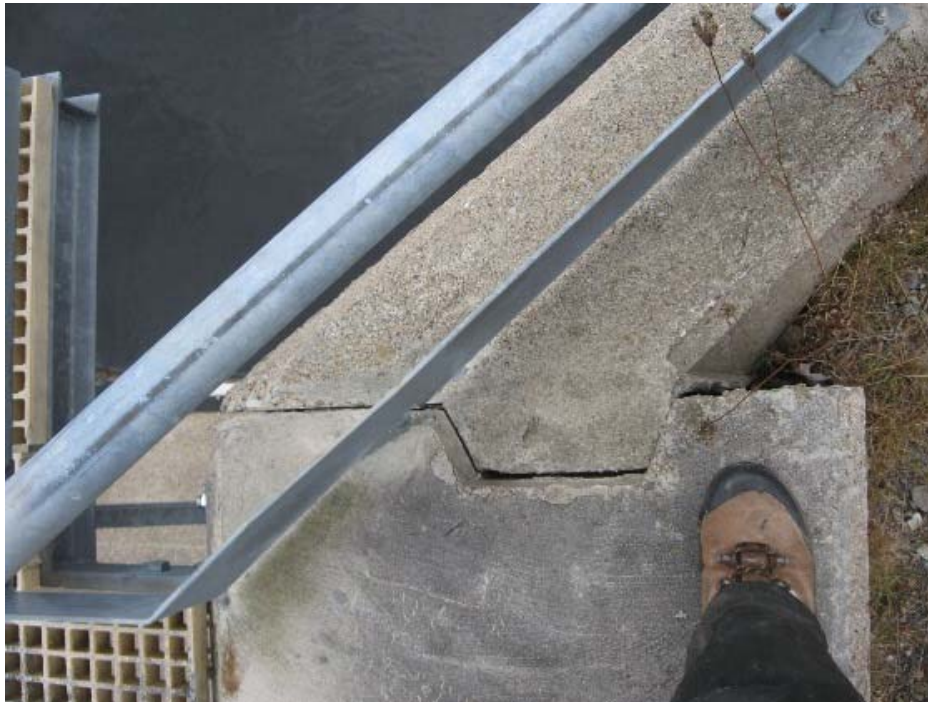
**Photo 29: Spruce Lake Dam – Concrete Spillway
Joint of left abutment wall and wing wall**

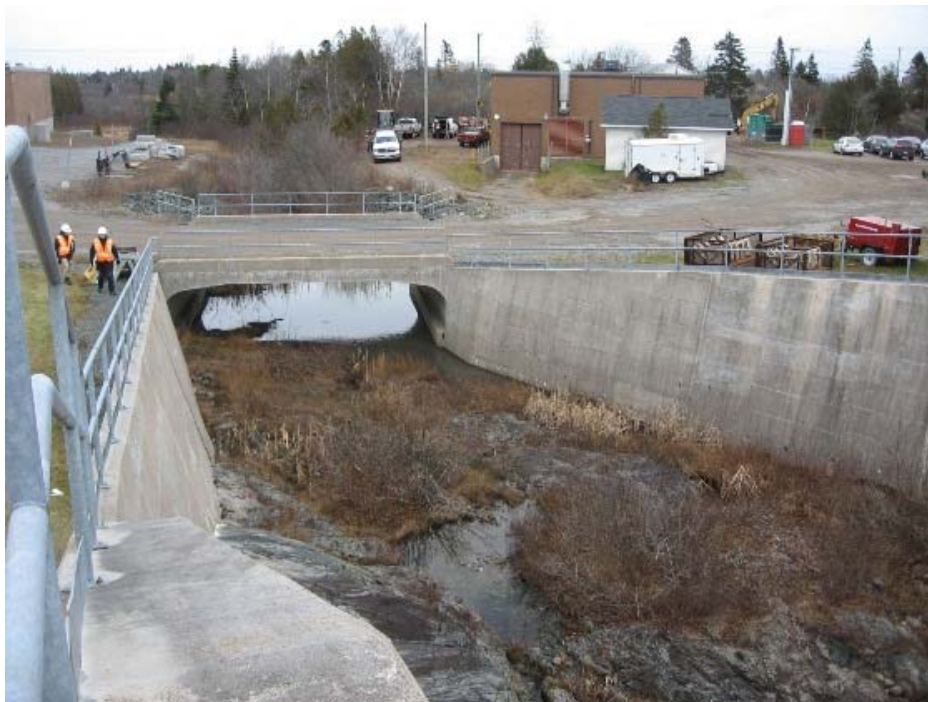
**Photo 30: Spruce Lake Dam – Concrete Spillway
Downstream retaining walls of discharge channel and precast concrete arch culvert**

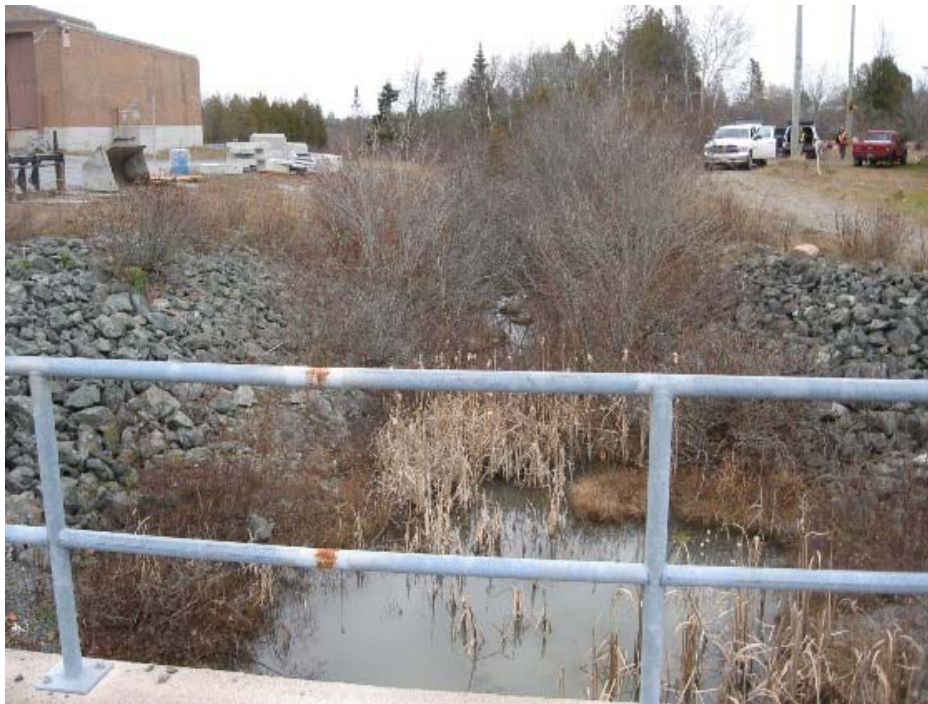
Photo 31: Spruce Lake Dam – Concrete Spillway
Discharge channel downstream of precast concrete arch culvert

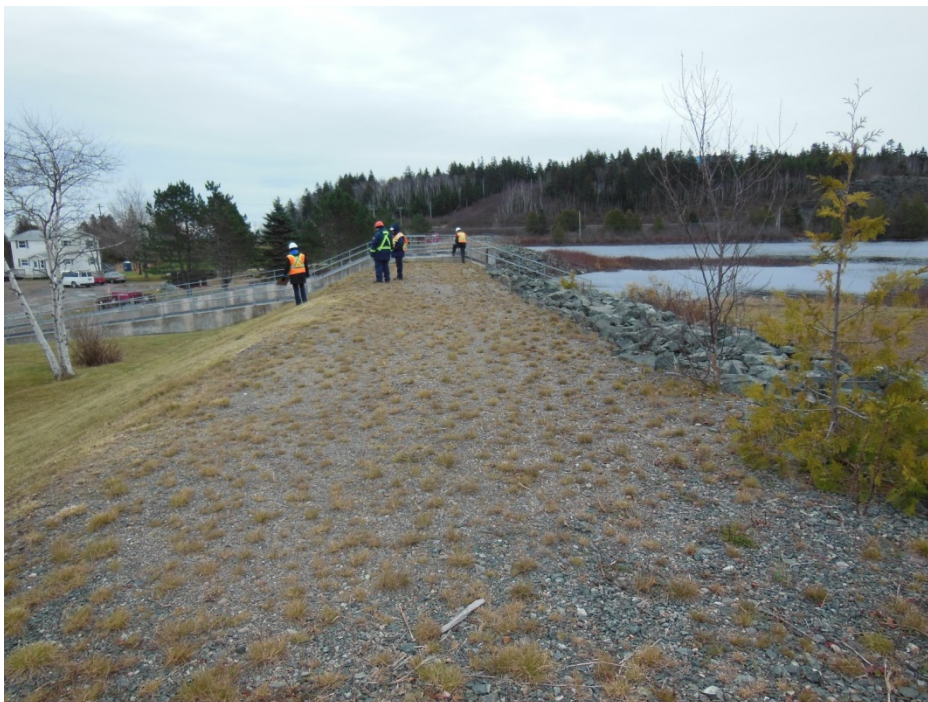
Photo 32: Spruce Lake Dam – Left Embankment
View from left abutment

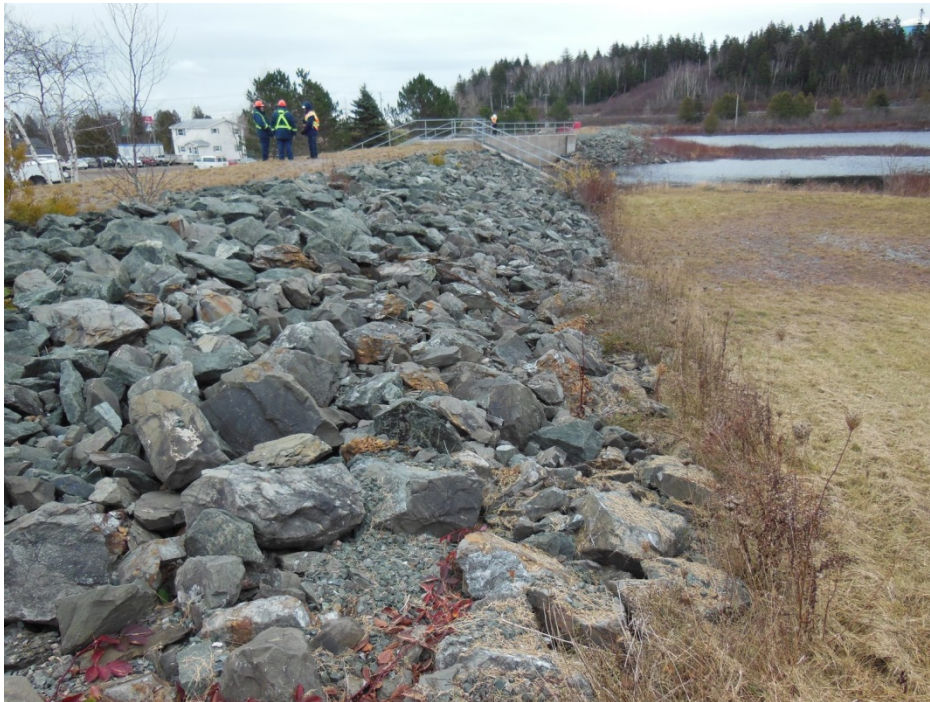
**Photo 33: Spruce Lake Dam – Left Embankment
Upstream riprap protection**

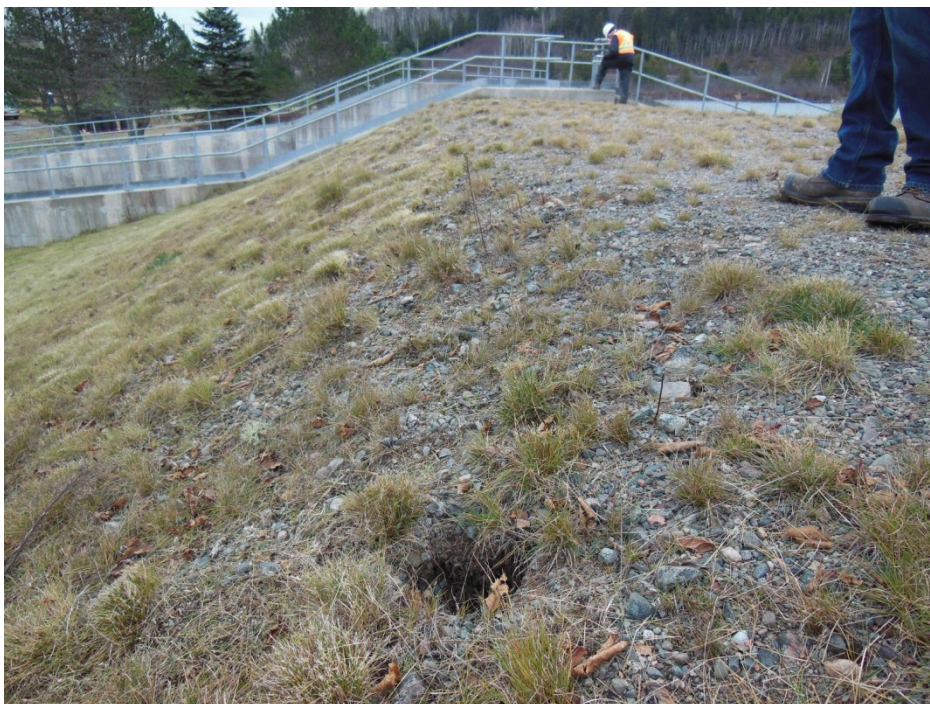
**Photo 34: Spruce Lake Dam – Left Embankment
Animal hole on downstream slope near crest**

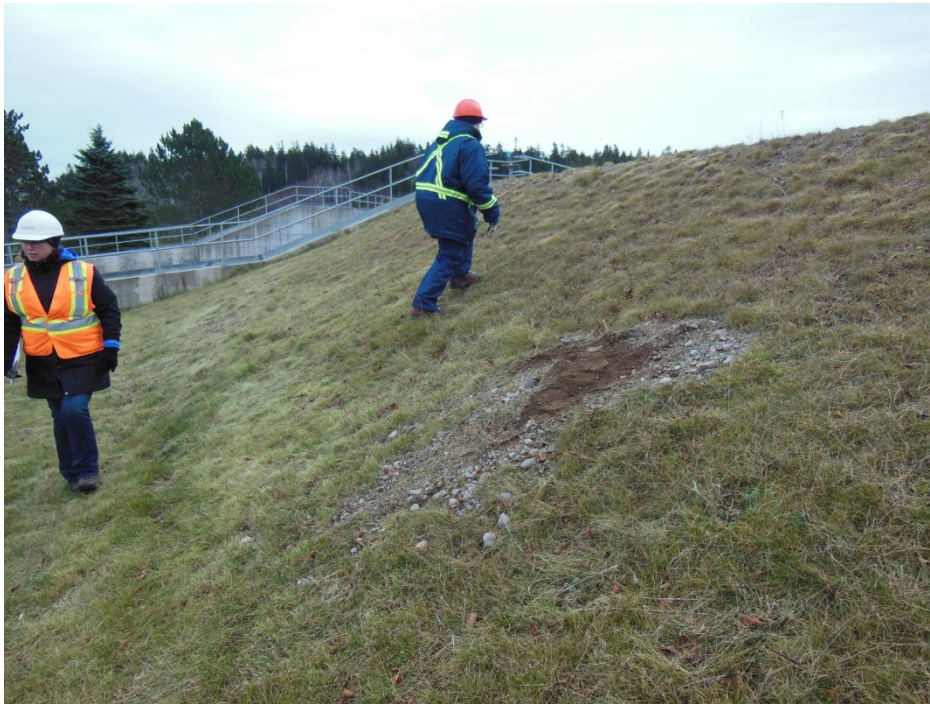
Photo 35: Spruce Lake Dam – Left Embankment
Area of granular material on downstream slope (appeared to be dumped)

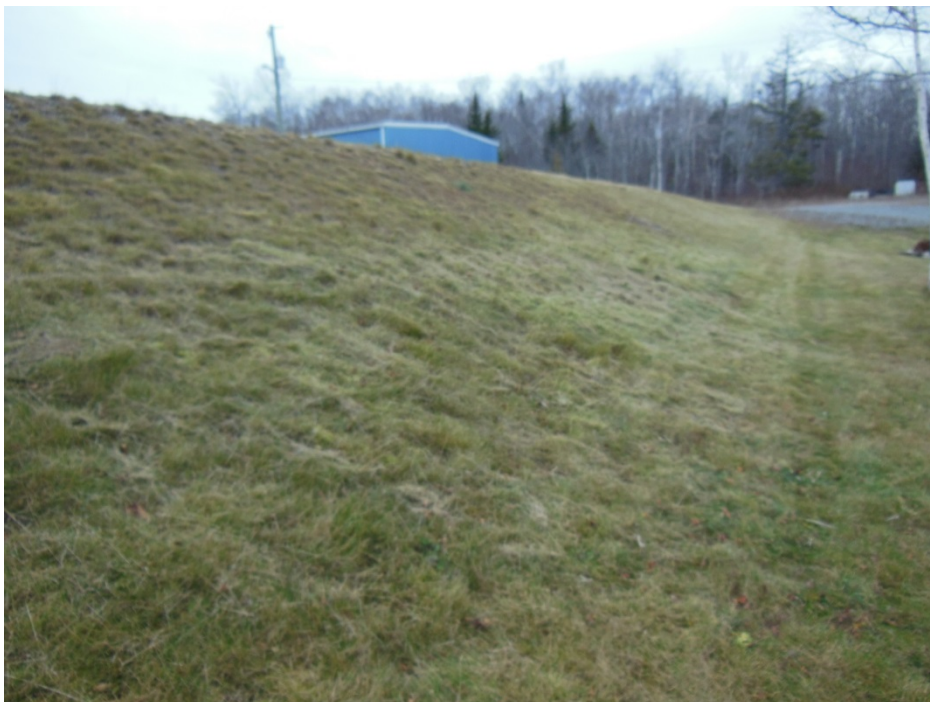
Photo 36: Spruce Lake Dam – Left Embankment
Downstream slope, access road and storage facility beyond abutment

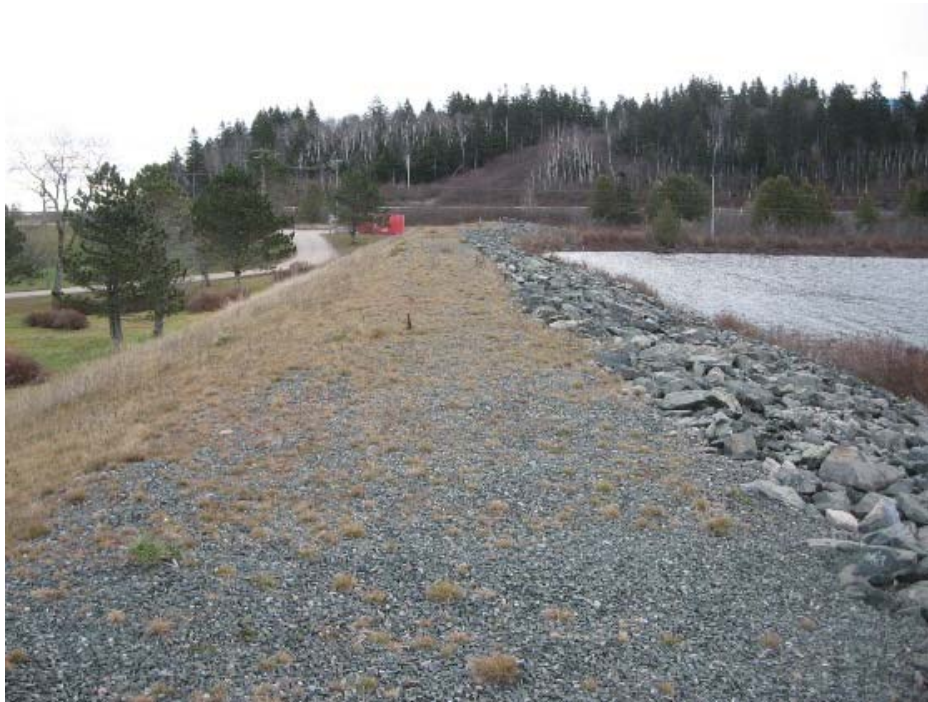
**Photo 37: Spruce Lake Dam – Right Embankment
View from abutment with spillway**
