2022-091006P

**“ENGINEERING SERVICES – MENZIES LAKE DAMS AND ACCESS ROAD
DRAINAGE UPGRADES”
SAINT JOHN, NB**

City of Saint John Menzies Lake Dam - Cost Update Final Report

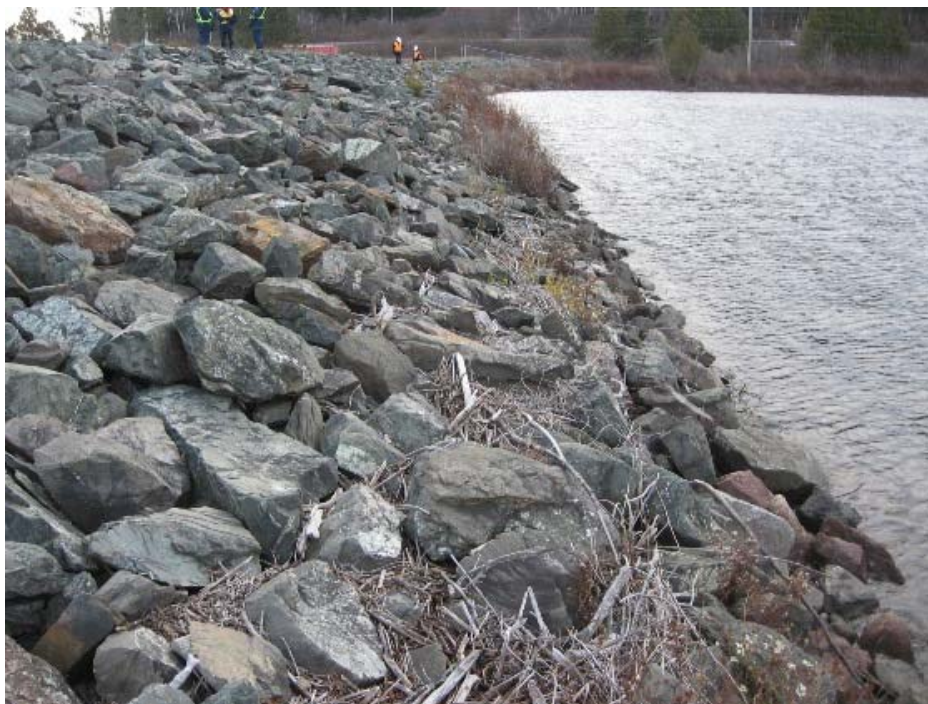
**Photo 38: Spruce Lake Dam – Right Embankment
Upstream riprap protection and driftwood debris**

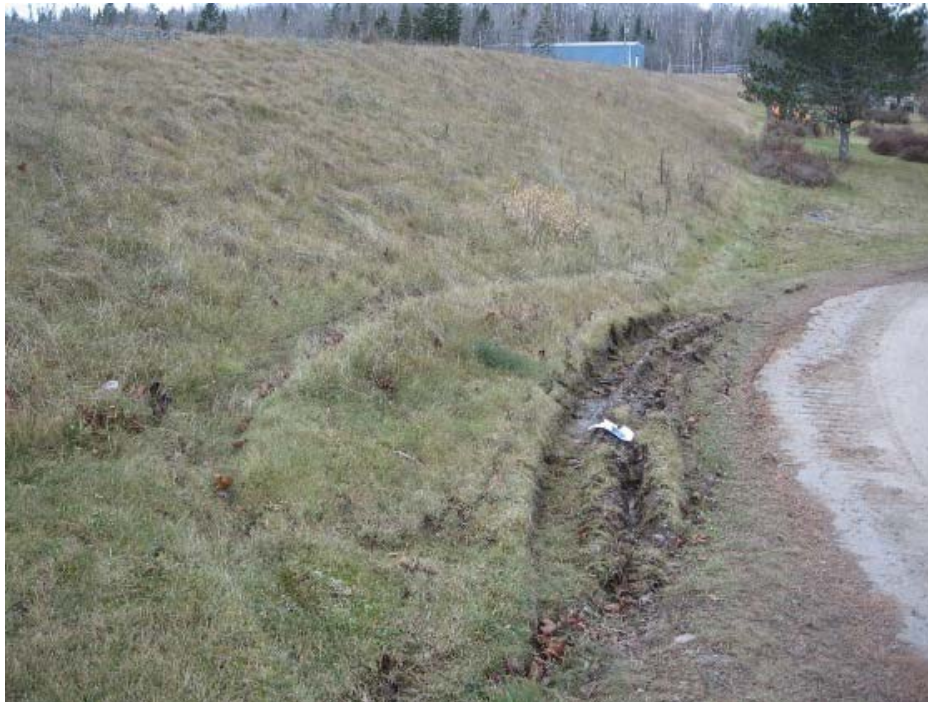
Photo 39: Spruce Lake Dam – Right Embankment
Downstream slope, note thick grass and damage at downstream toe

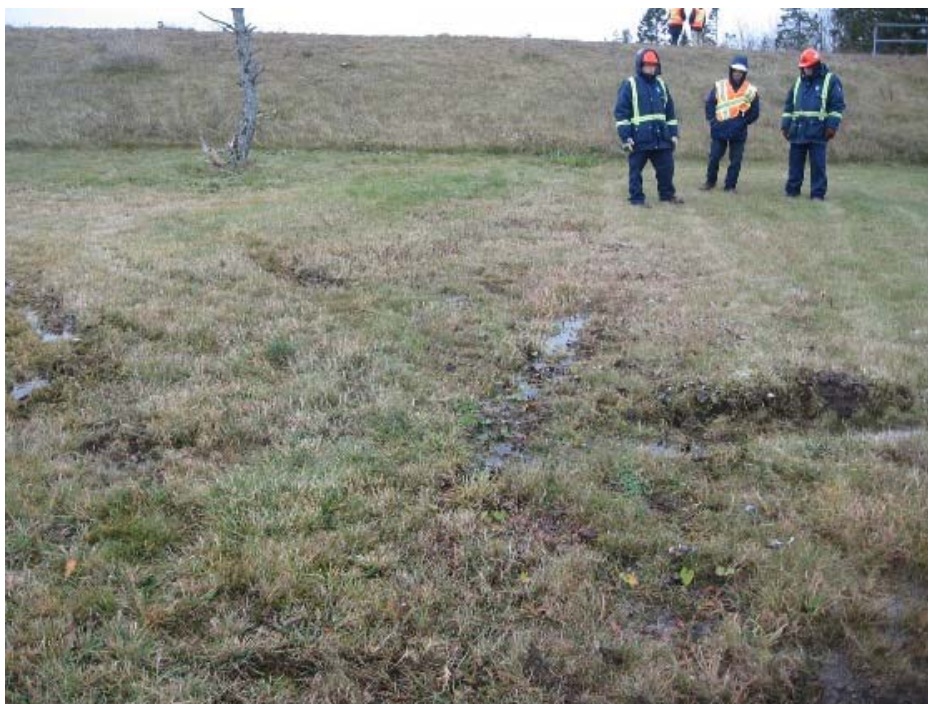
Photo 40: Spruce Lake Dam – Right Embankment
Wetness (from seepage) beyond downstream toe

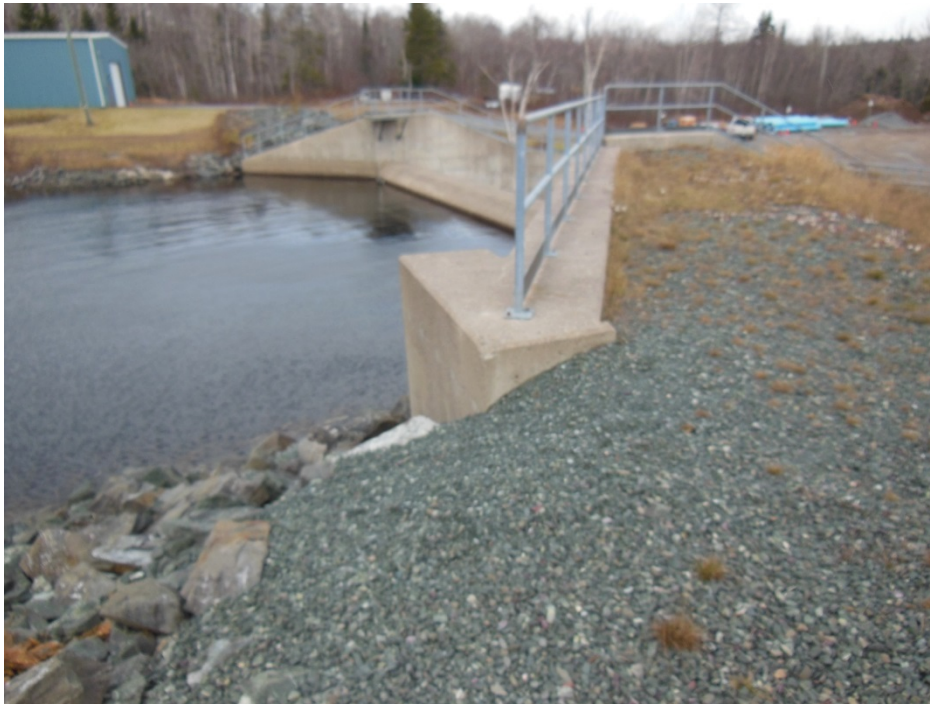
Photo 41: Spruce Lake Dam – Right Embankment
Crest material migrating into riprap at abutment of spillway wing wall

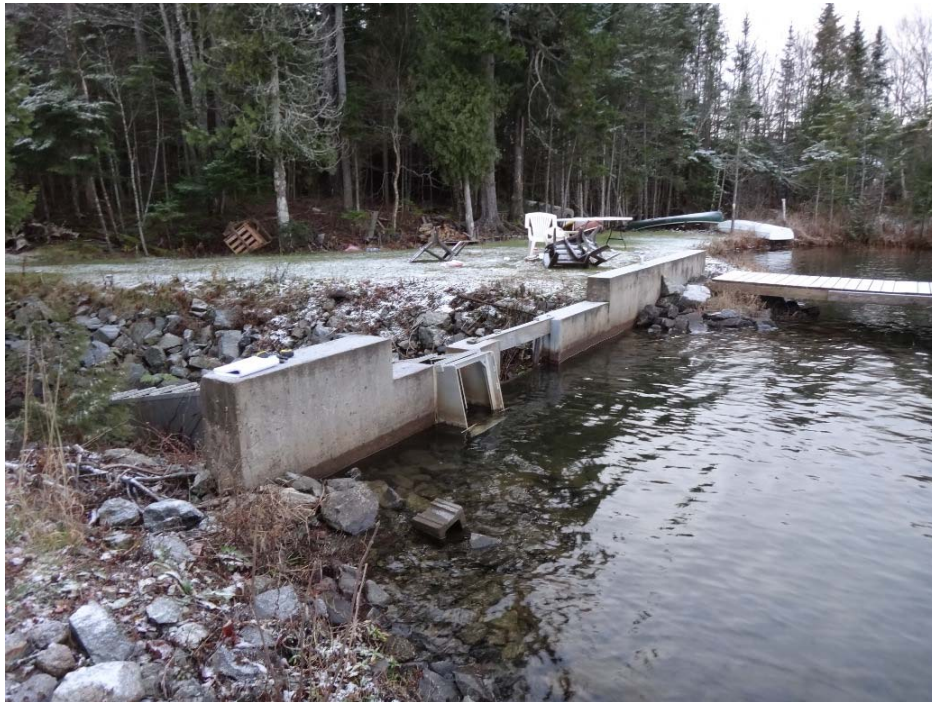
**Photo 42: Hunter Lake Dam
View of upstream face of structure**

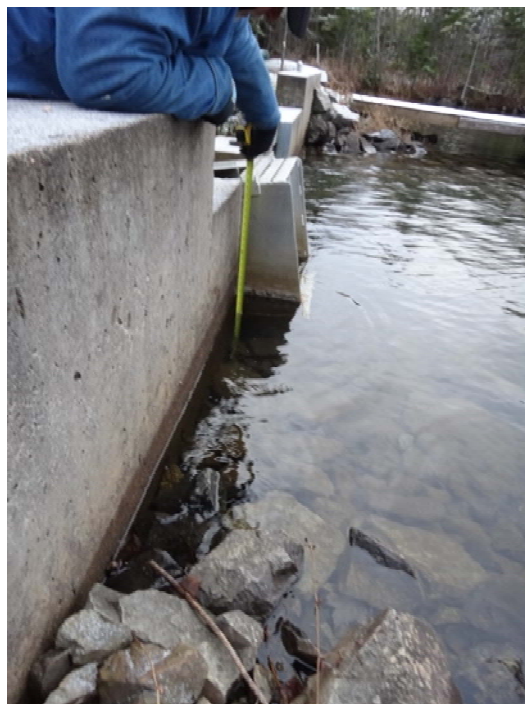
**Photo 43: Hunter Lake Dam
Sedimentation in reservoir upstream of the dam**

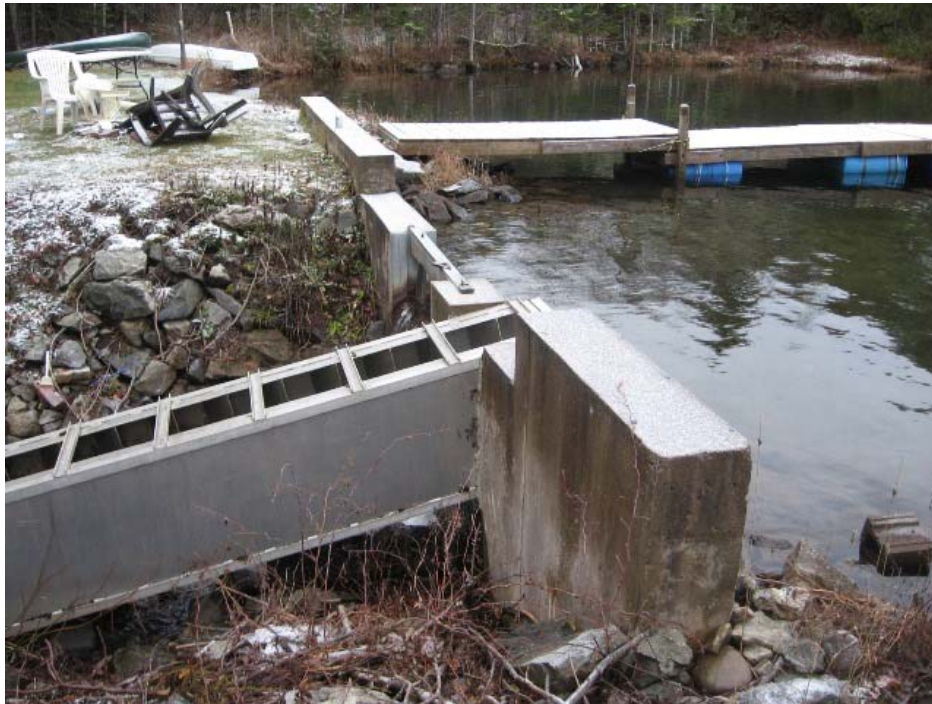
**Photo 44: Hunter Lake Dam
Downstream face of the dam**

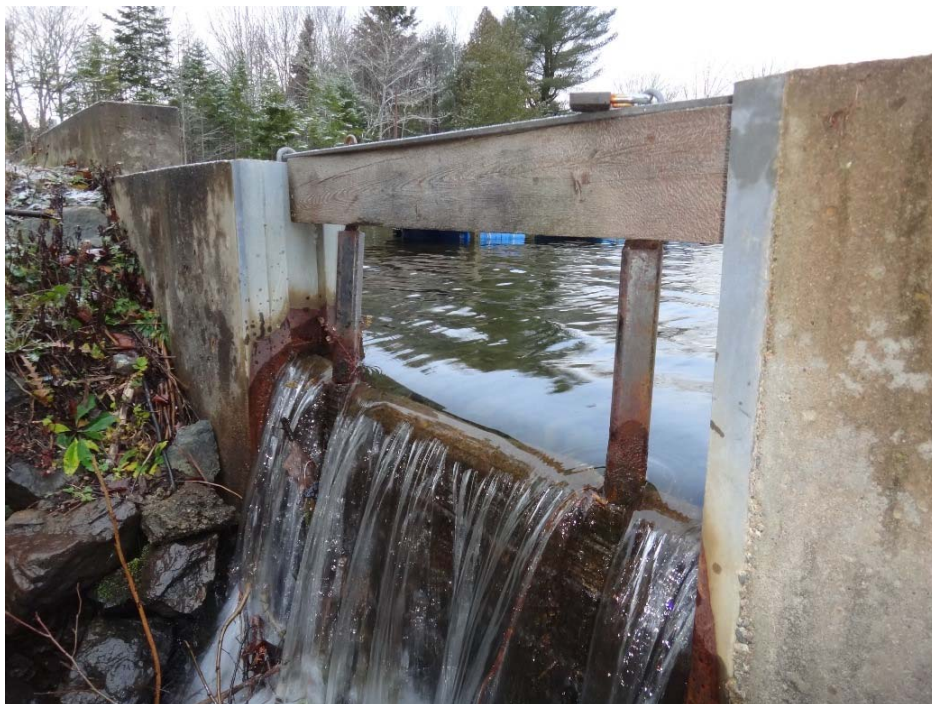
**Photo 45: Hunter Lake Dam
Stoplogs in place to 0.52 m below top of spillway**

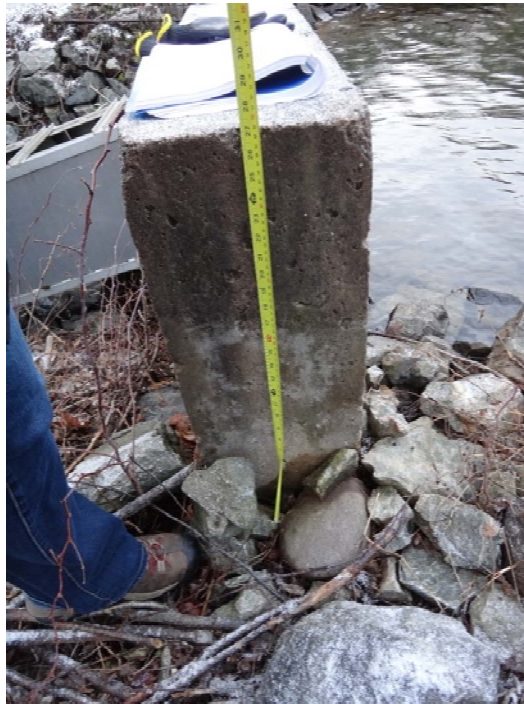
Photo 46: Hunter Lake Dam
Left abutment, corewall is not backfilled and water can go around the dam

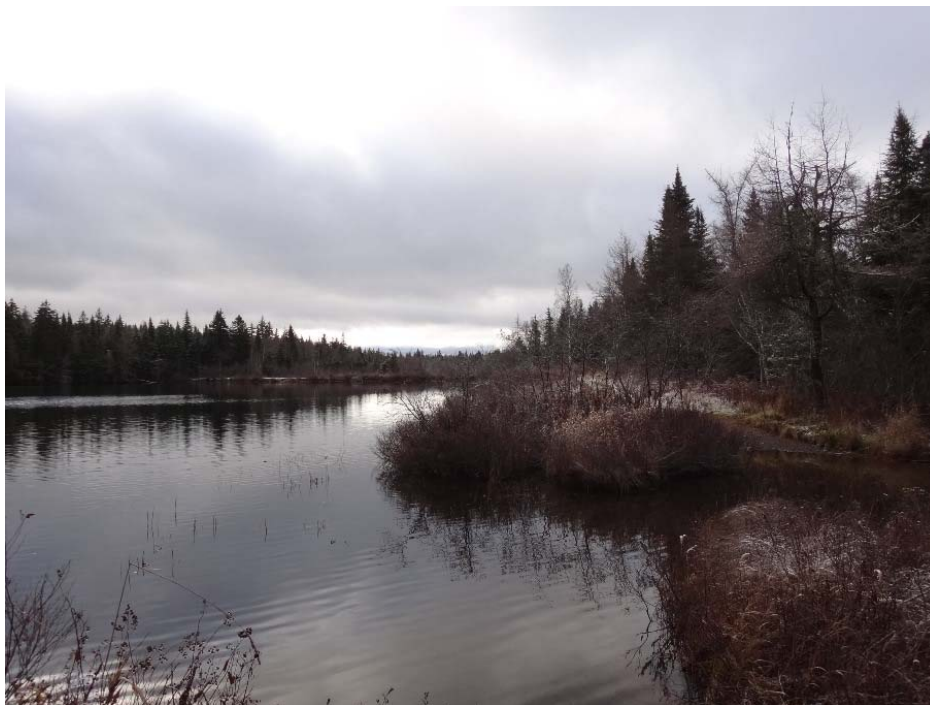
Photo 47: McBrien Southwest Dam
View from beyond the breach at right abutment

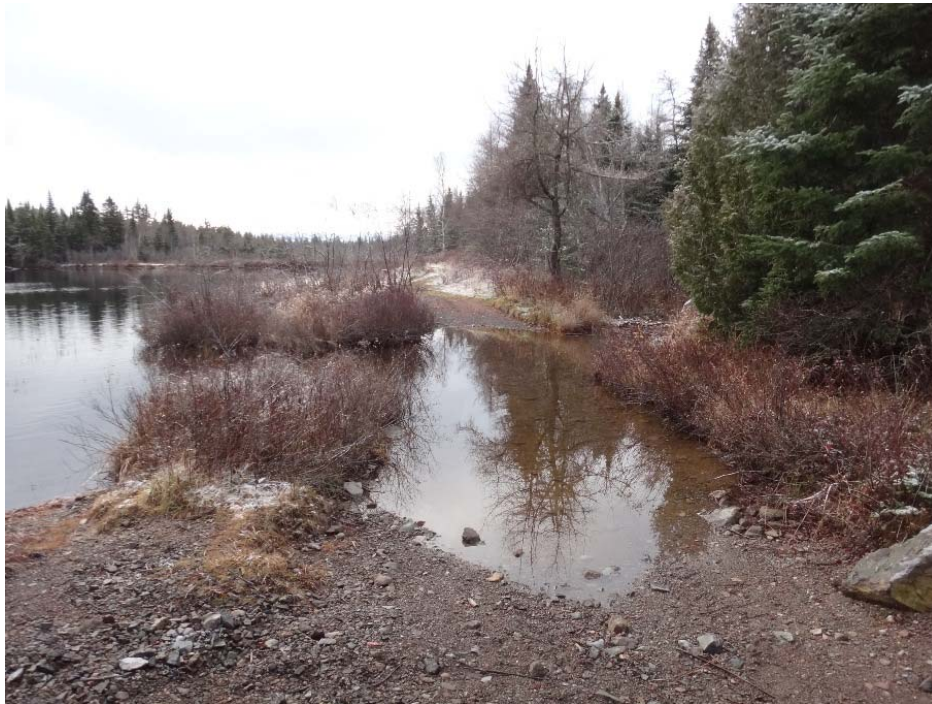
**Photo 48: McBrien Southwest Dam
View of breach near right abutment**

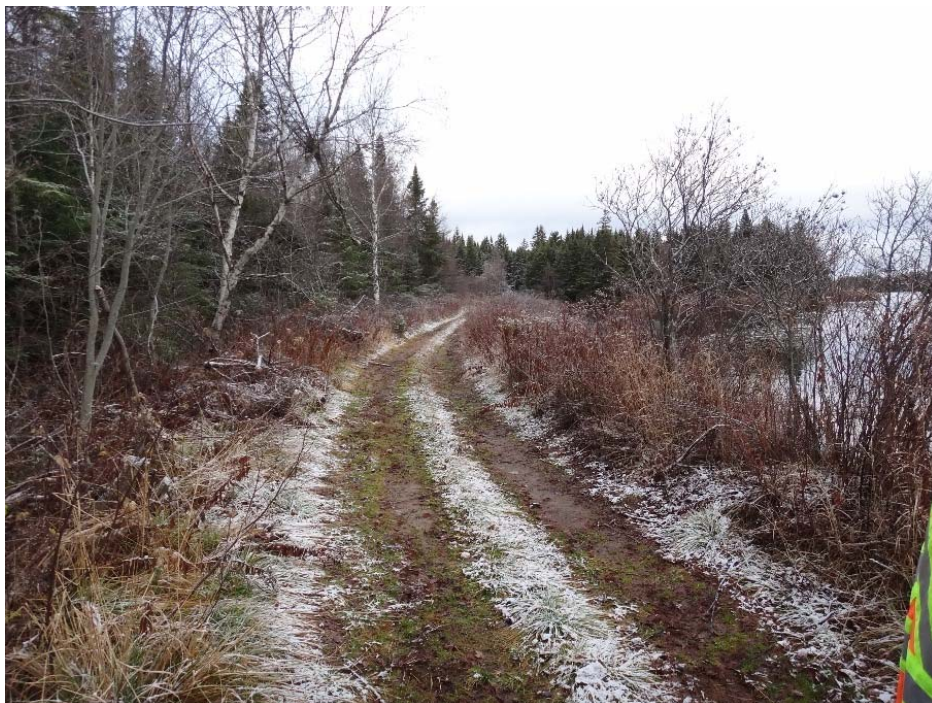
**Photo 49: McBrien Southwest Dam
Crest, upstream, and downstream slope, looking towards right abutment**

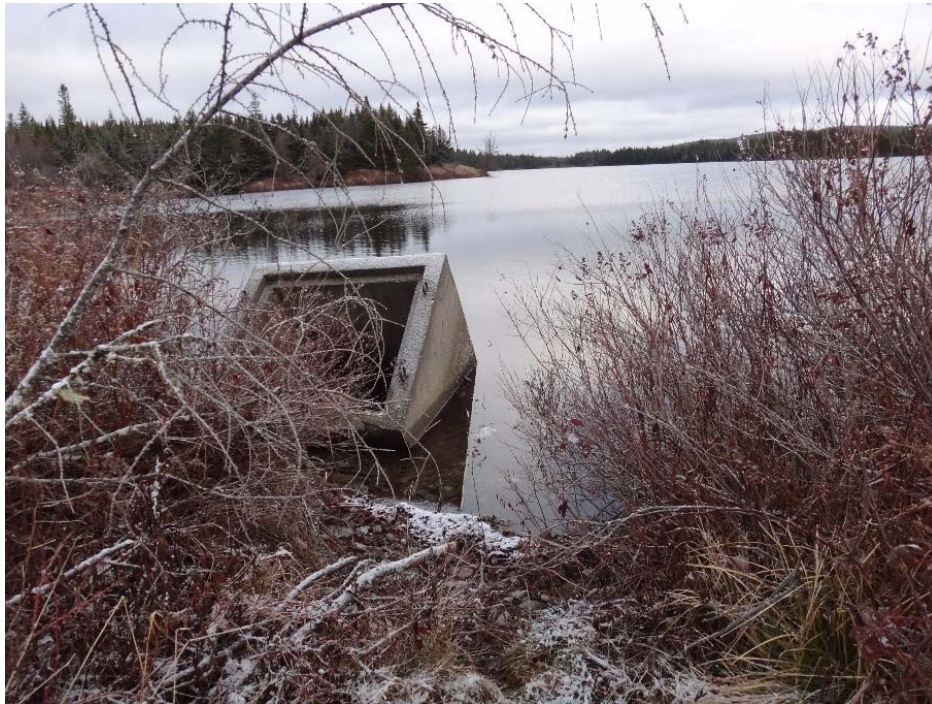
**Photo 50: McBrien Southwest Dam
Displaced decant structure**

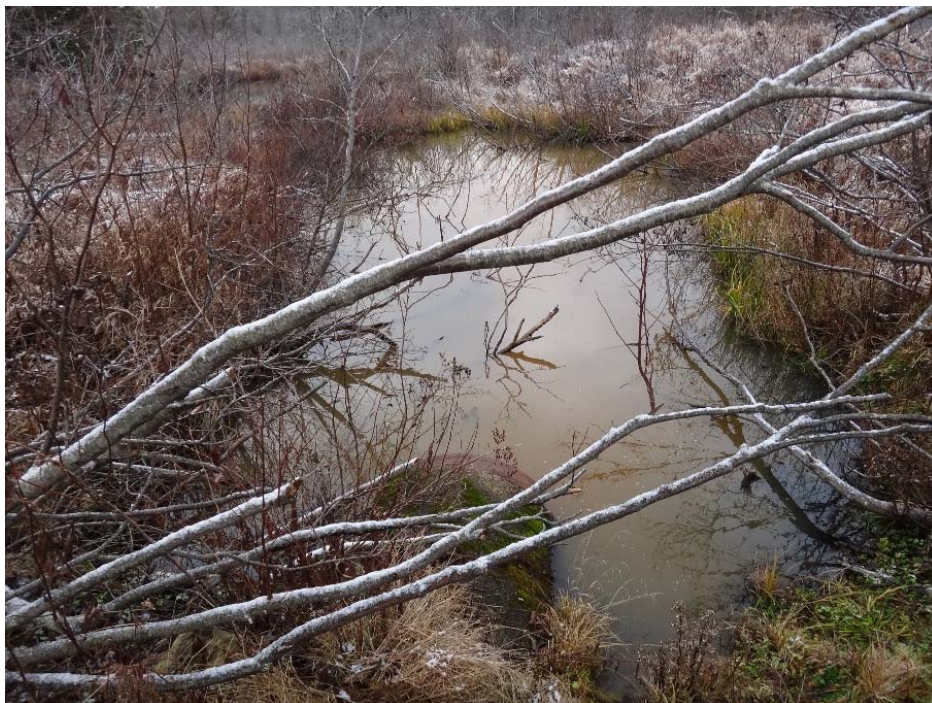
Photo 51: McBrien Southwest Dam

Outlet pipe downstream of displaced decant structure, murky water but no flow visible

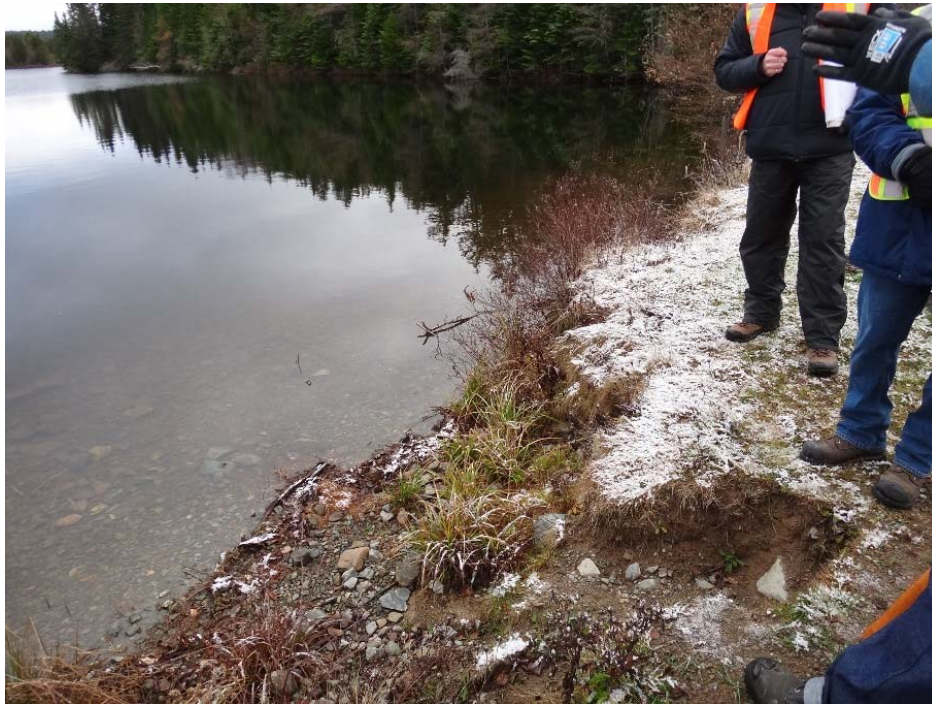
Photo 52: McBrien Southwest Dam

Erosion of upstream slope

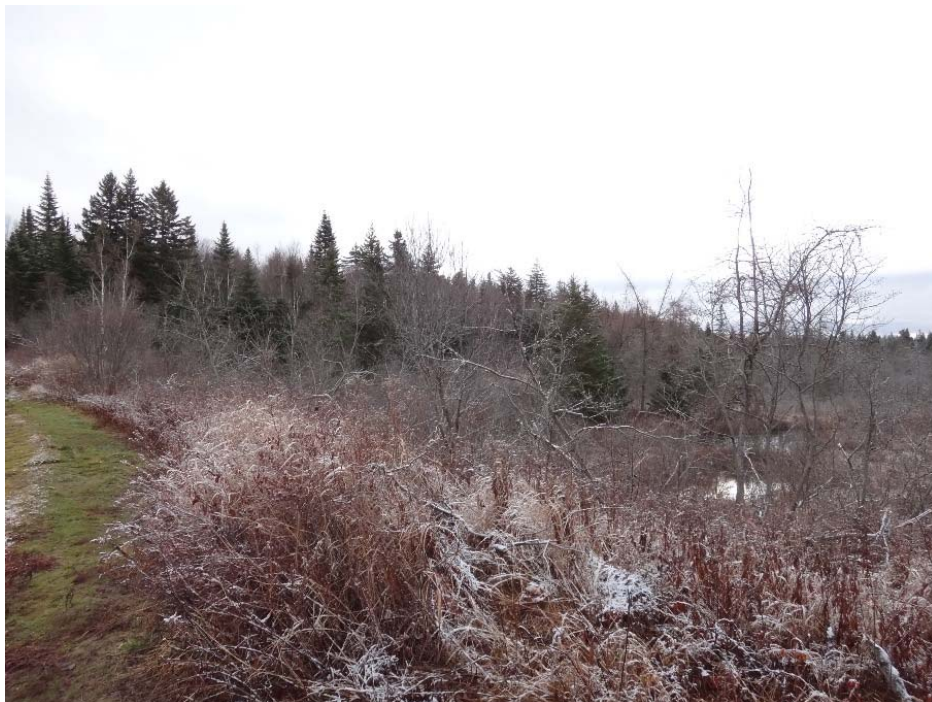
Photo 53: McBrien Southwest Dam

Vegetative growth on downstream slope

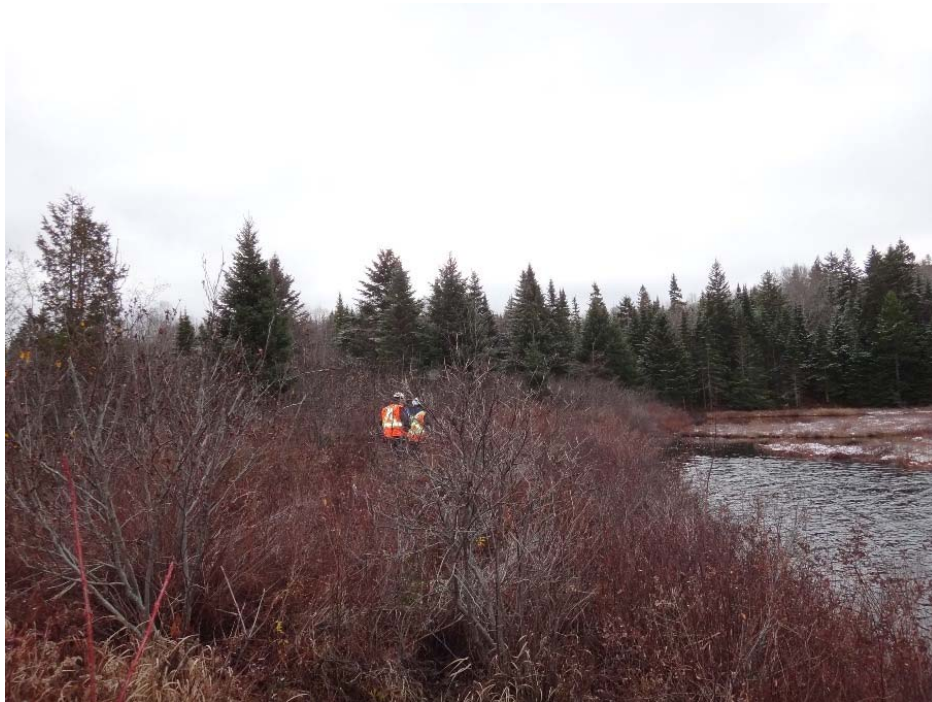
Photo 54: McBrien Southeast Dam
Trees and vegetative growth on crest and upstream slope

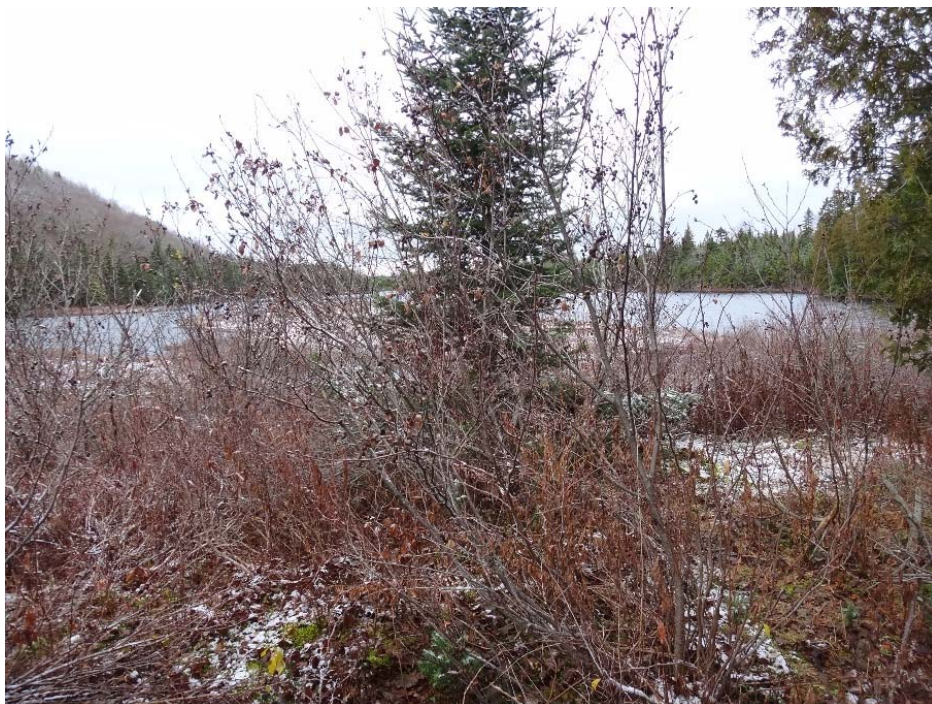
Photo 55: McBrien Southeast Dam
Looking upstream

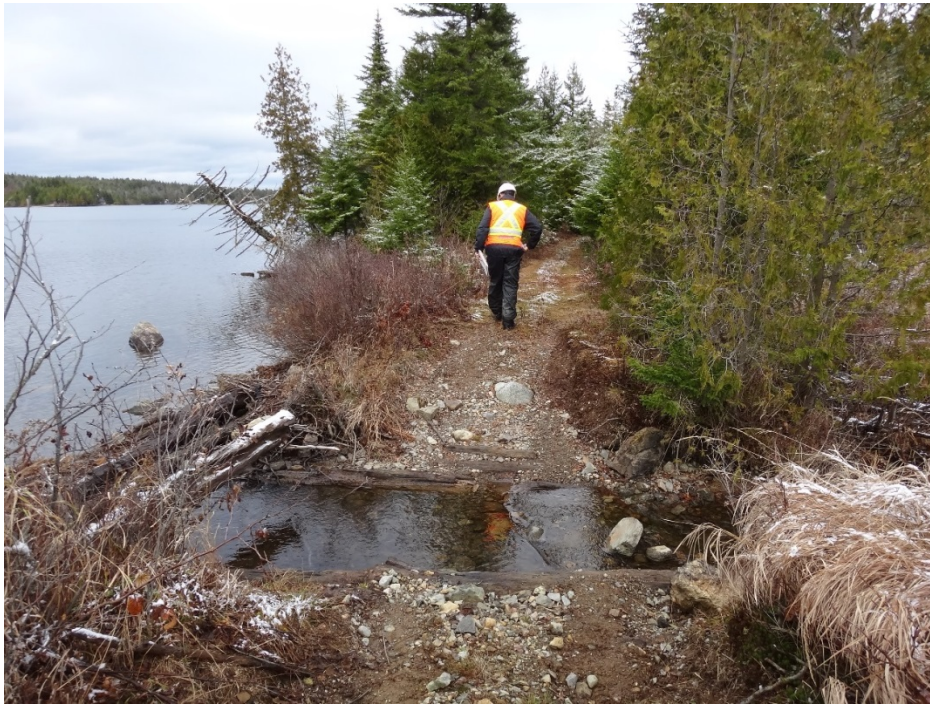
Photo 56: Terreo Lake Dam
Crest looking towards left abutment, note breached area and beaverdam upstream

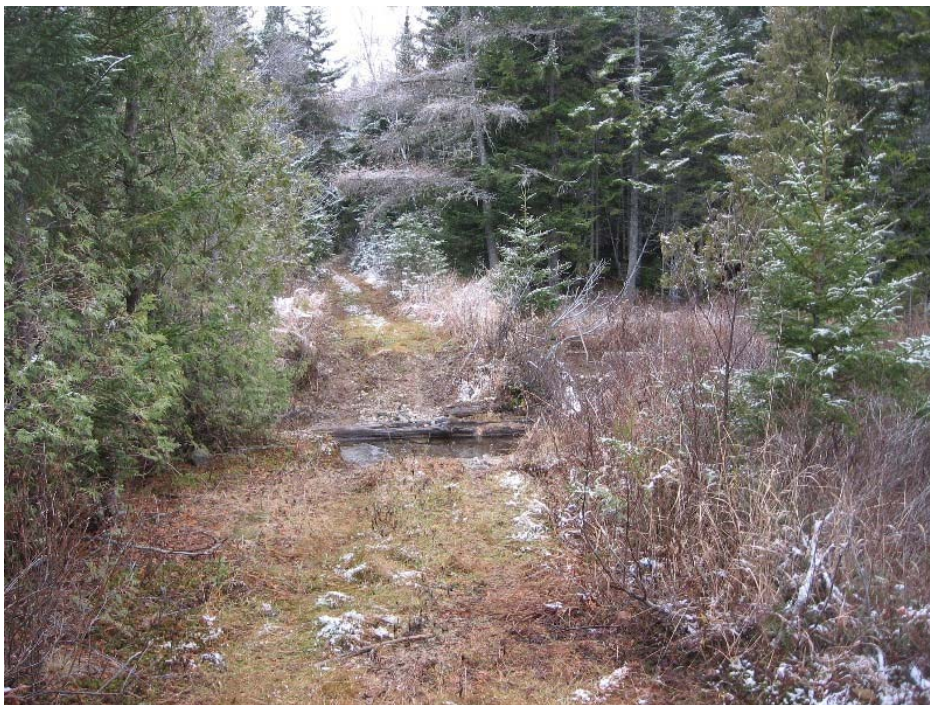
Photo 57: Terreo Lake Dam
Crest looking towards right abutment

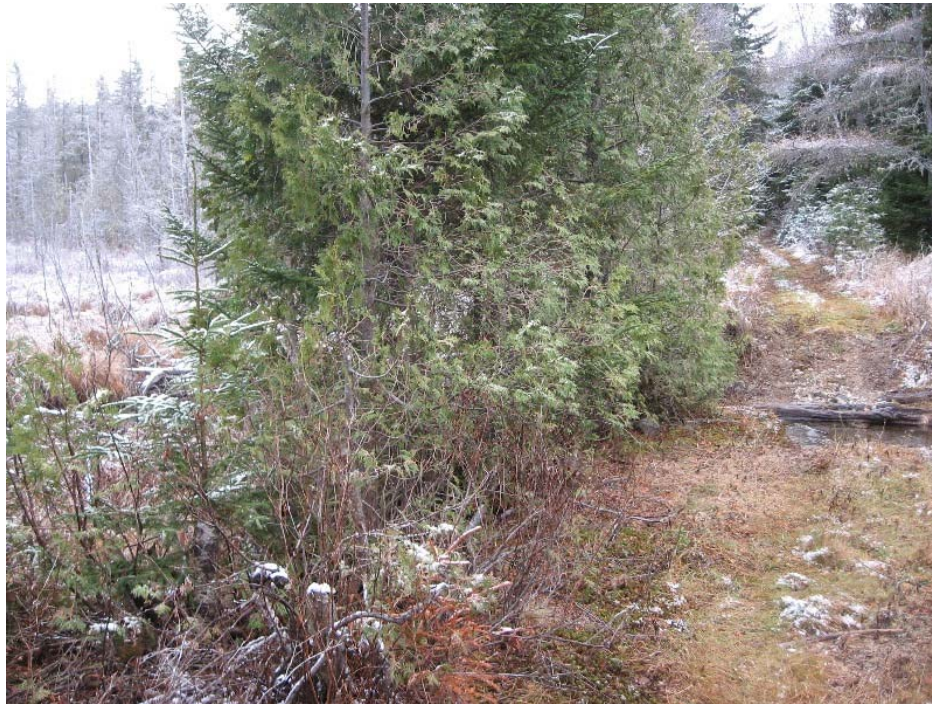
**Photo 58: Terreo Lake Dam
Crest and downstream slope**

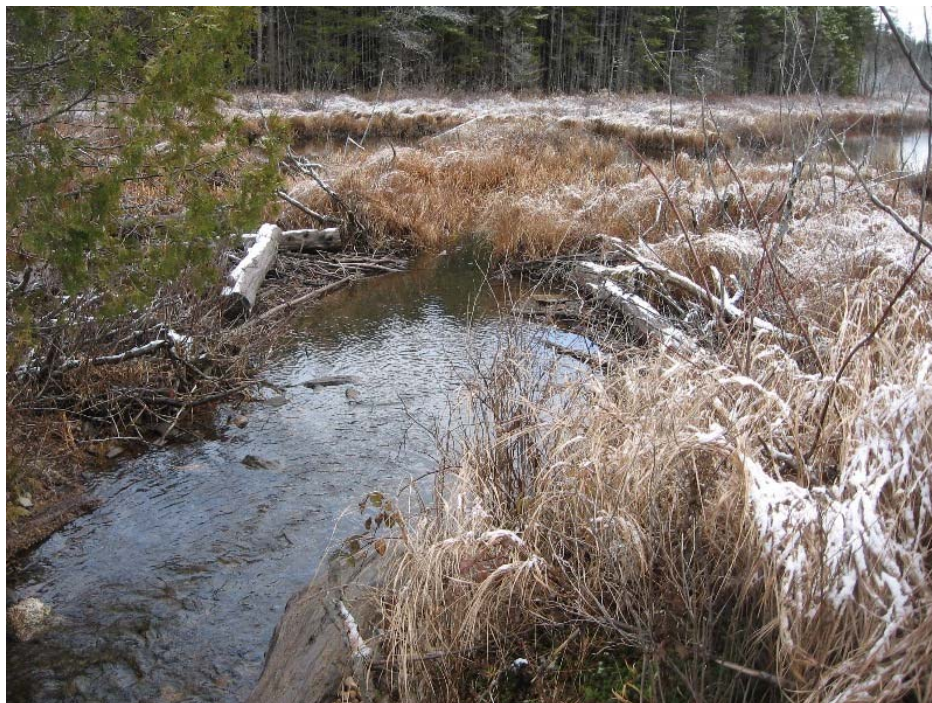
**Photo 59: Terreo Lake Dam
Looking downstream at breached area**

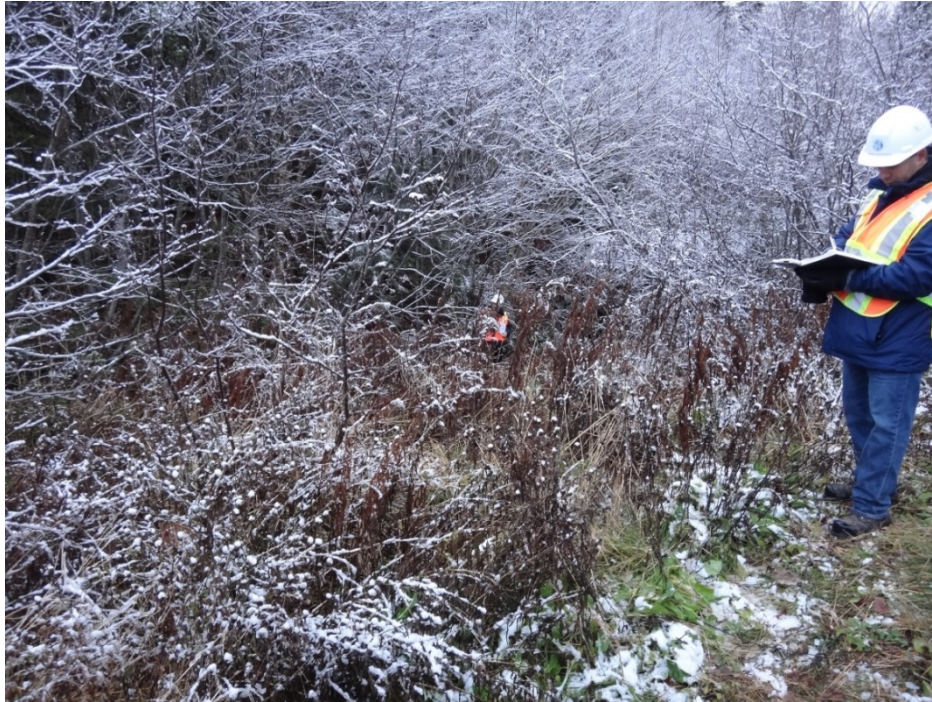
Photo 60: Taylor Lake Dam
Looking at crest towards downstream slope (person at toe visible)

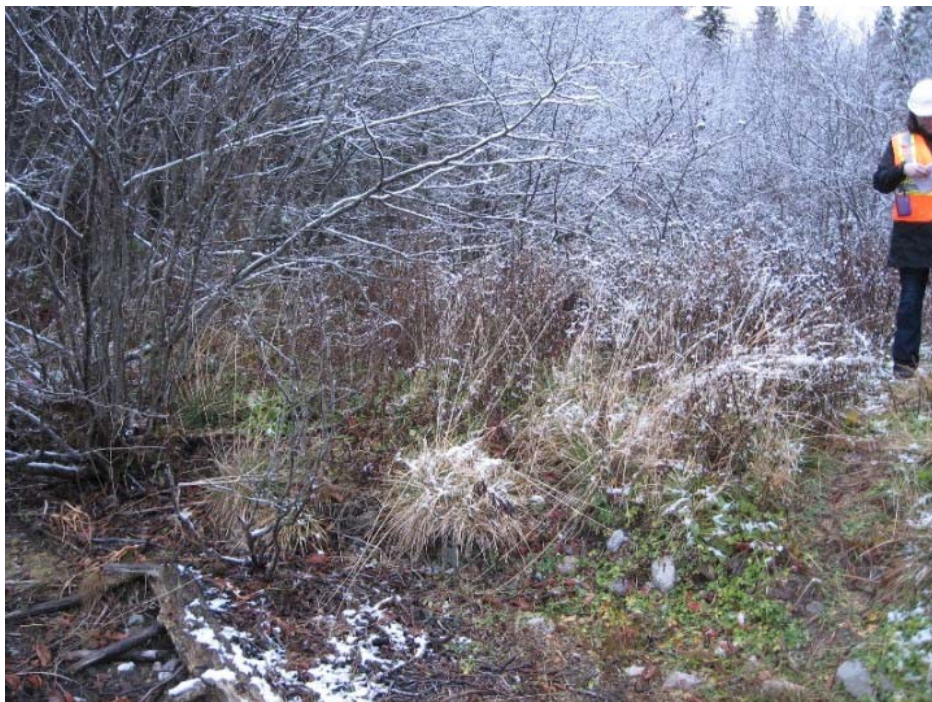
Photo 61: Taylor Lake Dam
Upstream slope

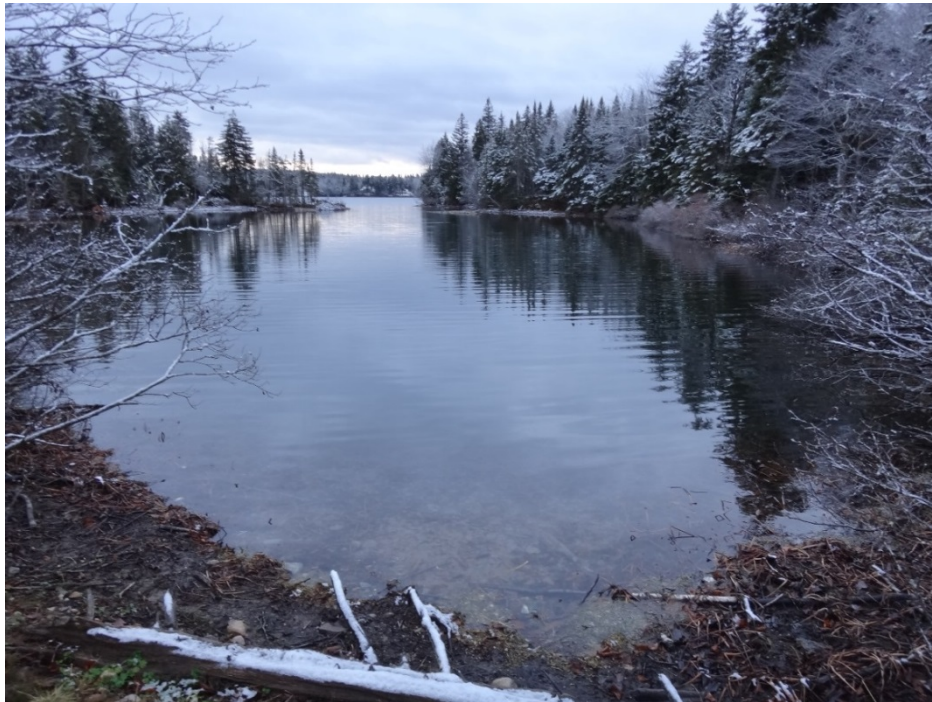
**Photo 62: Taylor Lake Dam
Looking upstream from dam**

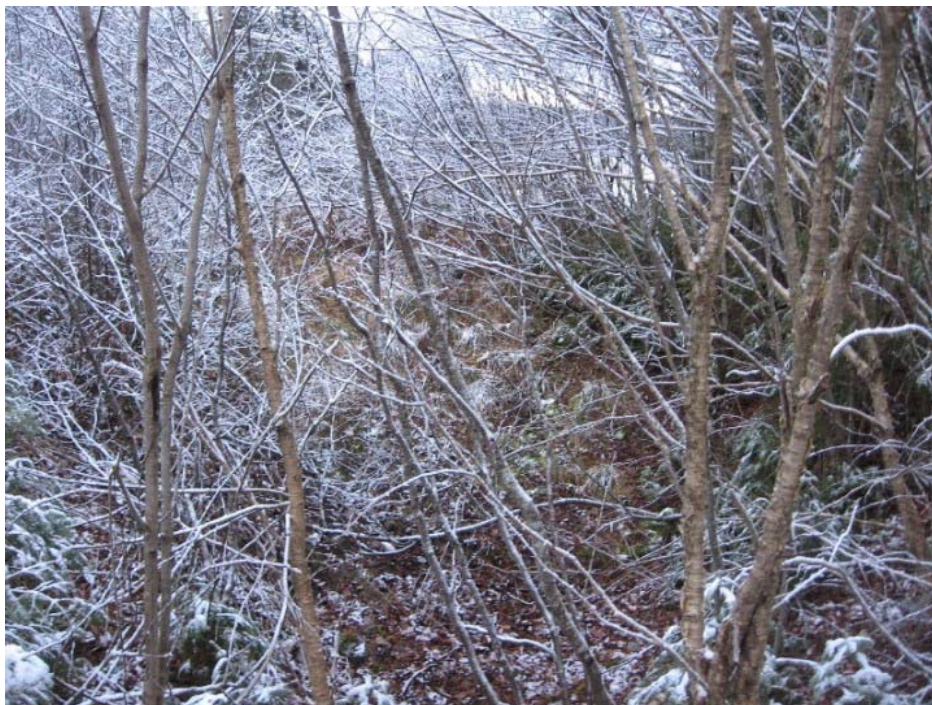
**Photo 63: Taylor Lake Dam
Looking towards downstream face of dam**

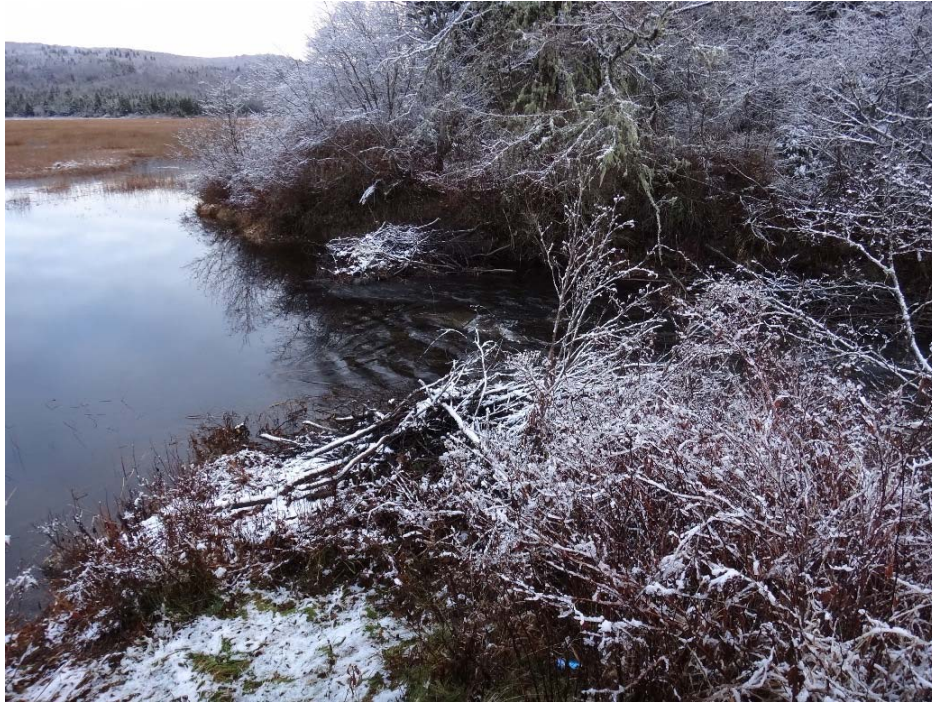
**Photo 64: Otter Lake Dam
Breach at Otter Lake Dam**

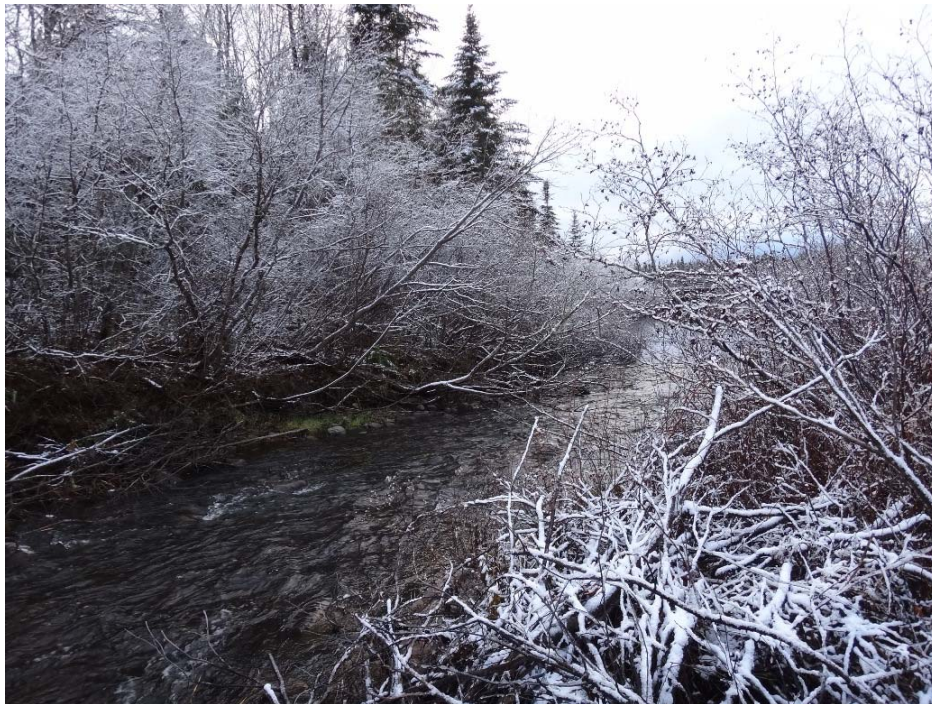
**Photo 65: Otter Lake Dam
Breach at Otter Lake Dam**
