SAINT JOHN HERITAGE CONSERVATION AREAS

Roofs

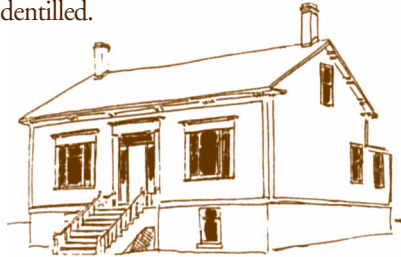
GREEK REVIVAL 1830-1860

Low pitched gable roof creates a temple-like profile. The cornice under the eaves was wide, plain or dentilled.

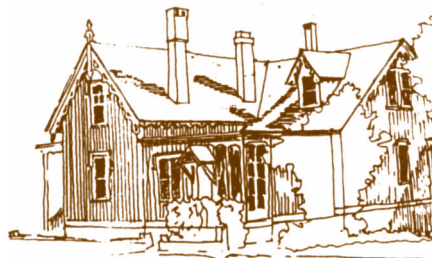
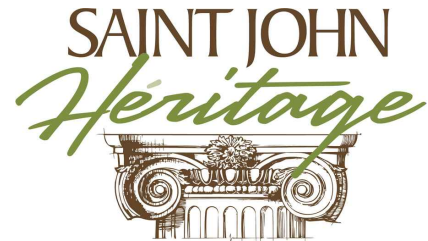
GOTHIC REVIVAL 1850-1870

Steep pitched gable roofs usually enlivened by dormers, finials, pinnacles, and chimneys. Decorative roof-edge "bargeboards" common.

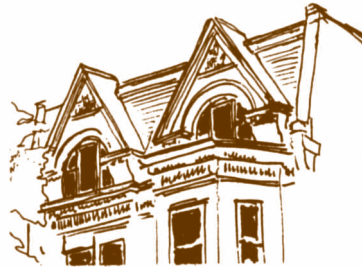
ROMANESQUE 1875-1895

Steeply sloping gable roofs, often intersecting. Enriched with delicate finials, terracotta panels.

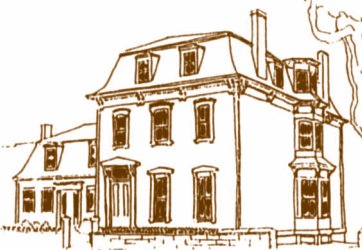
MANSARD 1860-1880

Steeply sloped surface may be straight, curved, convex, concave. Projecting eaves, supported by large wooden brackets on a wide cornice. Dormers and iron cresting common.
